EP-510/2016 – Police Facilities in Kong Nga Po

**Service Contract No. NDO 07/2019
Environmental Team for Site Formation and
Infrastructure Works for Police Facilities in
Kong Nga Po**

**Monthly Environmental Monitoring and
Audit Report for April 2022
(Version 1.0)**

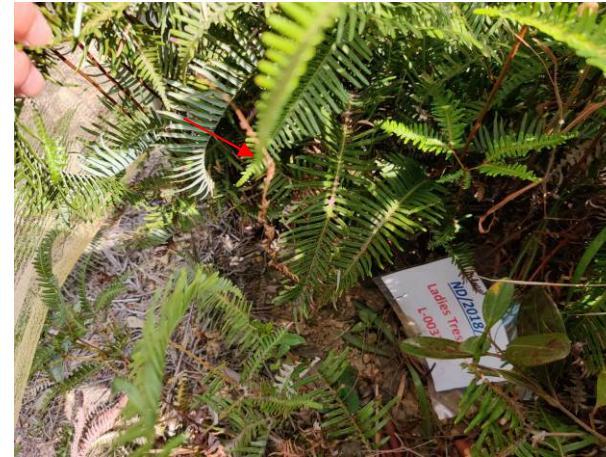
Photo 7

Description: Wilting of *Spiranthes sinensis* are observed after flowering season.

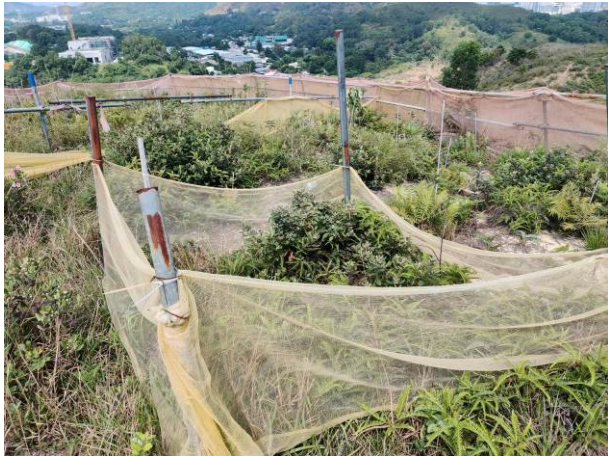
Photo 8

Description: Protective fence for transplanted *Spiranthes sinensis* are properly erected.

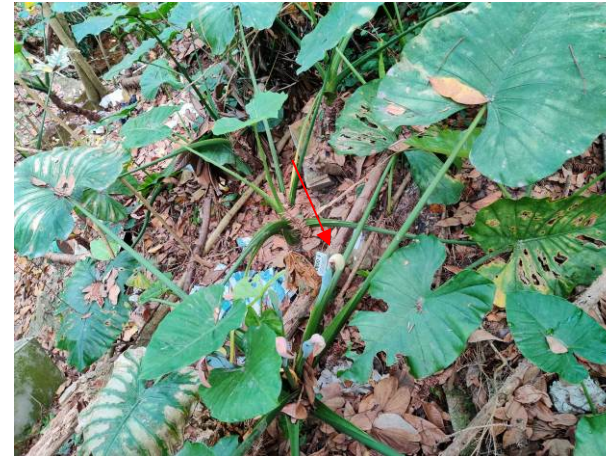
Photo 13

Description: An undersized seedling of *Keteleeria fortunei* (F-0081) was found collapsed due to internal decay.

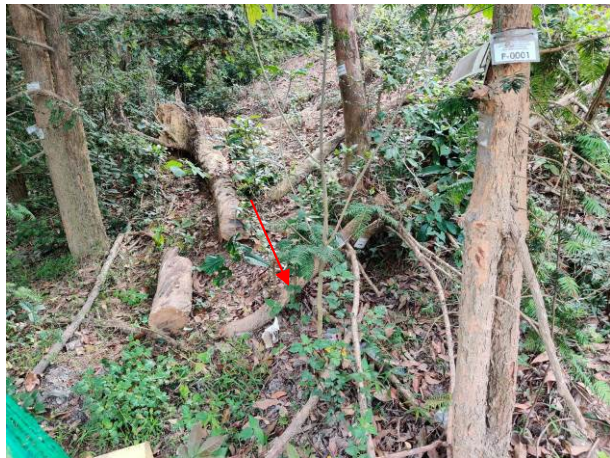
Photographic Records for Monthly Monitoring of Flora Species of Conservation Interest on 22nd April 2022

Description: An undersized seedling of *Keteleeria fortunei* (F-0051) was found uprooted by the nearby fallen tree.

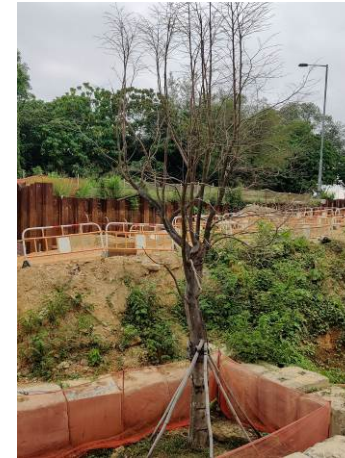
Photo 16

Description: Poor health condition of *Aquilaria sinensis* A-008 (dead branches, dieback twigs, algae on branches etc.) was found. The Contractor was reminded to urge their landscape specialist to closely monitor and take appropriate and prompt action to rescue the plants without further delay especially during the spring season.

- 5.10 During monthly monitoring, poor health condition of *Aquilaria sinensis* A-008, A-0009 and A-0010 (dead branches, dieback twigs, algae on the branches etc.) were found. The Contractor was reminded to closely monitor and take appropriate and prompt action according to the tree conditions to rescue the trees with reference to the approved transplantation proposal. No construction activity and equipment storage were observed within the receptor site. Temporary protective fence was properly erected and maintained for the transplanted species. The Contractor was also recommended to check any influencing factors outside the receptor sites which are likely affected, directly or indirectly to the transplanted individuals.

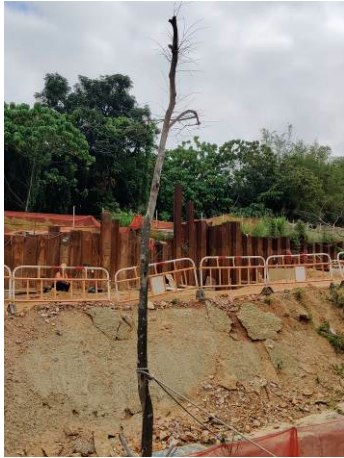
Photo 17

Description: Poor health condition of *Aquilaria sinensis* A-0010 (dead branches, dieback twigs, algae on branches etc.) was found. The Contractor was reminded to urge their landscape specialist to closely monitor and take appropriate and prompt action to rescue the plants without further delay especially during the spring season.

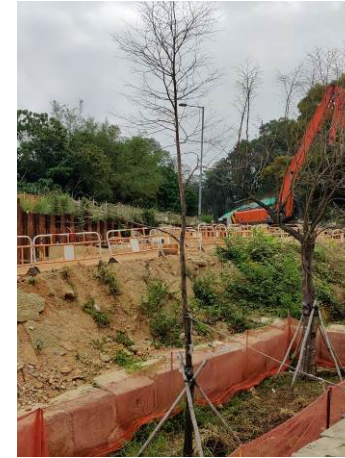
Photographic Records for Monthly Monitoring of Flora Species of Conservation Interest on 22nd April 2022

Description: Poor health condition of *Aquilaria sinensis* A-0009 (dead branches, dieback twigs, algae on branches etc.) was found. The Contractor was reminded to urge their landscape specialist to closely monitor and take appropriate and prompt action to rescue the plants without further delay especially during the spring season.

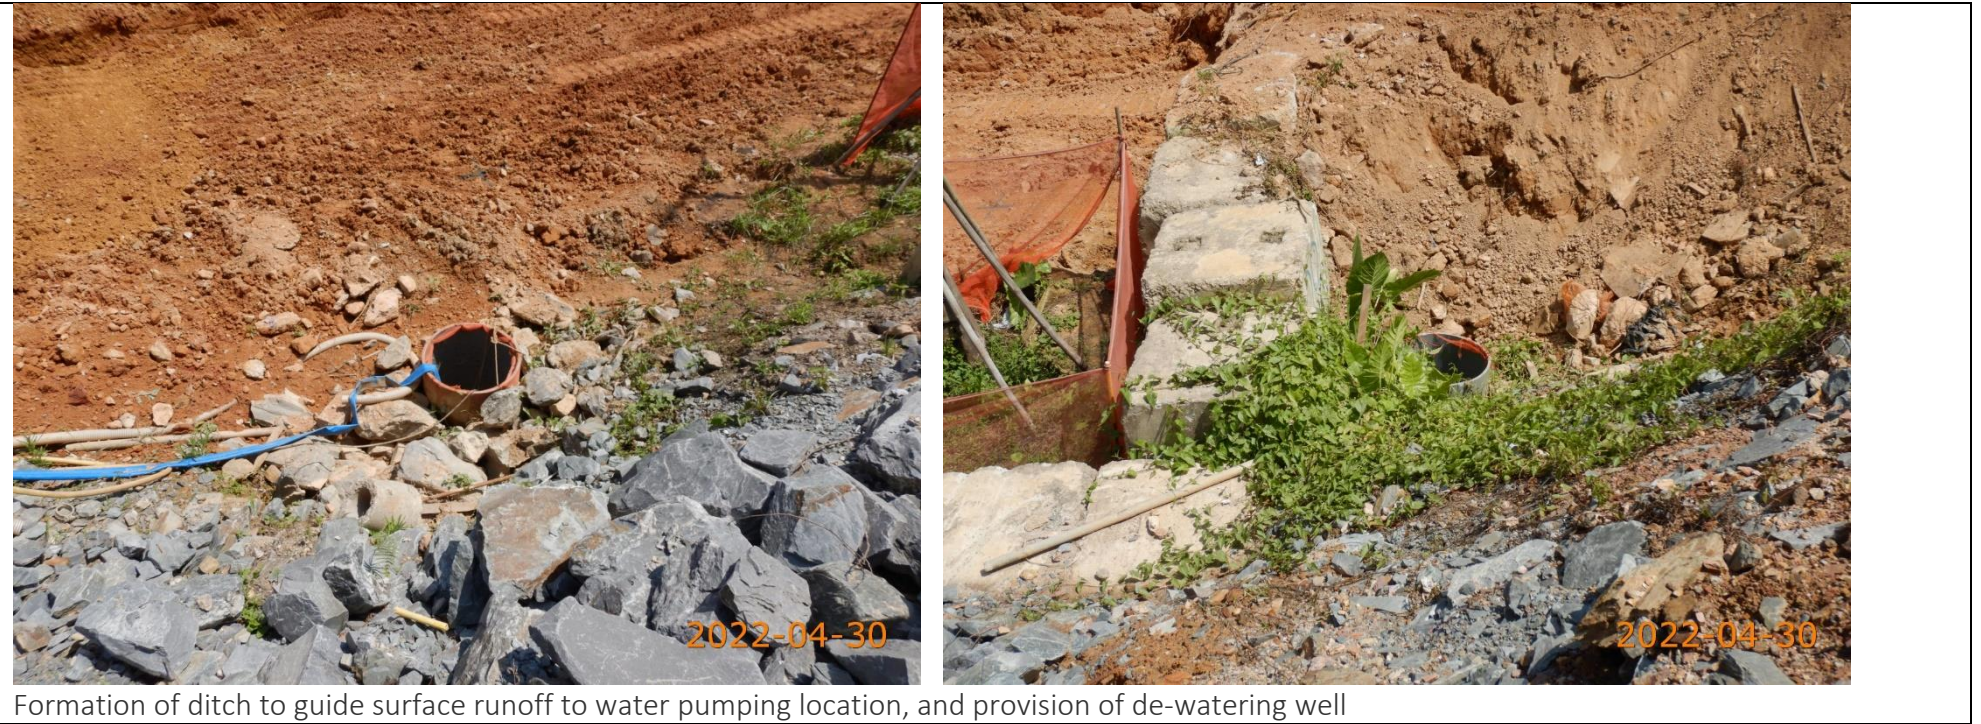
Formation of ditch to guide surface runoff to water pumping location, and provision of de-watering well

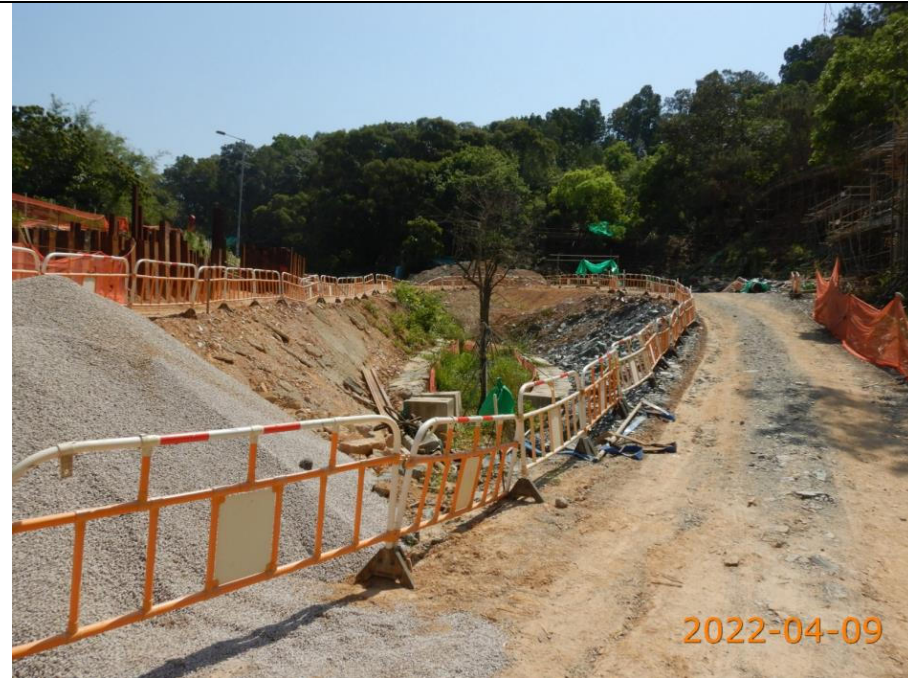
Formation of ditch to guide surface runoff to water pumping location, moist soil surface observed

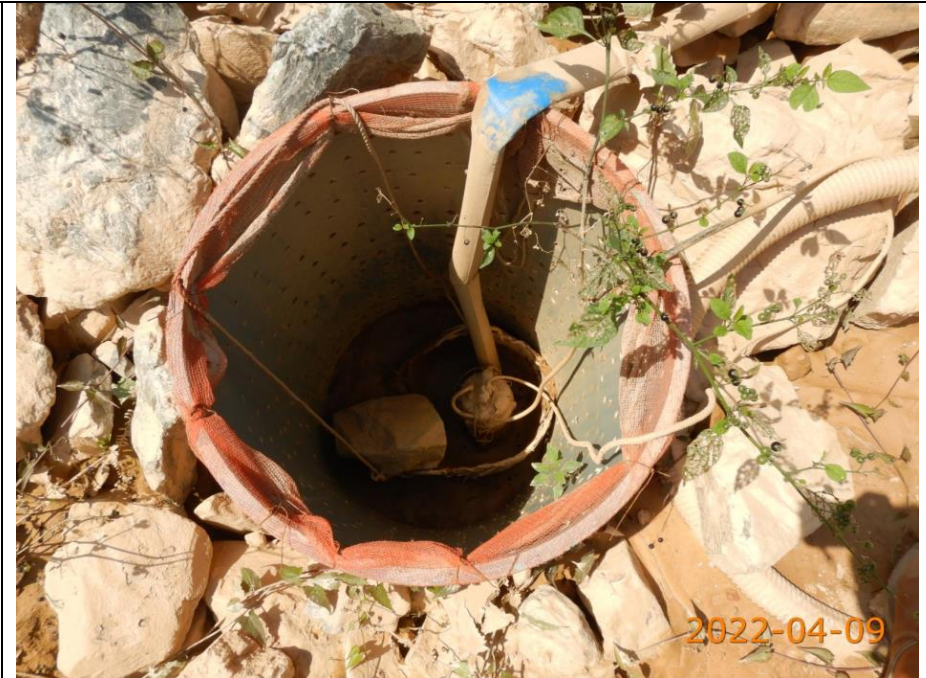
Submersible pump standby
