**EP-510/2016 – Police Facilities in Kong Nga Po**

**Service Contract No. NDO 07/2019  
Environmental Team for Site Formation and  
Infrastructure Works for Police Facilities in  
Kong Nga Po**

**Quarterly Environmental Monitoring and  
Audit Report for January to March 2022  
(Version 1.0)**

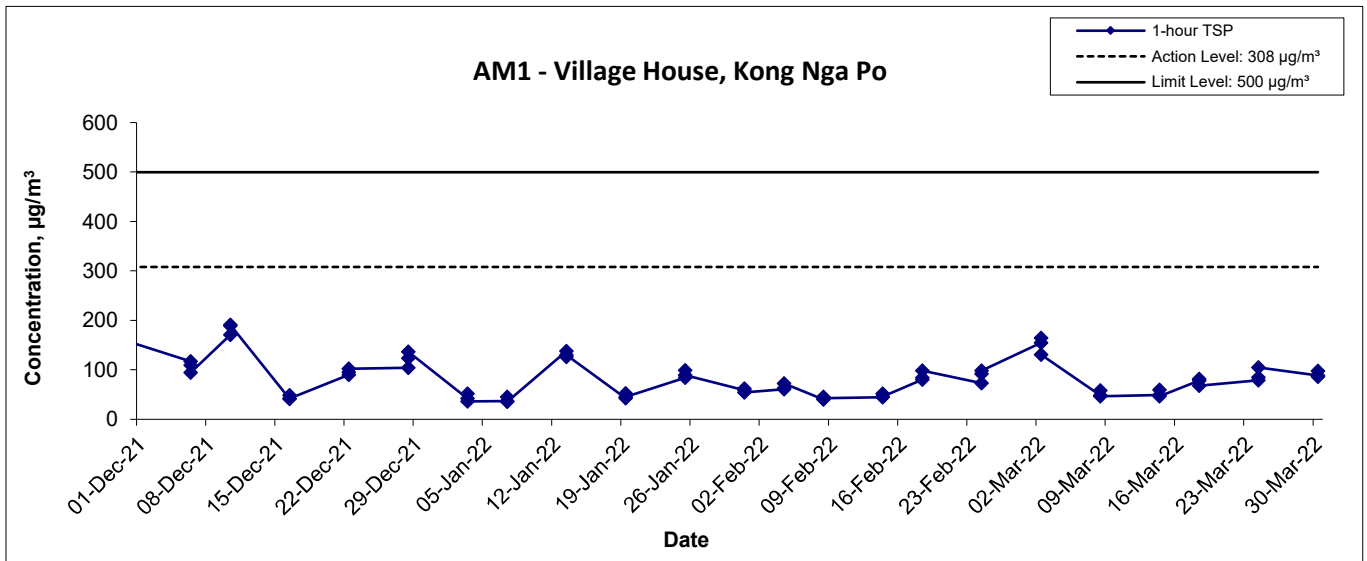
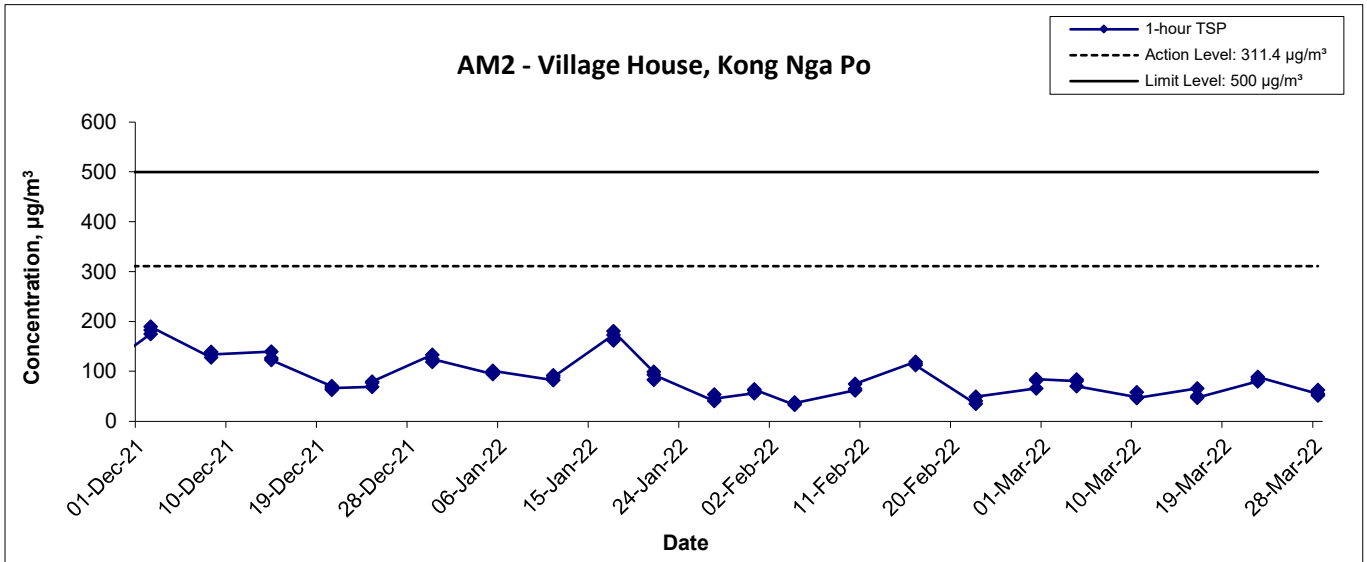
Title Service Contract No. NDO 07/2019 Environmental Team for Site Formation and Infrastructure Works for Police Facilities in Kong Nga Po Graphical Presentation of 1-hour TSP Monitoring Results	Scale N.T.S	Project No. WMA20001

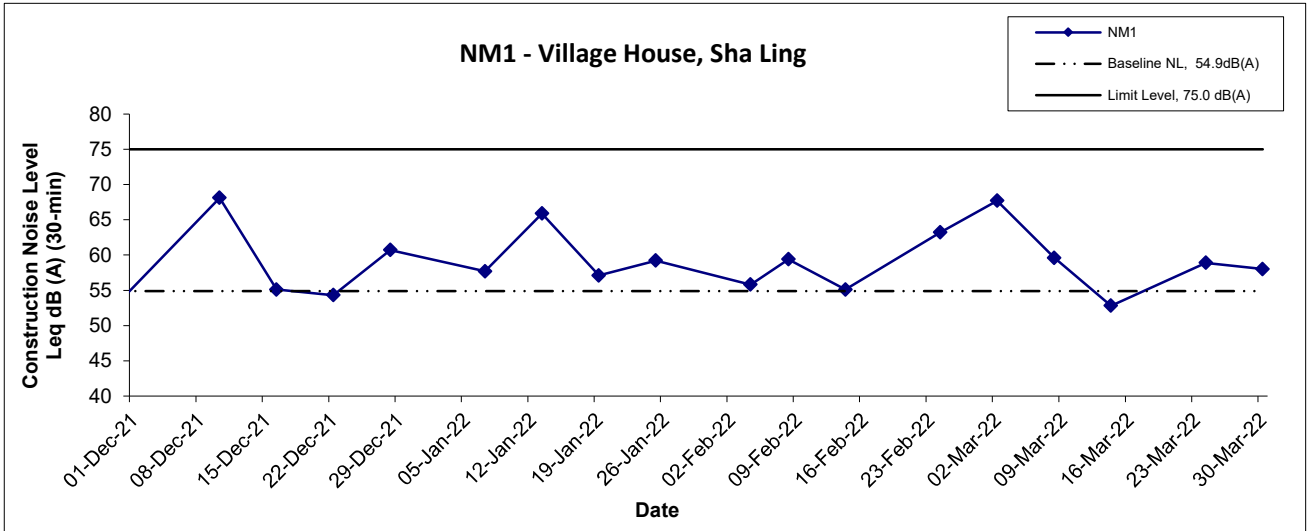
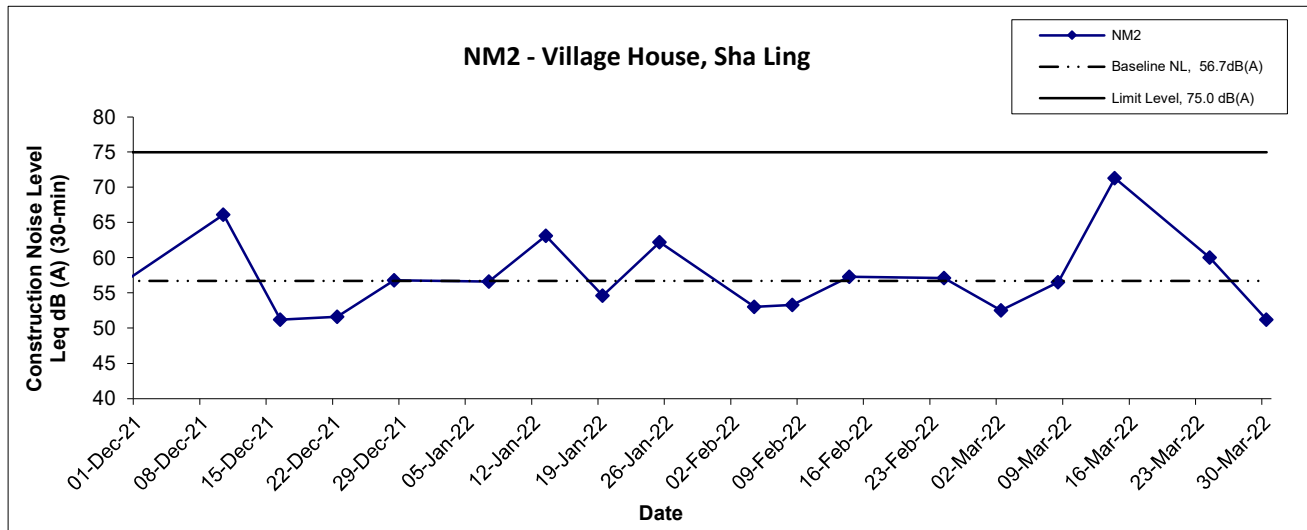
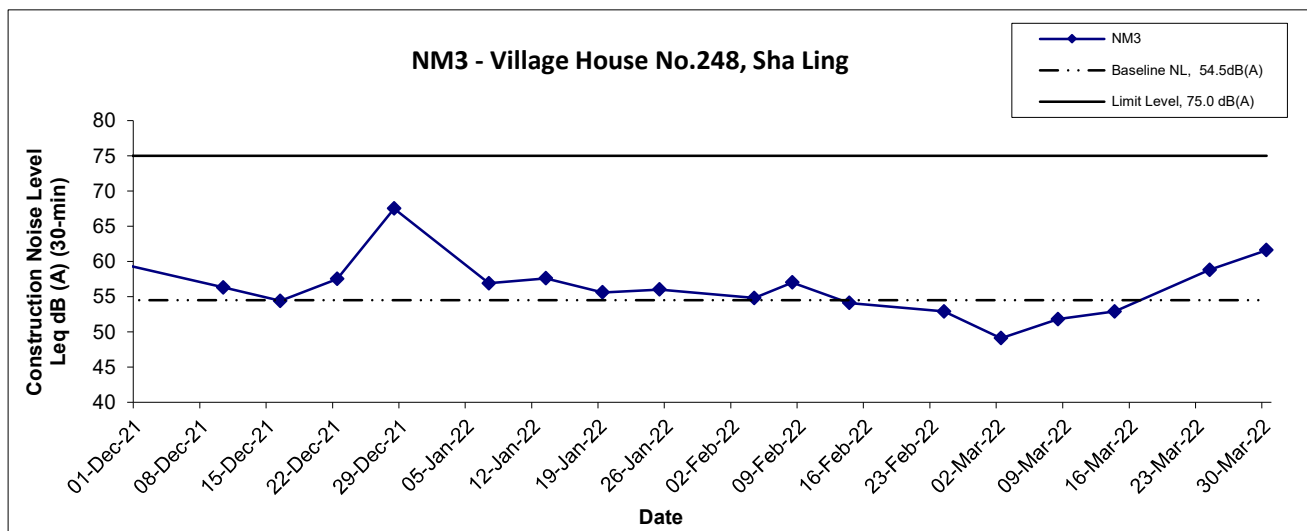
Title Service Contract No. NDO 07/2019 Environmental Team for Site Formation and Infrastructure Works for Police Facilities in Kong Nga Po Graphical Presentation of Construction Noise Monitoring Results	Scale N.T.S	Project No. WMA20001	consulting . testing . research
	Date Mar 22	Appendix C

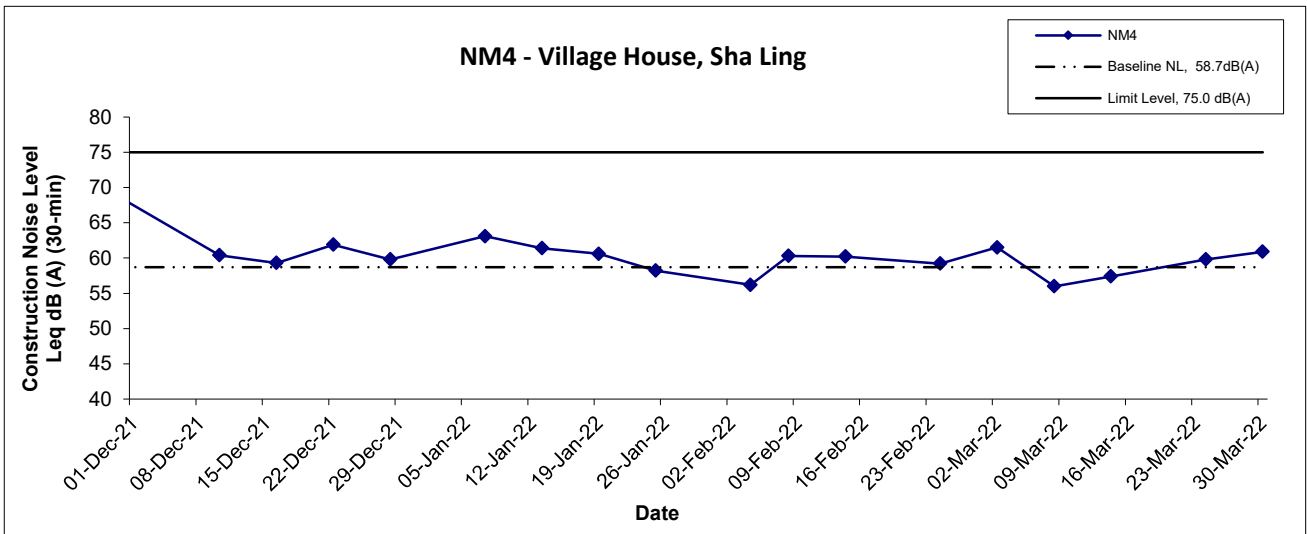
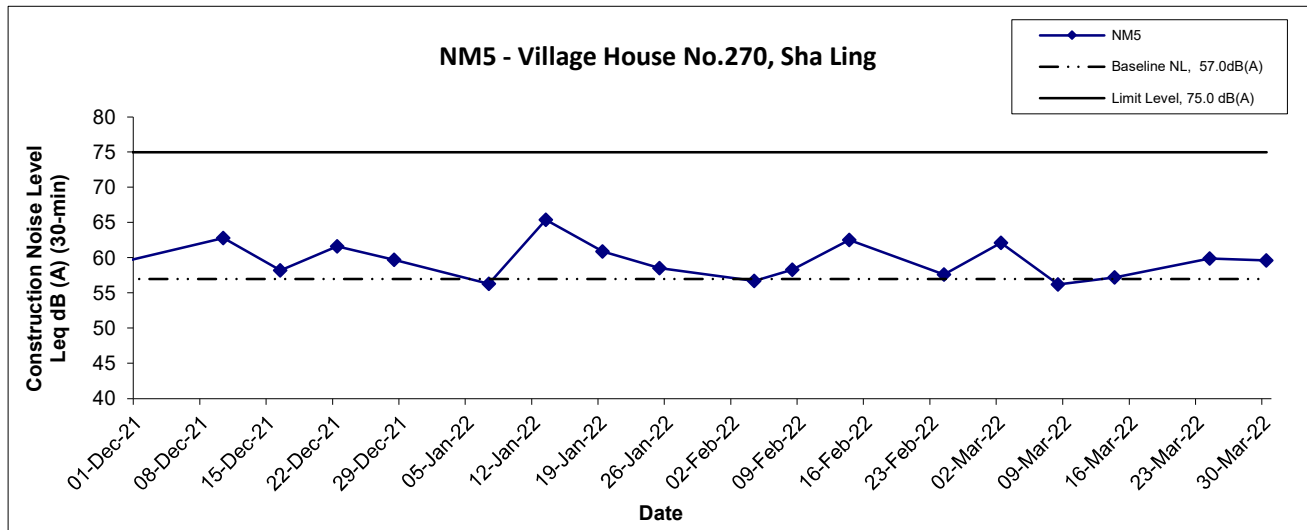
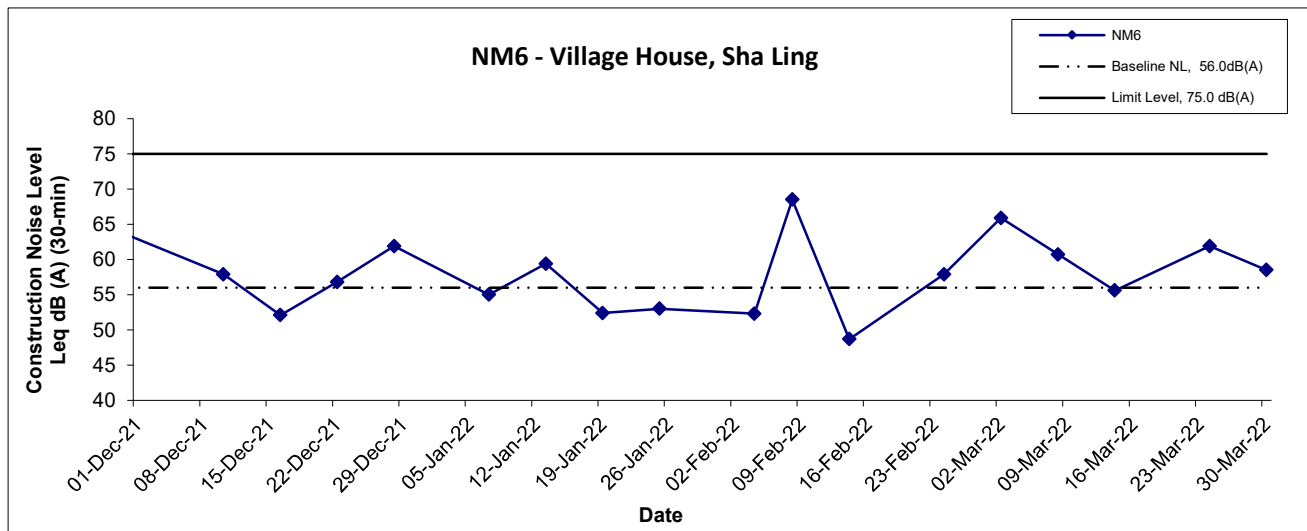
Title Service Contract No. NDO 07/2019 Environmental Team for Site Formation and Infrastructure Works for Police Facilities in Kong Nga Po Graphical Presentation of Construction Noise Monitoring Results	Scale N.T.S	Project No. WMA20001	consulting . testing . research
	Date Mar 22	Appendix C

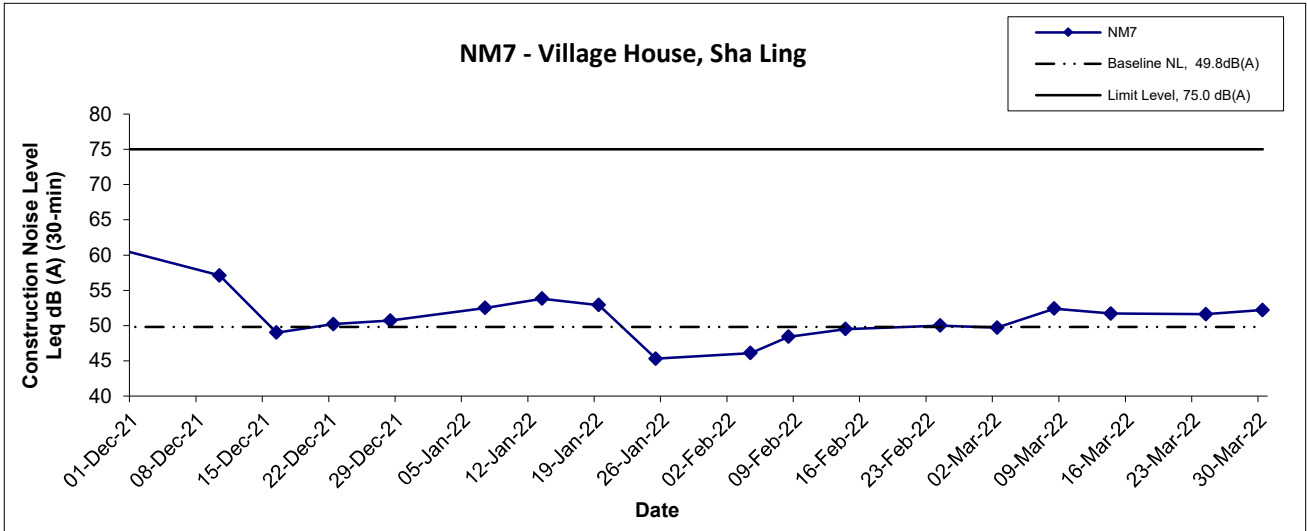
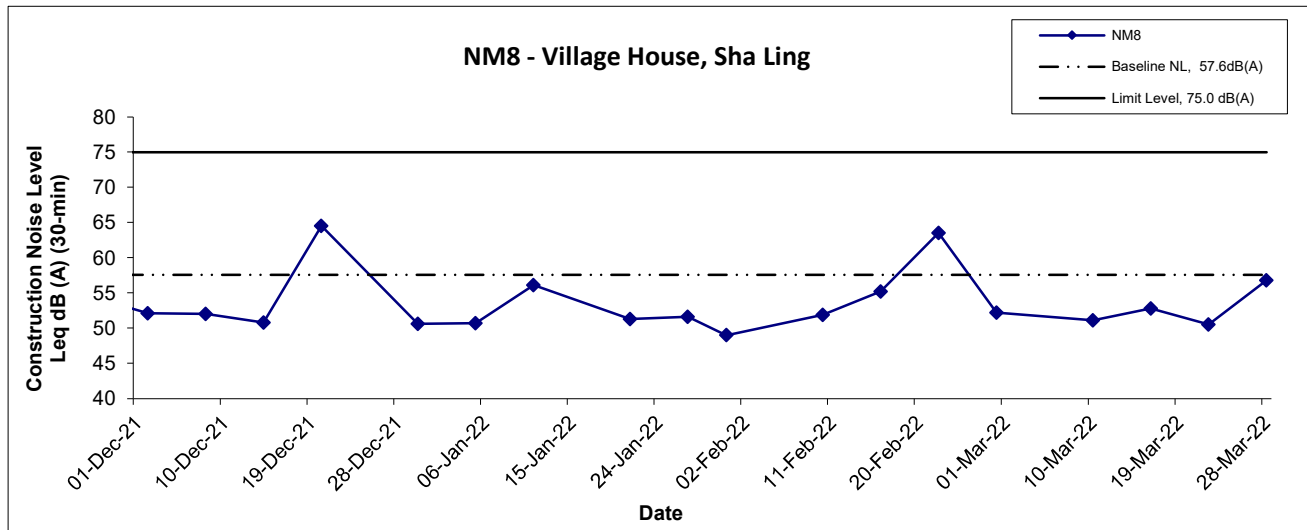
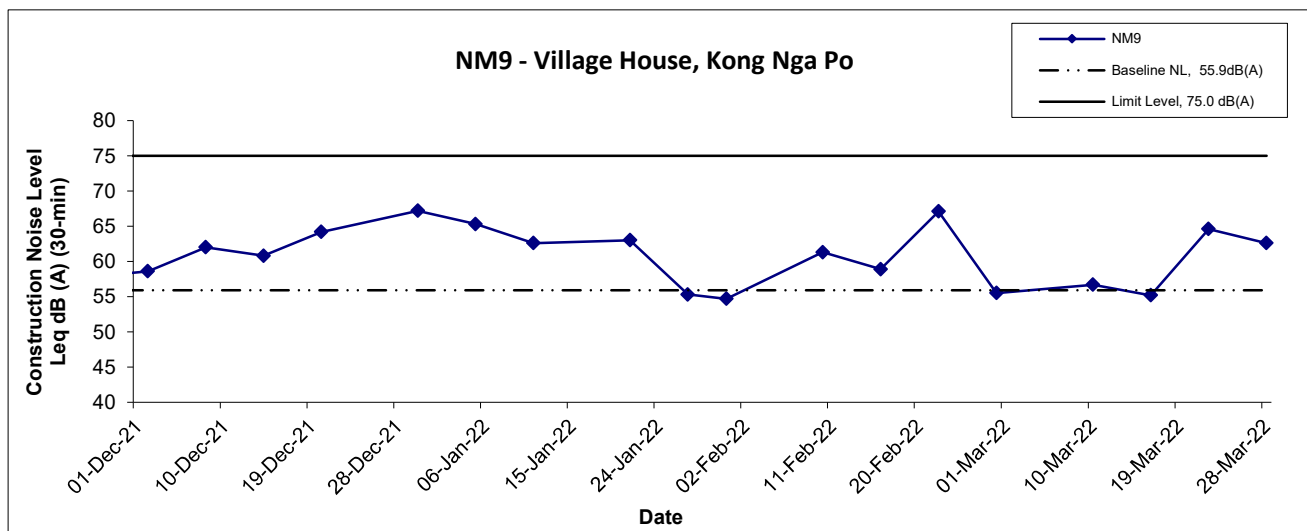
Title Service Contract No. NDO 07/2019 Environmental Team for Site Formation and Infrastructure Works for Police Facilities in Kong Nga Po Graphical Presentation of Construction Noise Monitoring Results	Scale N.T.S	Project No. WMA20001	consulting . testing . research
	Date Mar 22	Appendix C

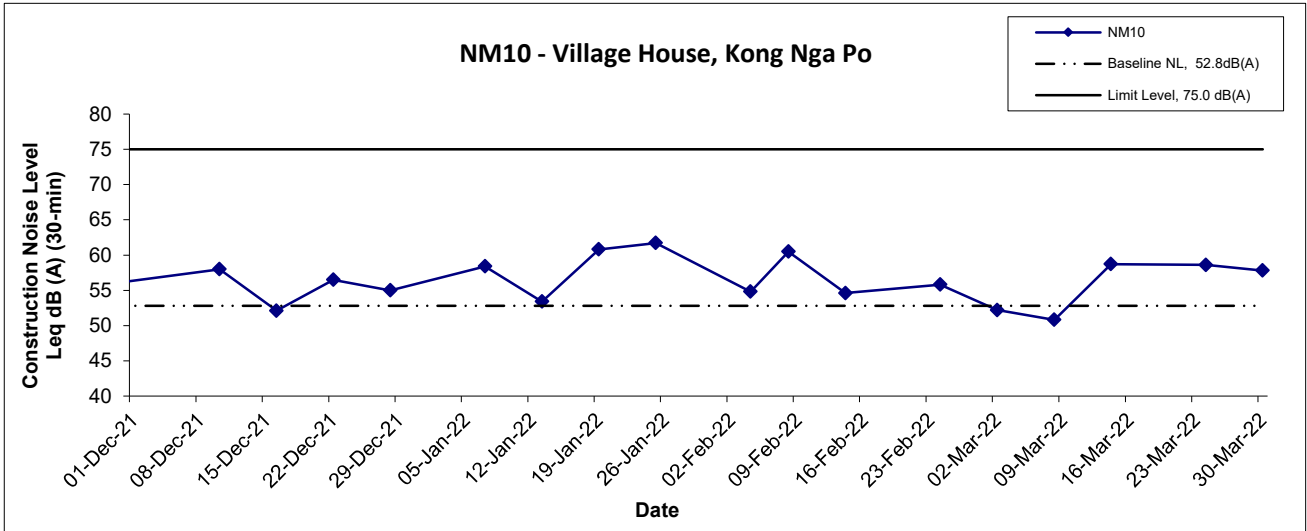
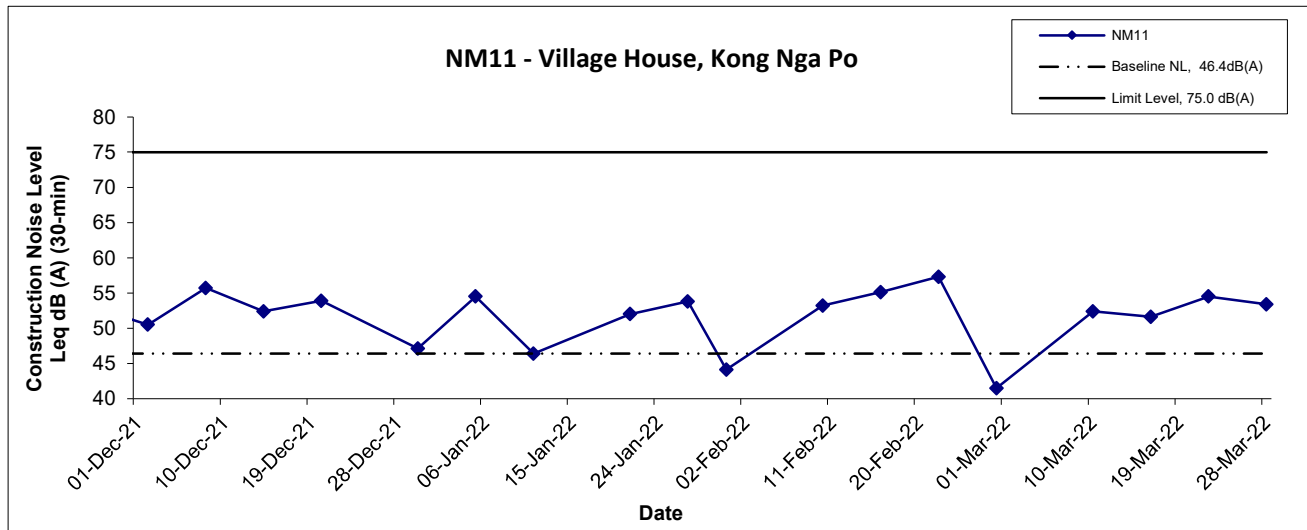
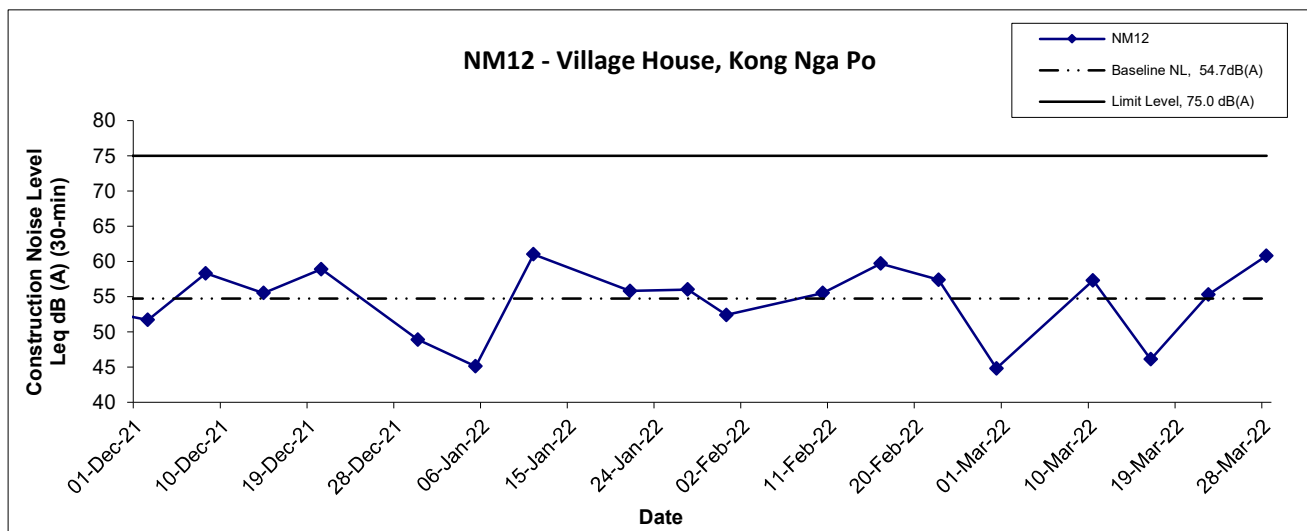
Title Service Contract No. NDO 07/2019 Environmental Team for Site Formation and Infrastructure Works for Police Facilities in Kong Nga Po Graphical Presentation of Construction Noise Monitoring Results	Scale N.T.S	Project No. WMA20001	consulting . testing . research
	Date Mar 22	Appendix C

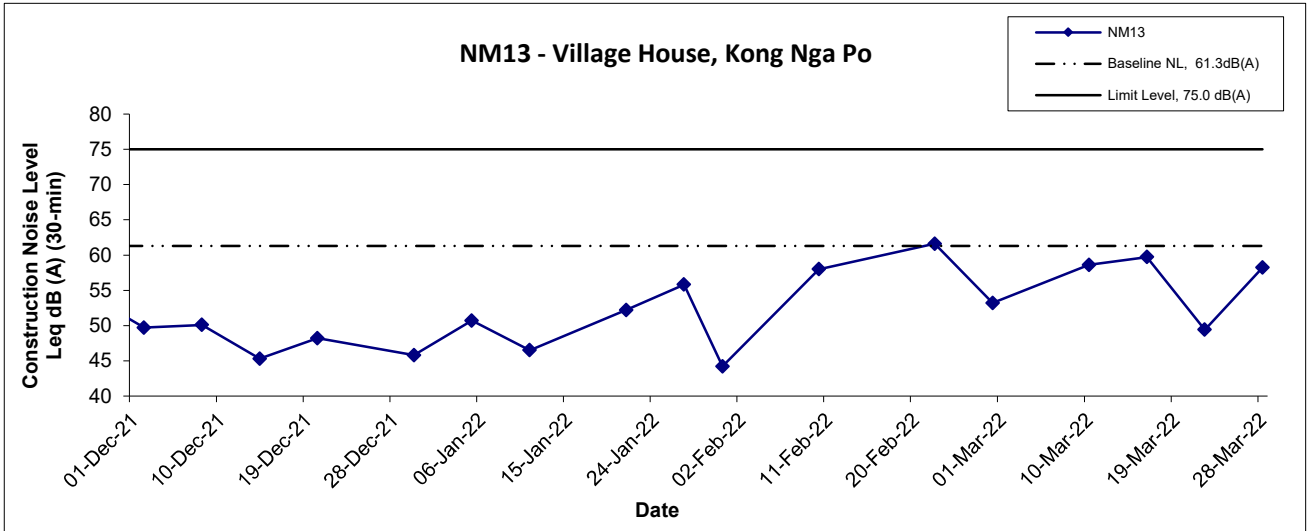
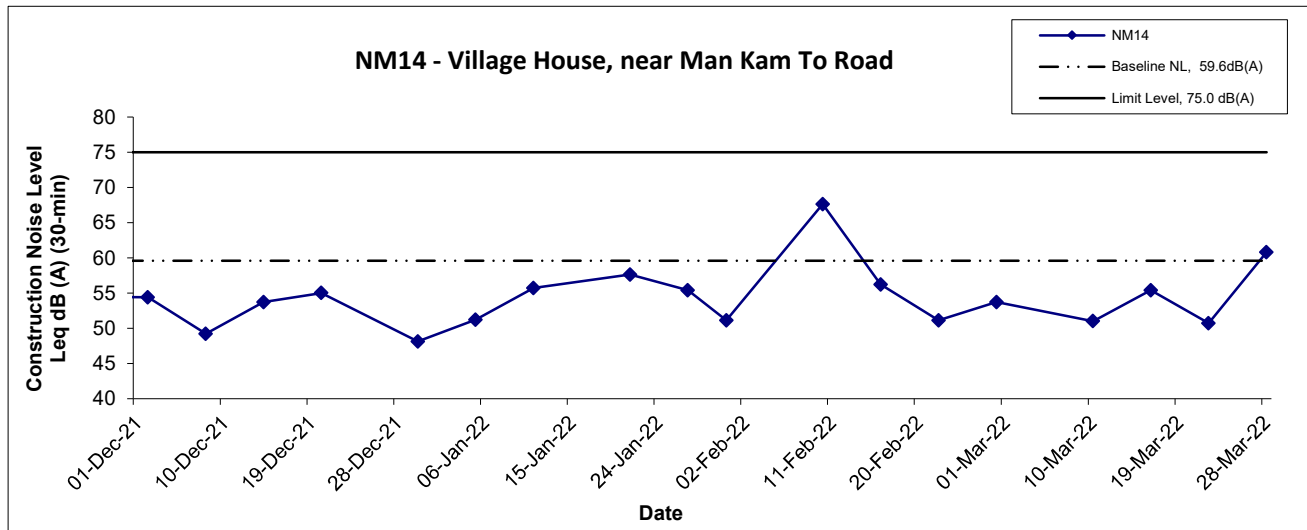
Title Service Contract No. NDO 07/2019 Environmental Team for Site Formation and Infrastructure Works for Police Facilities in Kong Nga Po Graphical Presentation of Construction Noise Monitoring Results	Scale N.T.S	Project No. WMA20001	匯力 consulting . testing . research
	Date Mar 22	Appendix C
