EP-510/2016 – Police Facilities in Kong Nga Po

**Service Contract No. NDO 07/2019
Environmental Team for Site Formation and
Infrastructure Works for Police Facilities in
Kong Nga Po**

**Monthly Environmental Monitoring and
Audit Report for May 2022
(Version 1.0)**

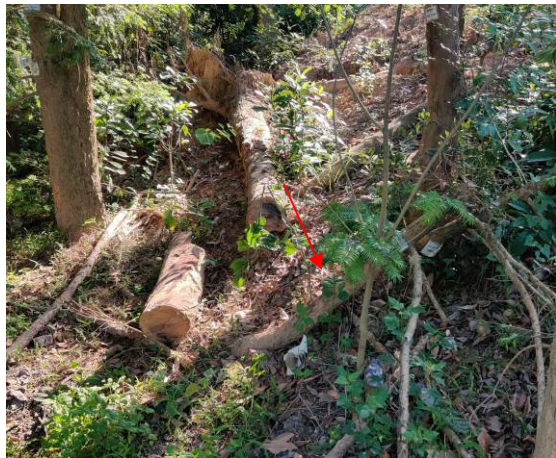
Photo 13

Description: An undersized seedling of *Keteleeria fortunei* (F-0051) was found uprooted by the nearby fallen tree.

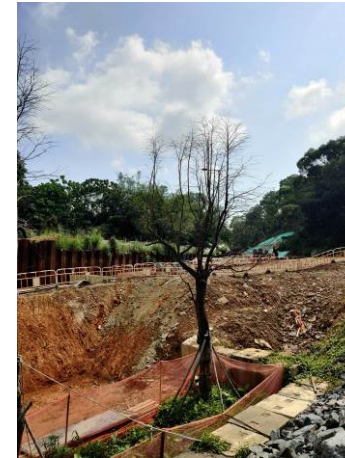
Photo 15

- 5.10 During monthly monitoring, poor health condition of *Aquilaria sinensis* A-008, A-0009 and A-0010 (dead branches, dieback twigs, algae on the branches etc.) were found. The Contractor was reminded to closely monitor and take appropriate and prompt action according to the tree conditions to rescue the trees with reference to the approved transplantation proposal. No construction activity and equipment storage were observed within the receptor site. Temporary protective fence was properly erected and maintained for the transplanted species. The Contractor was also recommended to check any influencing

Description: Poor health condition of *Aquilaria sinensis* A-008 (dead branches, dieback twigs, algae on branches etc.) was found. The Contractor was reminded to urge their landscape specialist to closely monitor and take appropriate and prompt action to rescue the plants without further delay especially during the spring season.

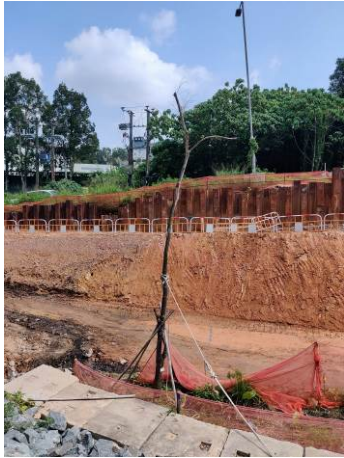
Photo 16

Description: Poor health condition of *Aquilaria sinensis* A-0010 (dead branches, dieback twigs, algae on branches etc.) was found. The Contractor was reminded to urge their landscape specialist to closely monitor and take appropriate and prompt action to rescue the plants without further delay especially during the spring season.

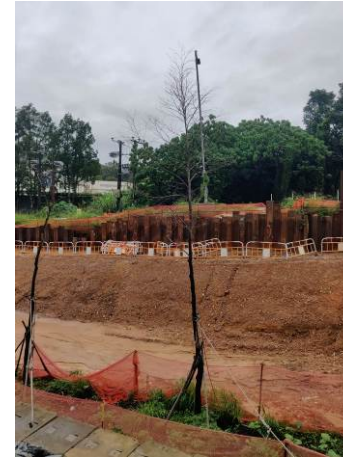
Photo 17

Description: Poor health condition of *Aquilaria sinensis* A-0009 (dead branches, dieback twigs, algae on branches etc.) was found. The Contractor was reminded to urge their landscape specialist to closely monitor and take appropriate and prompt action to rescue the plants without further delay especially during the spring season.

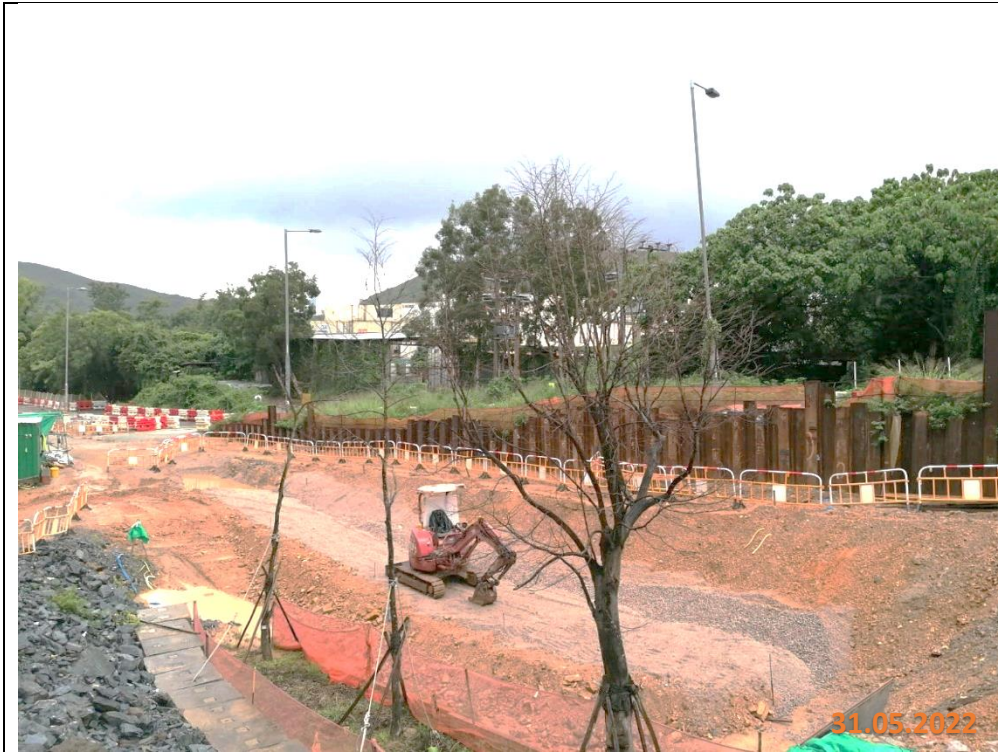
Formation of ditch to divert the surface runoff into water collection point

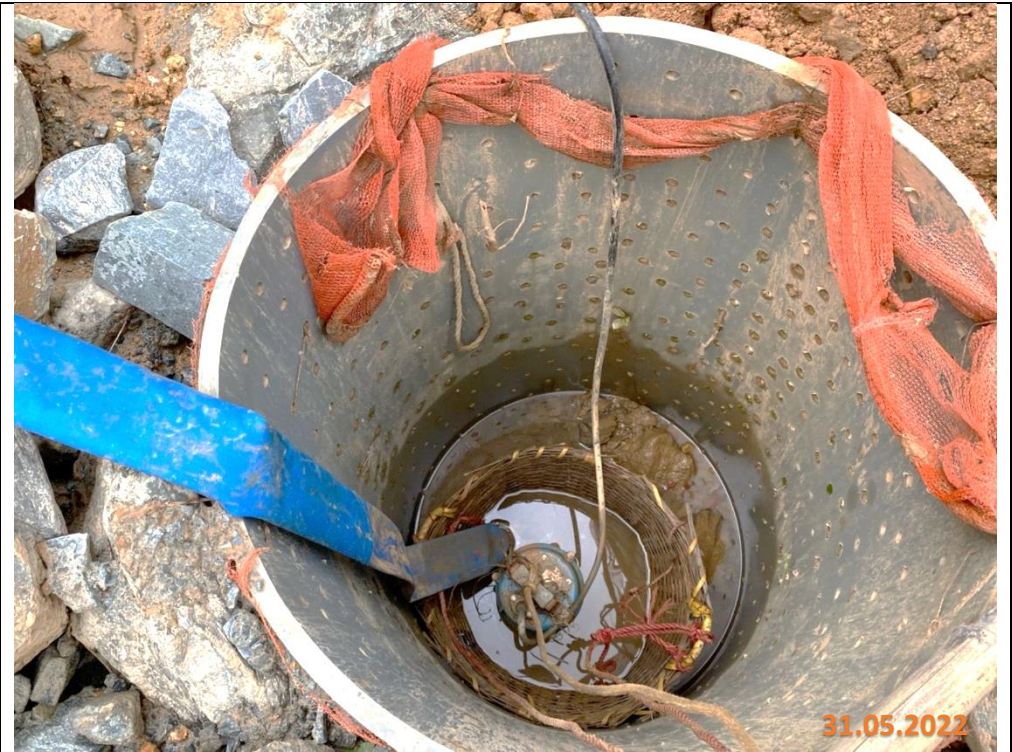
Submersible pump in place and dewatering was carrying out to drain away the collected surface runoff when it was raining

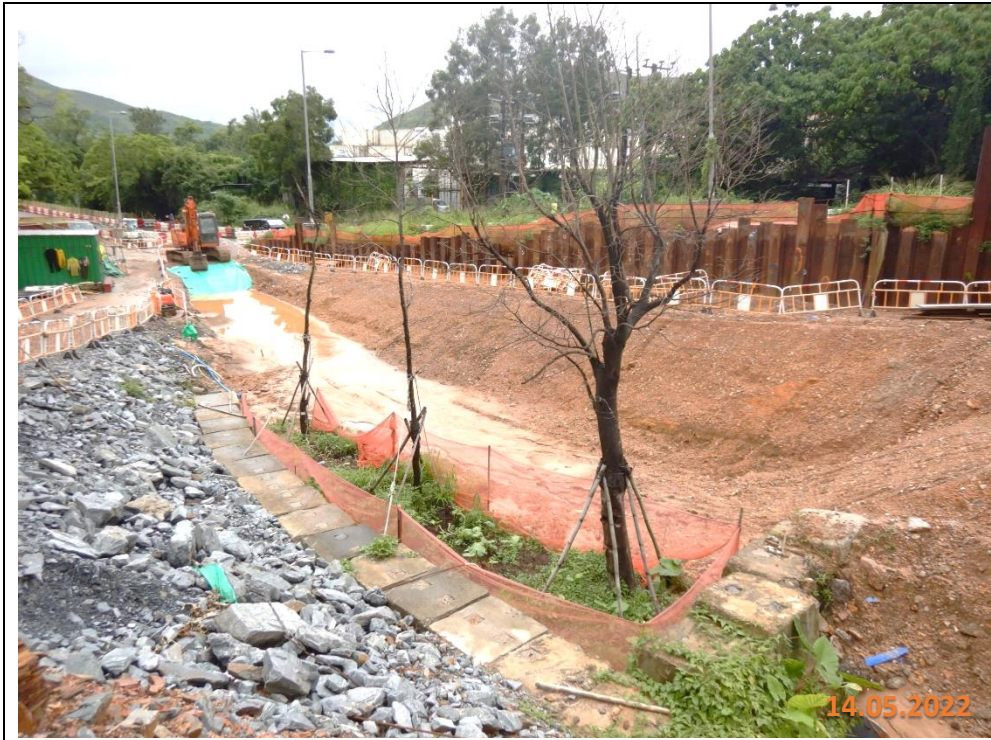
Formation of ditch to divert the surface runoff into water collection point

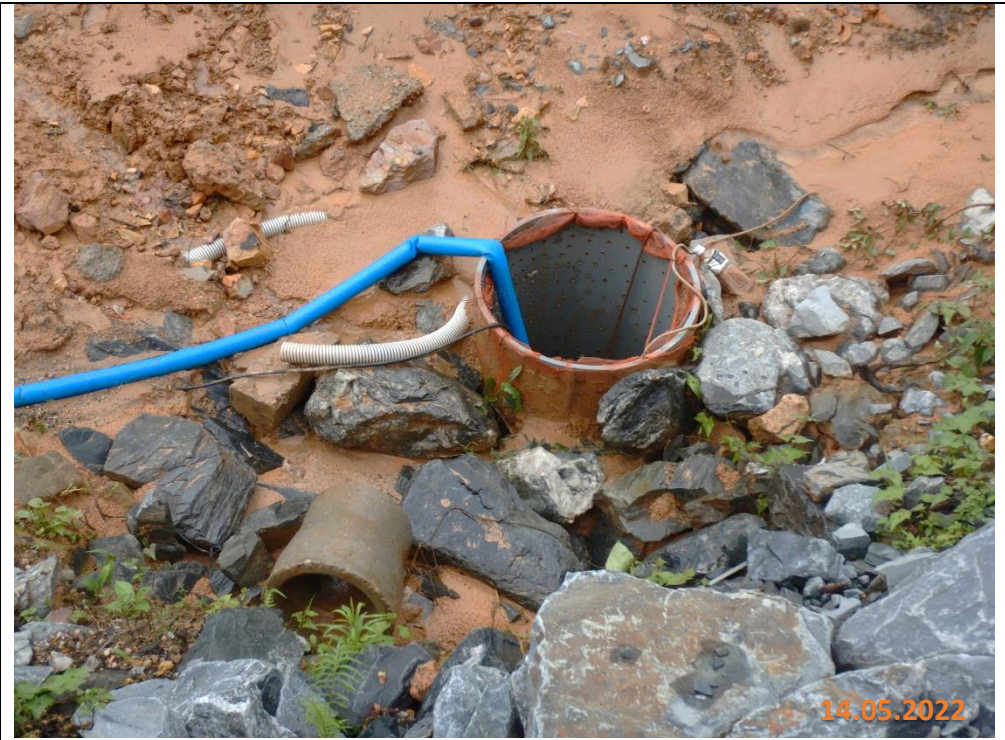
Submersible pump in place and dewatering was carrying out to drain away the collected surface runoff when it was raining

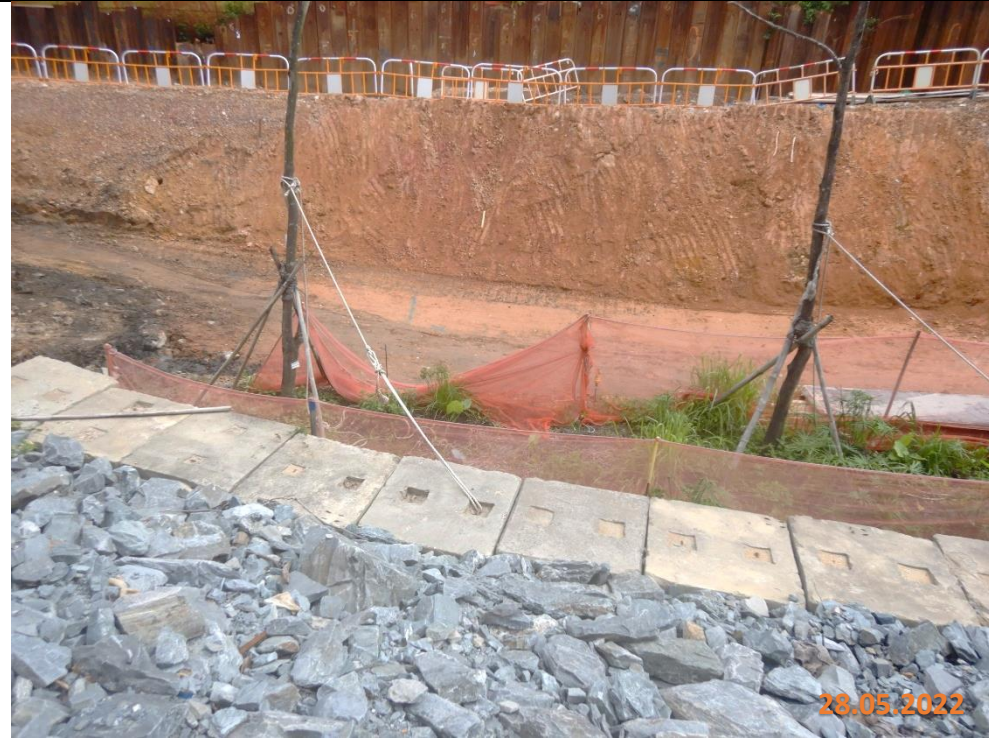
Formation of ditch to divert the surface runoff into water collection point

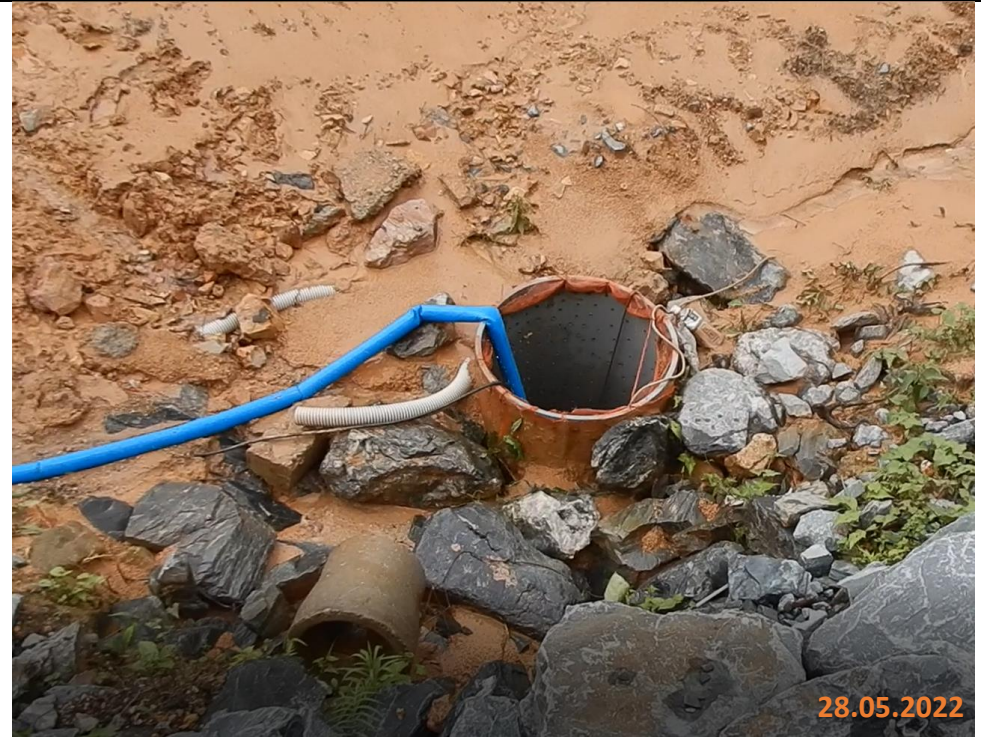
Submersible pump in place and dewatering was carrying out to drain away the collected surface runoff when it was raining

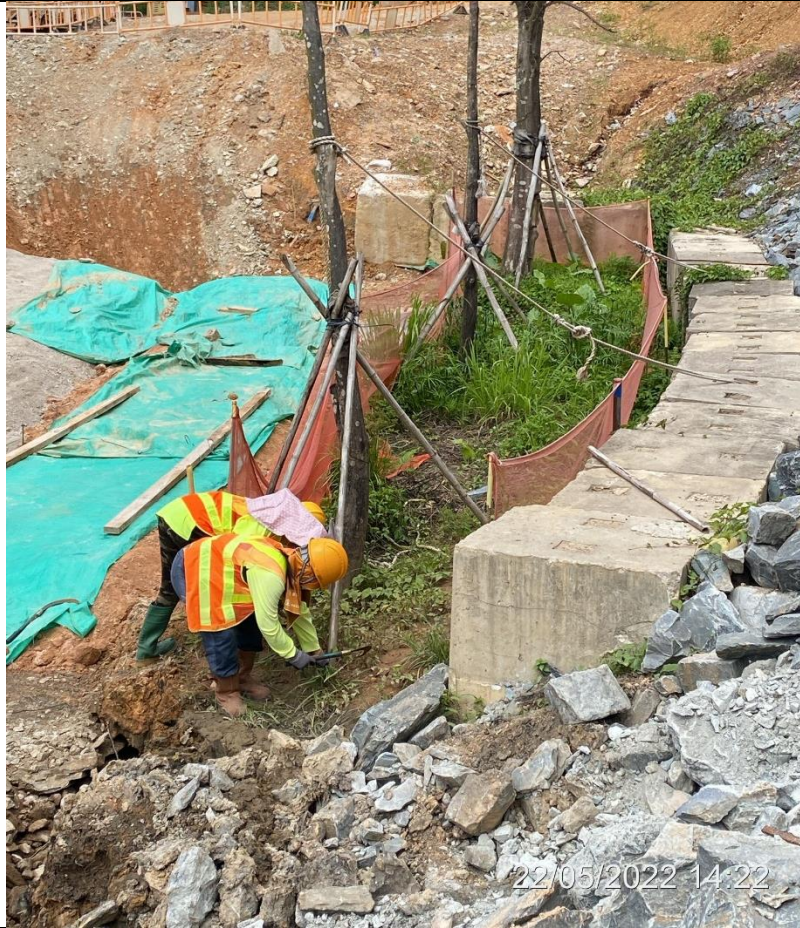
Weeding has been conducted on 22 May 2022.
