**Re: Contract No. SS K/509
Provision of Independent Environmental Checker Consultancy for Design
and Construction of Kong Nga Po Police Training Facilities
Verification of Monthly EM&A Report (March 2024)**

**Provision of Environmental Team consultancy
for Design and Construction of Kong Nga Po Police
Training Facilities (Programme No. 279LP)**

**Monthly Environmental Monitoring and
Audit Report for March 2024
(Version 2)**

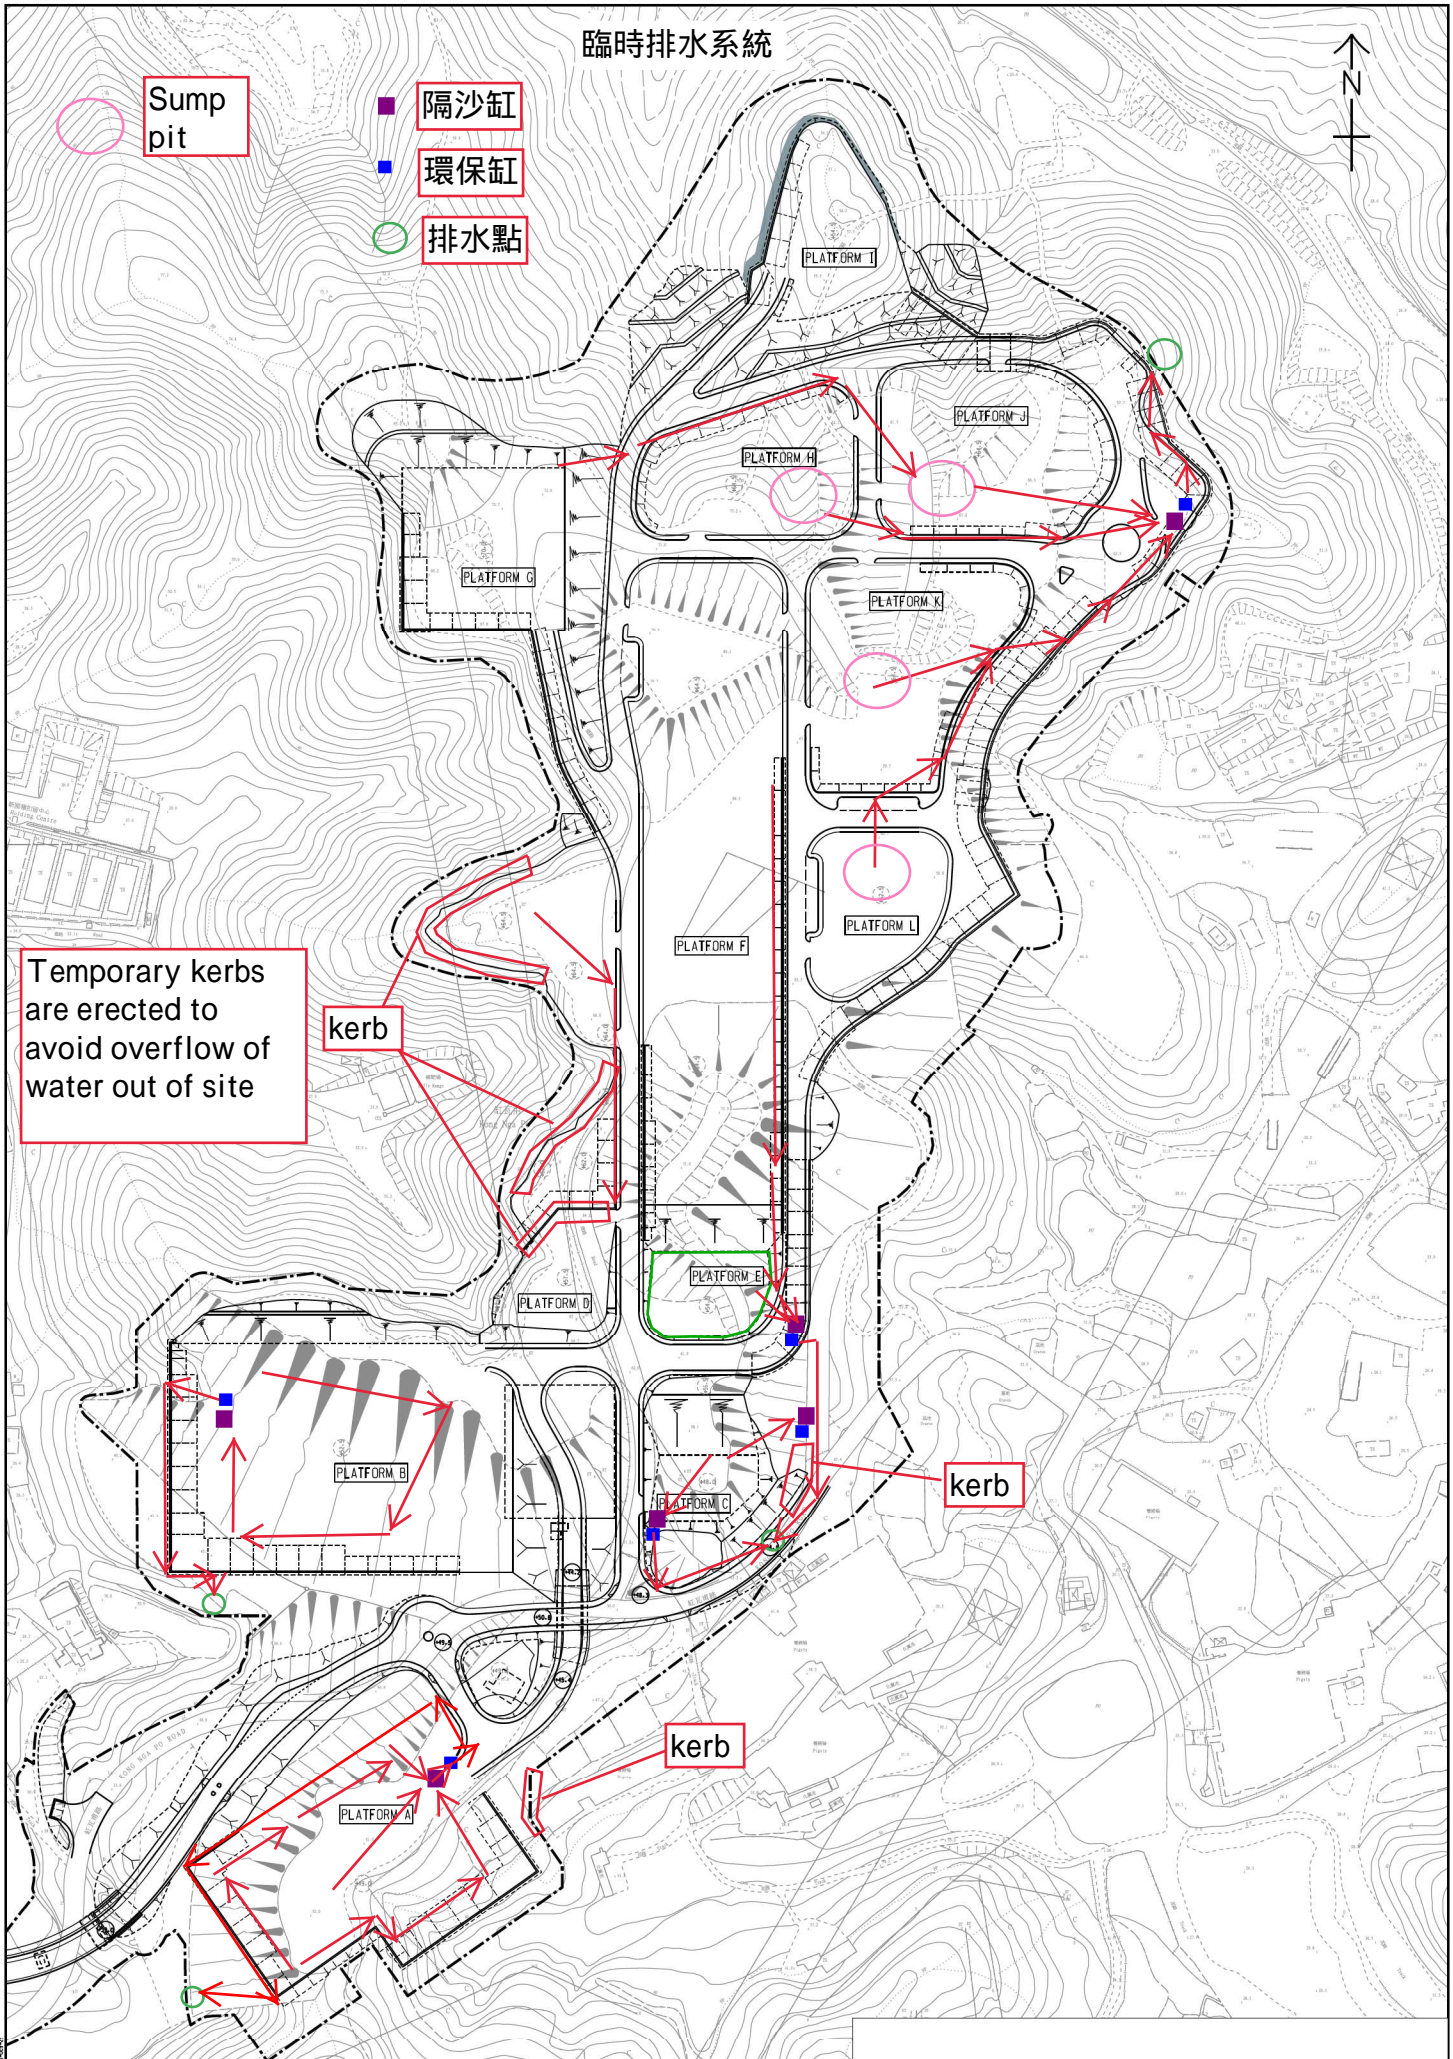
Temporary kerbs are erected to avoid overflow of water out of site
