**Provision of Independent Environmental Checker Consultancy for Design
and Construction of Kong Nga Po Police Training Facilities
Verification of Monthly EM&A Report (May 2024)**

**Provision of Environmental Team consultancy
for Design and Construction of Kong Nga Po Police
Training Facilities (Programme No. 279LP)**

**Monthly Environmental Monitoring and
Audit Report for May 2024
(Version 4)**

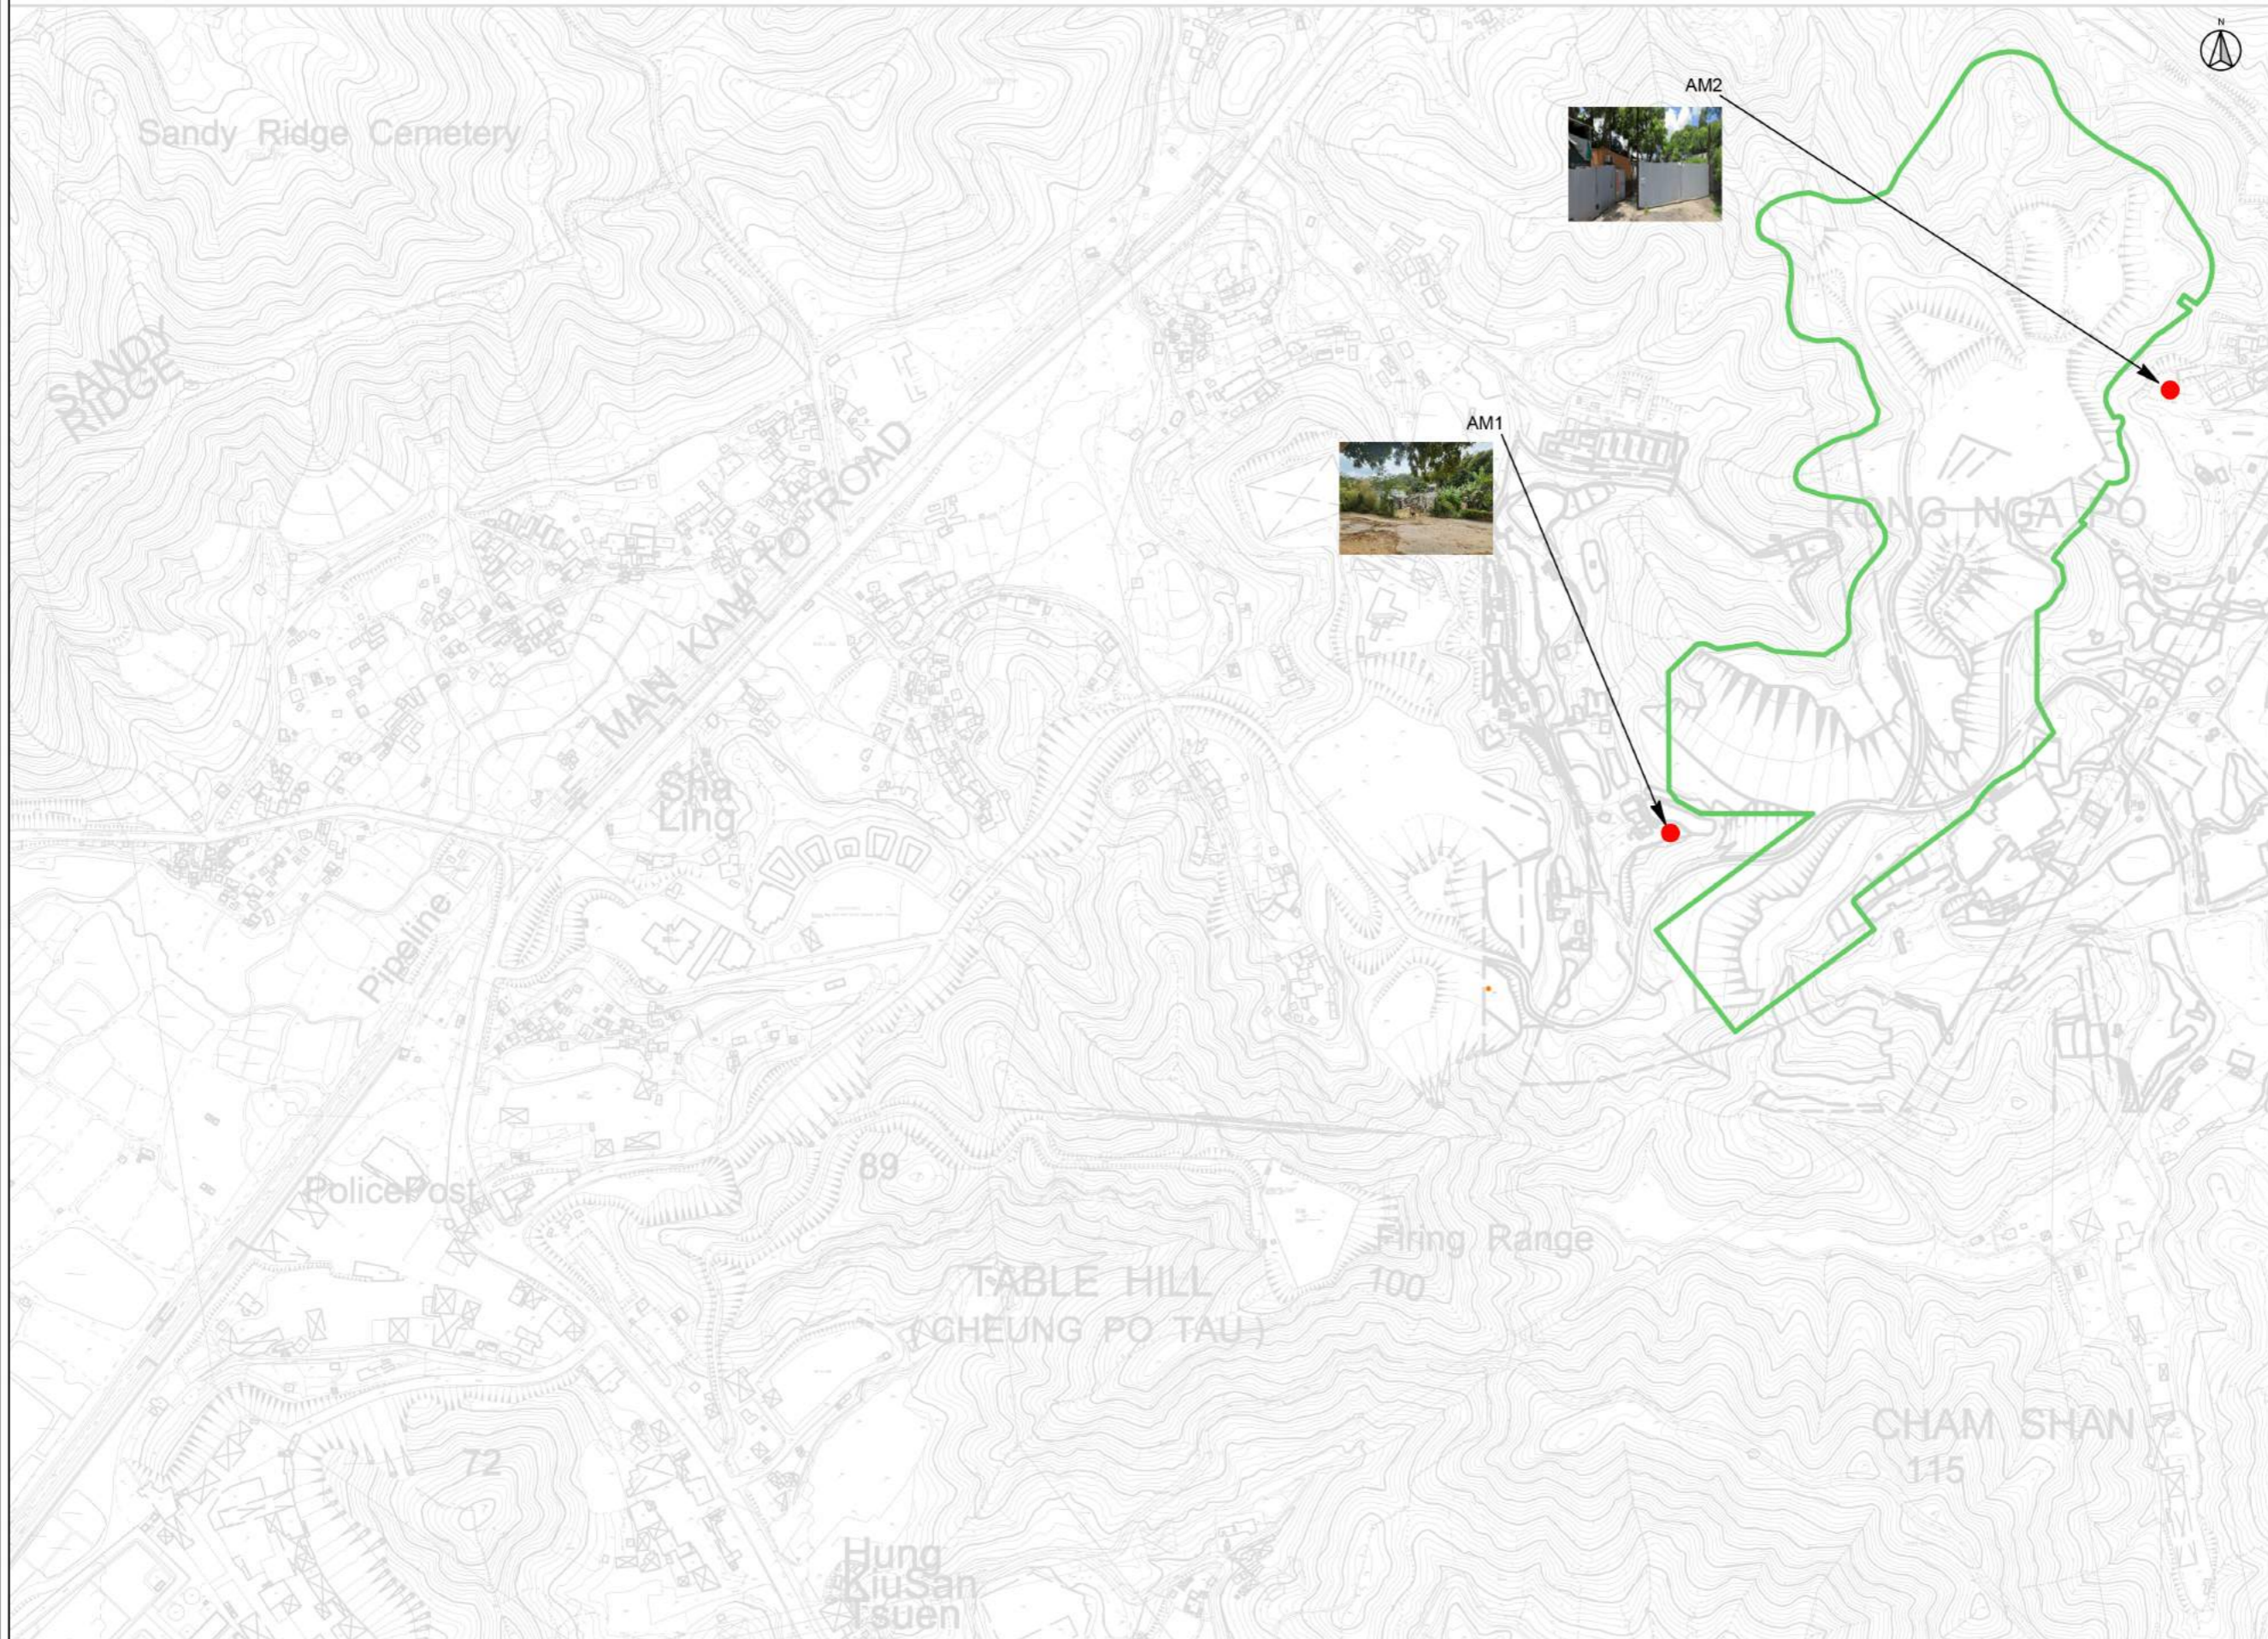
Figure 2 Location of Air Quality Monitoring Stations

- LEGENDS:
- KONG NGA PO SITE BOUNDARY
 - AIR QUALITY MONITORING STATIONS

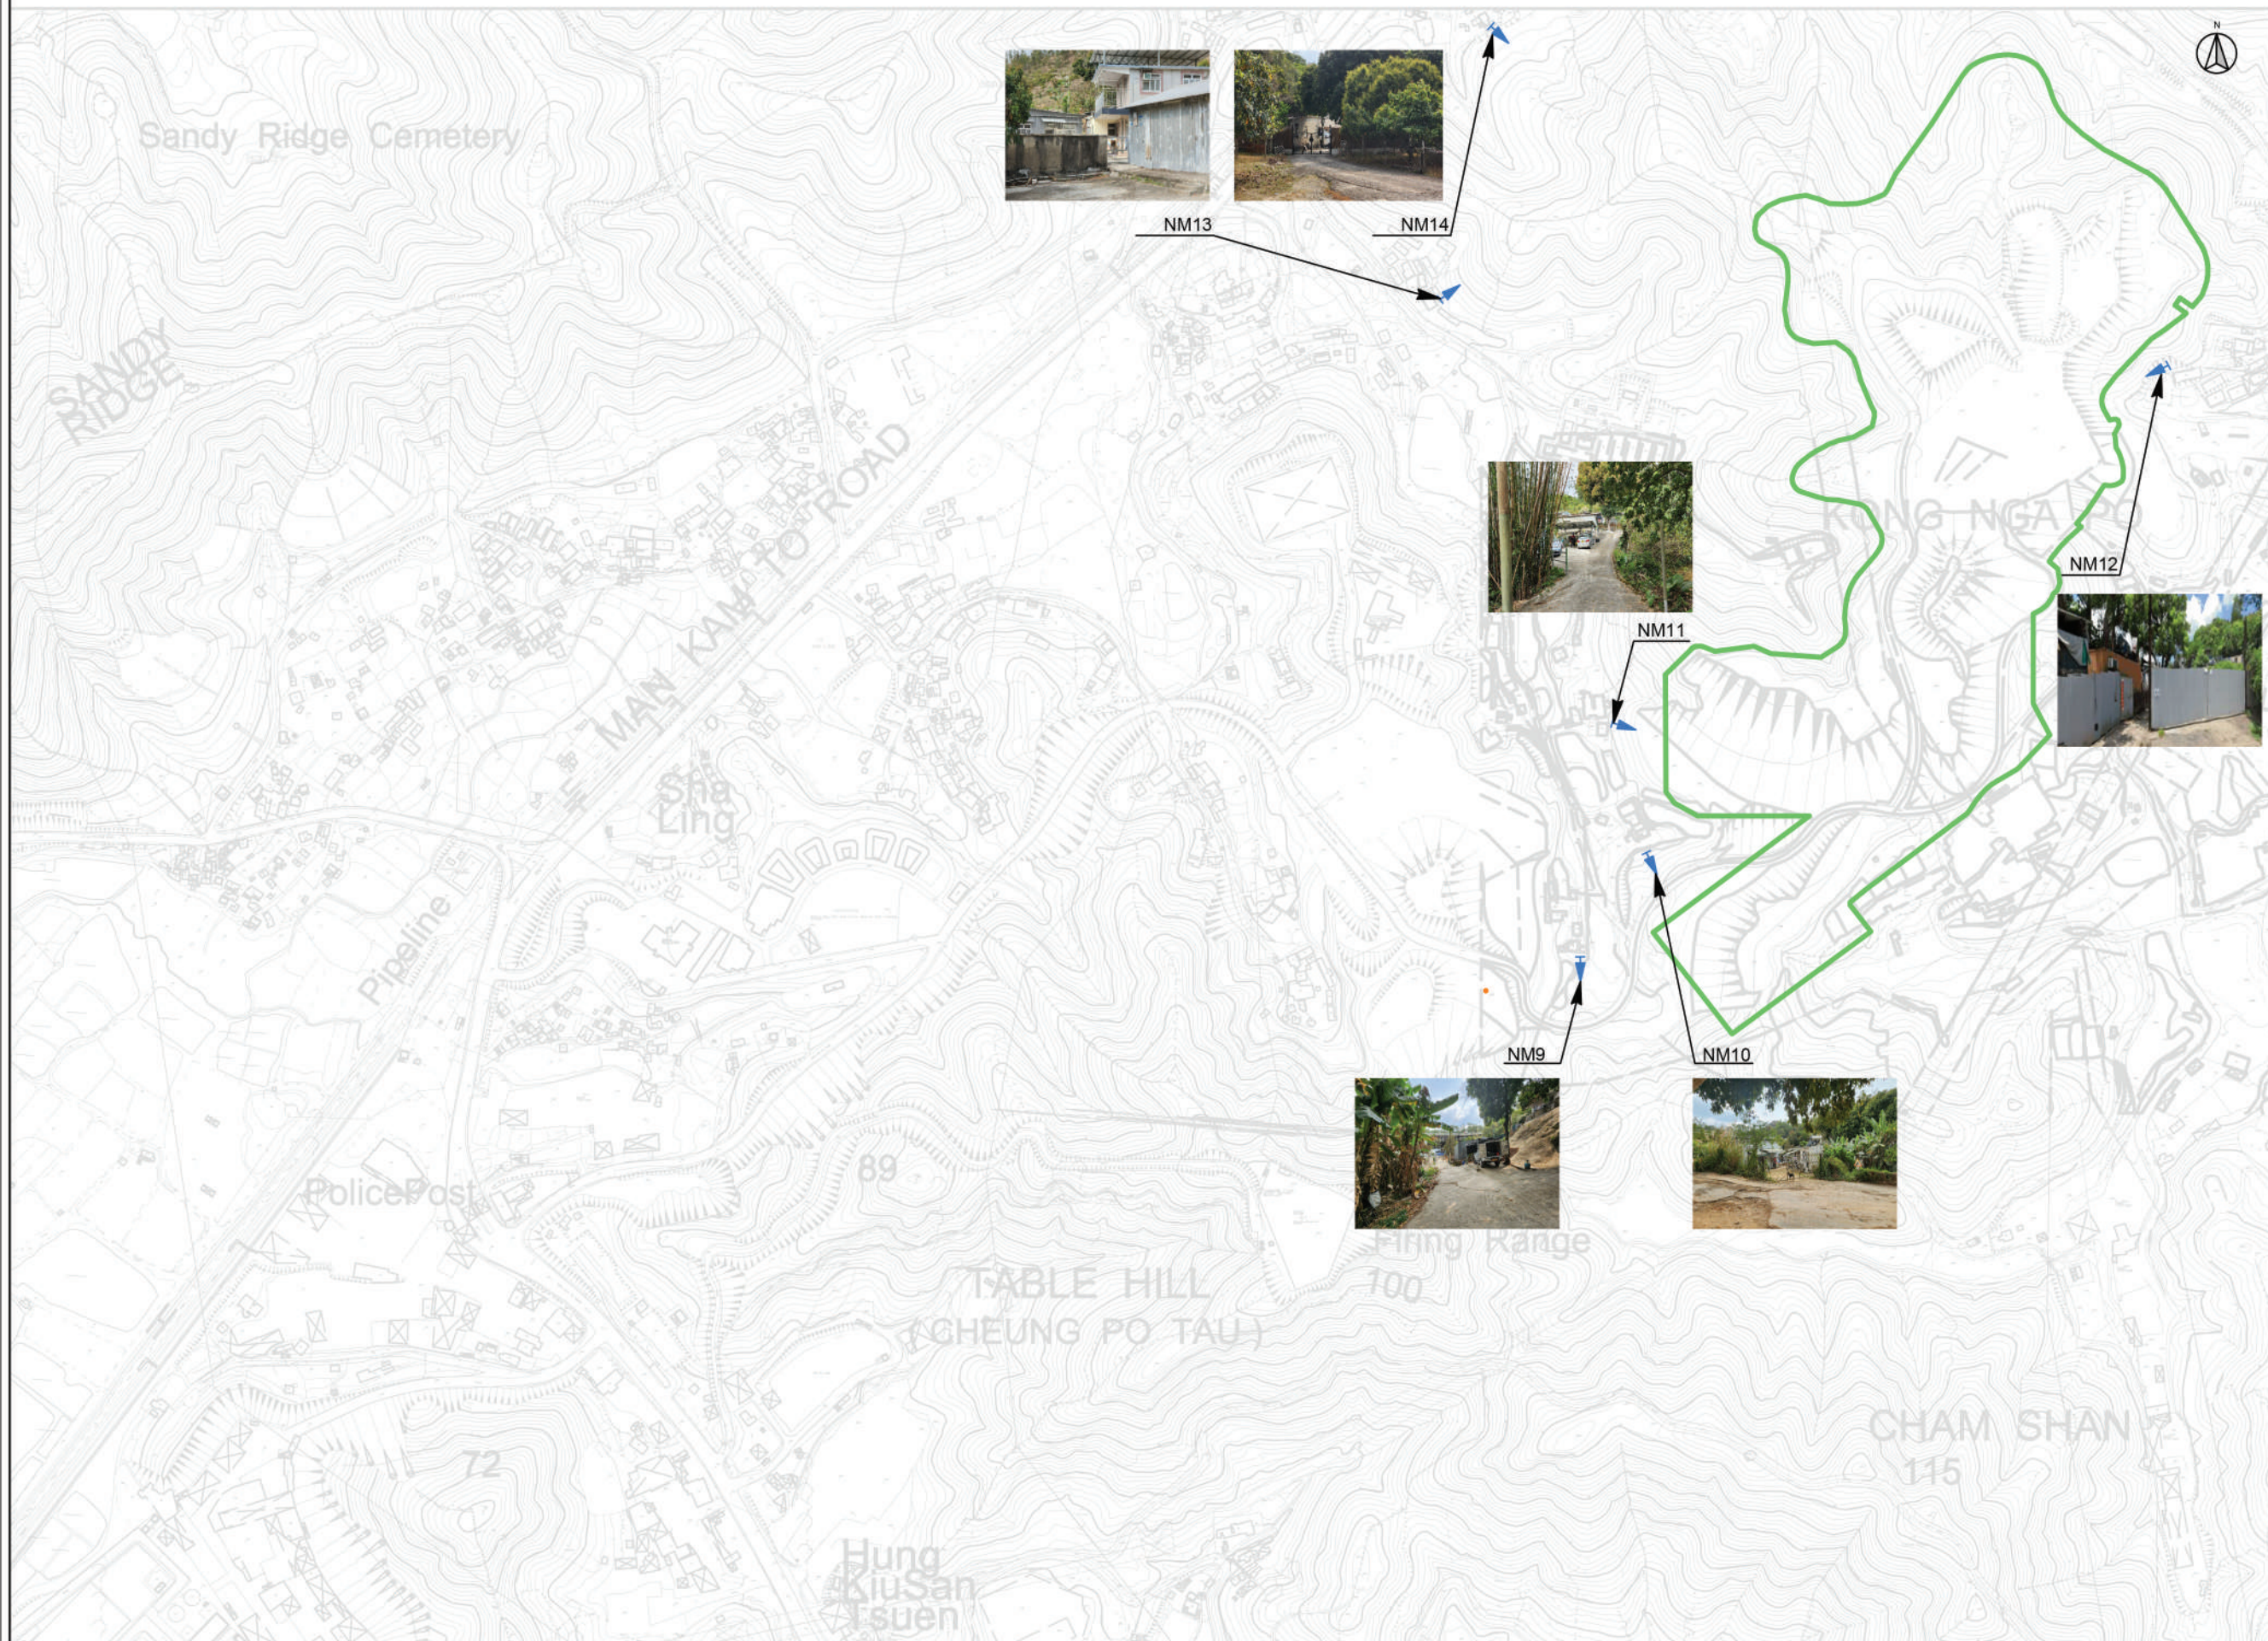
Figure 3 Location of Noise Monitoring Stations

LEGENDS
 KONG NGA PO SITE BOUNDARY
 NOISE MONITORING STATIONS

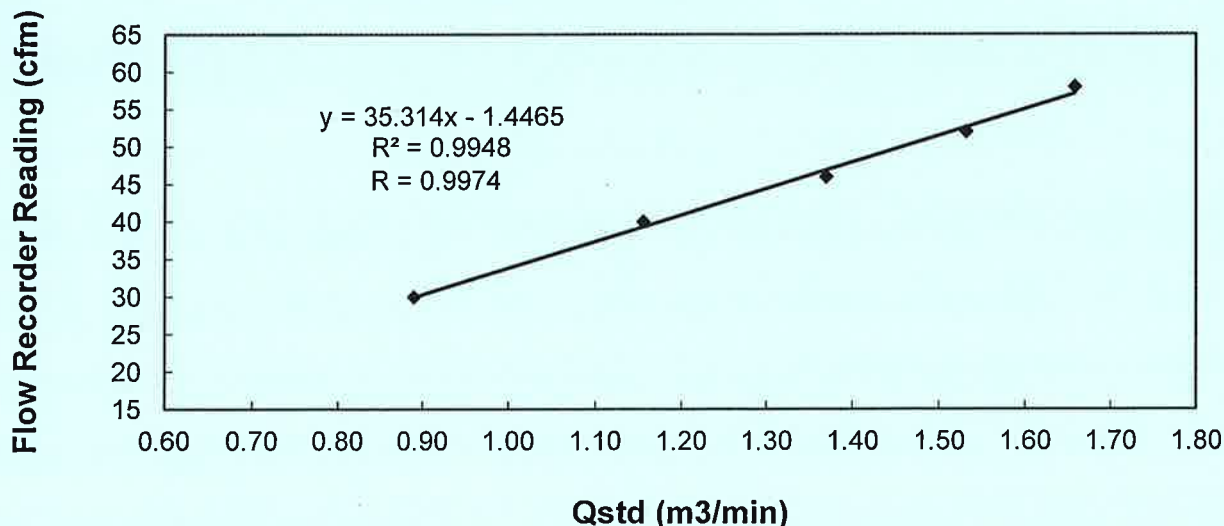
**Sampler 1180 Calibration Curve
Site: Tuen Mun (TM-RA2)**

Flow recorder reading (cfm)	58	52	46	40	30
Qstd (Actual flow rate, m ³ /min)	1.66	1.53	1.37	1.16	0.89
Pressure : 756.74 mm Hg	Temp. : 300 K

Acceptance Criteria : Correlation coefficient (r) of the calibration curve greater than 0.990 after a 5-point calibration

The high volume sampler complies* / ~~does not comply*~~ with the specified requirements and is deemed acceptable* / unacceptable* for use.

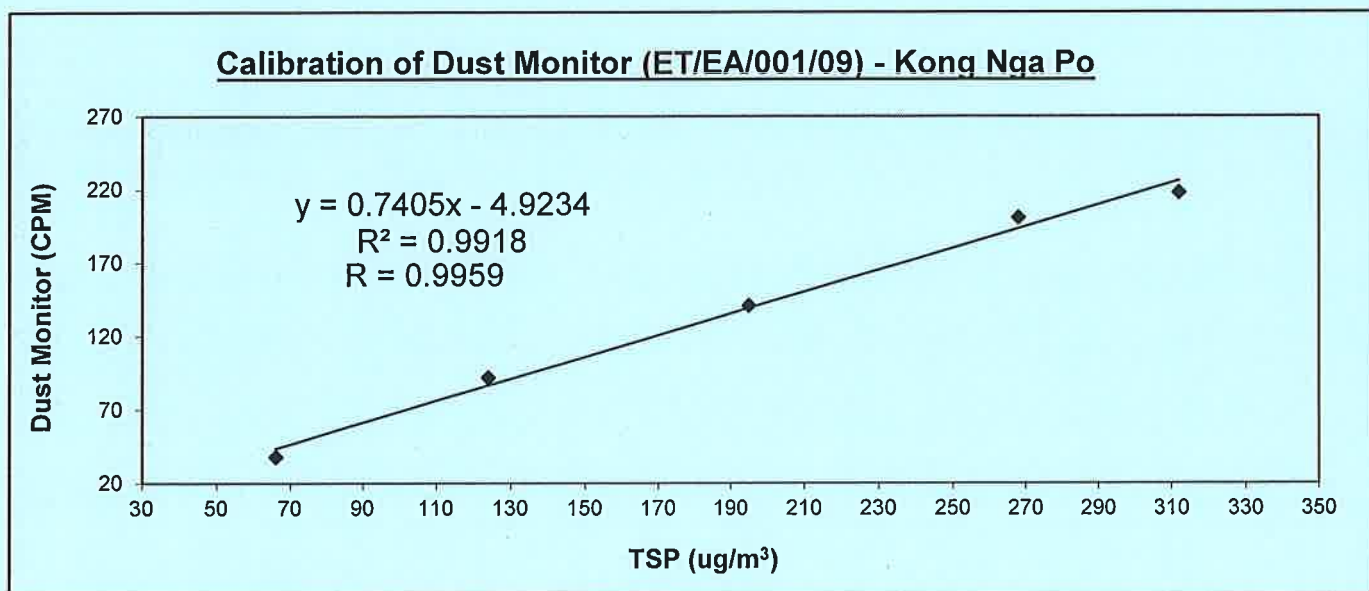
Method : Parallel measurement (Five-point calibration) by placing the Dust Monitor and High Volume Air Samper together under the same environmental condition

Results	Dust Monitor (CPM)	38	92	141	201	218
	TSP (ug/m ³)	66	124	195	268	312
	High Volume Air Sampler Serail No.: 1180	Calibration Due Date: 18 April 2024

Acceptance Criteria : Correlation coefficient (R) of the calibration curve greater than 0.990 after a five-point calibration

The Dust Trak Monitor complies * / ~~does not comply~~ * with the internal calibration procedures and is deemed acceptable * / unacceptable * for use.

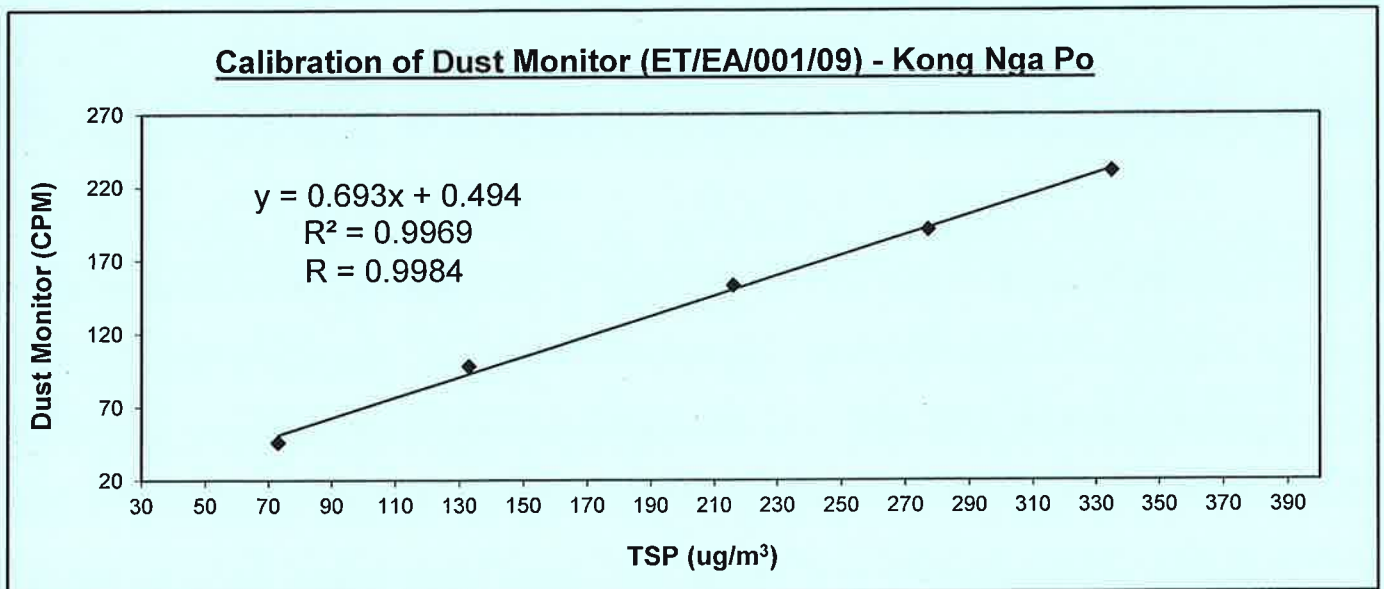
Manufacturer : SIBATA (LD-3B) Date of Calibration : 24 May 2024
Serial No. : 155331 (ET/EA/001/09) Calibration Due Date : 23 July 2024
Method : Parallel measurement (Five-point calibration) by placing the Dust Monitor and High Volume Air Samper together under the same environmental condition

Dust Monitor (CPM)	46	98	153	191	231
TSP (ug/m ³)	73	133	216	277	335
High Volume Air Sampler Serail No.: 1180	Calibration Due Date: 17 June 2024

Acceptance Criteria : Correlation coefficient (R) of the calibration curve greater than 0.990 after a five-point calibration

The Dust Trak Monitor complies * / ~~does not comply~~ * with the internal calibration procedures and is deemed acceptable * / ~~unacceptable~~ * for use.

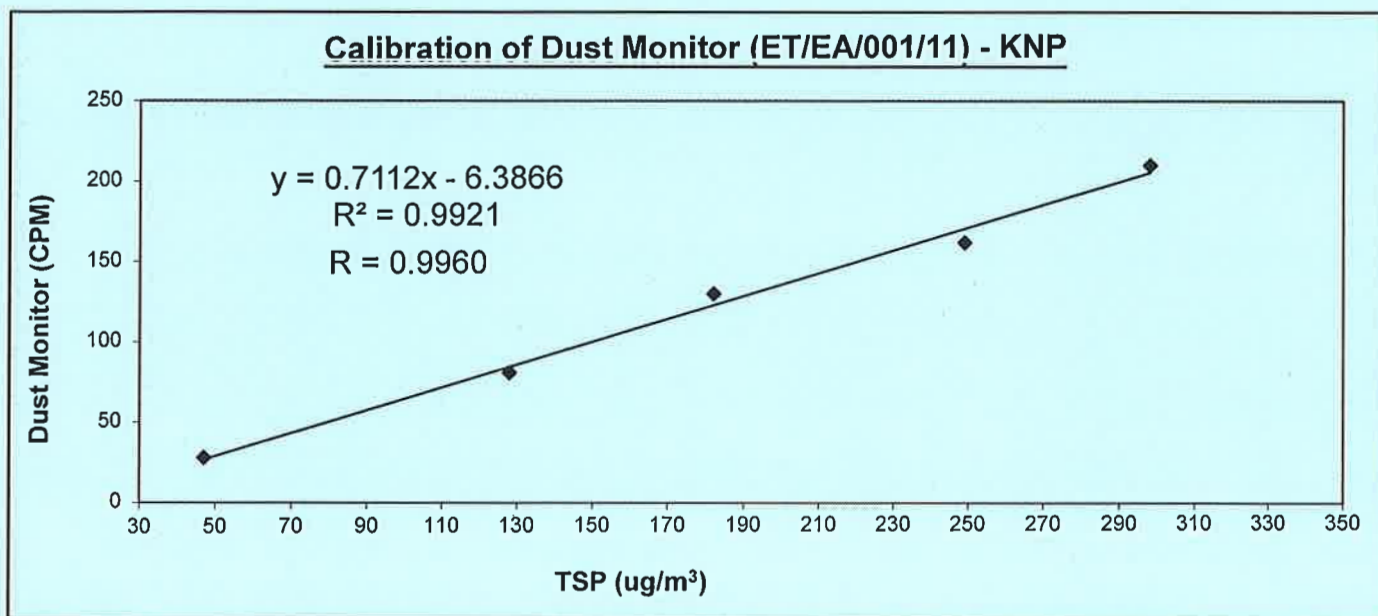
Method : Parallel measurement (Five-point calibration) by placing the Dust Monitor and High Volume Air Samper together under the same environmental condition

Results	Dust Monitor (CPM)	28	81	130	162	210
	TSP ($\mu\text{g}/\text{m}^3$)	47	128	182	249	298
	High Volume Air Sampler Serail No.:1180	Calibration Due Date: 18 April 2024

Acceptance Criteria : Correlation coefficient (R) of the calibration curve greater than 0.990 after a five-point calibration

The Dust Trak Monitor complies * / ~~does not comply~~ * with the internal calibration procedures and is deemed acceptable * / unacceptable * for use.

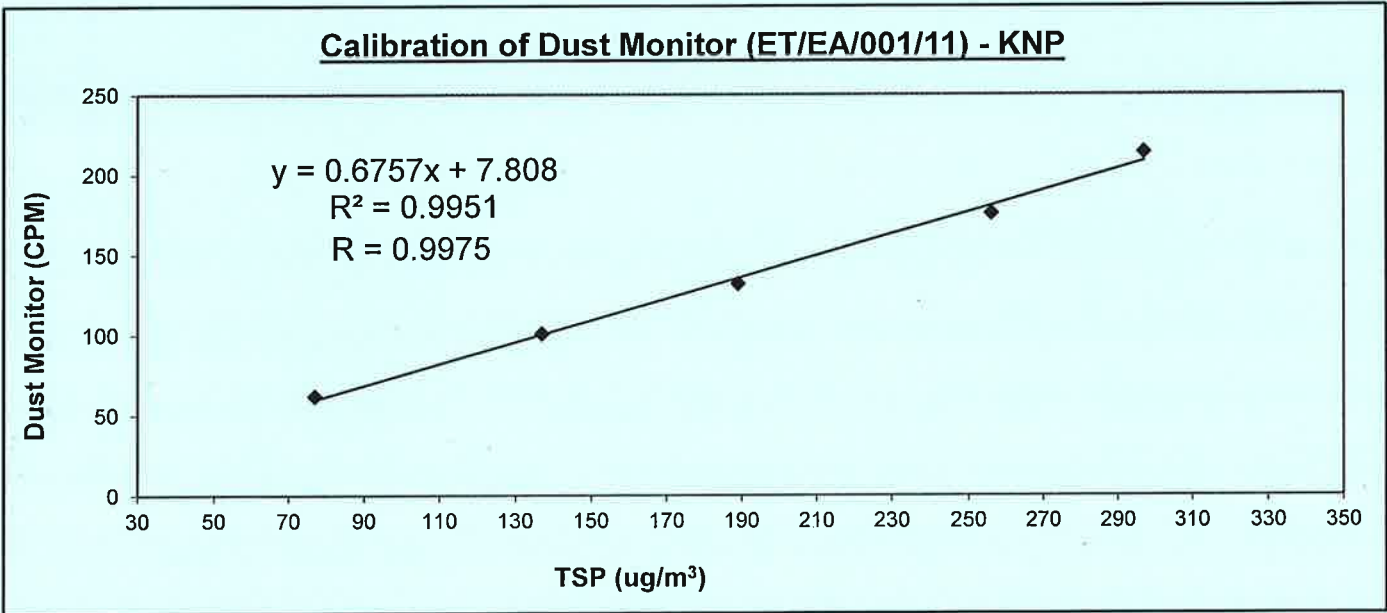
Method : Parallel measurement (Five-point calibration) by placing the Dust Monitor and High Volume Air Sampler together under the same environmental condition

Dust Monitor (CPM)	62	101	132	176	214
TSP (ug/m ³)	77	137	189	256	297
High Volume Air Sampler Serial No.:1180	Calibration Due Date: 17 June 2024

Acceptance Criteria : Correlation coefficient (R) of the calibration curve greater than 0.990 after a five-point calibration

The Dust Trak Monitor complies * / does-not-comply * with the internal calibration procedures and is deemed acceptable * / unacceptable * for use.

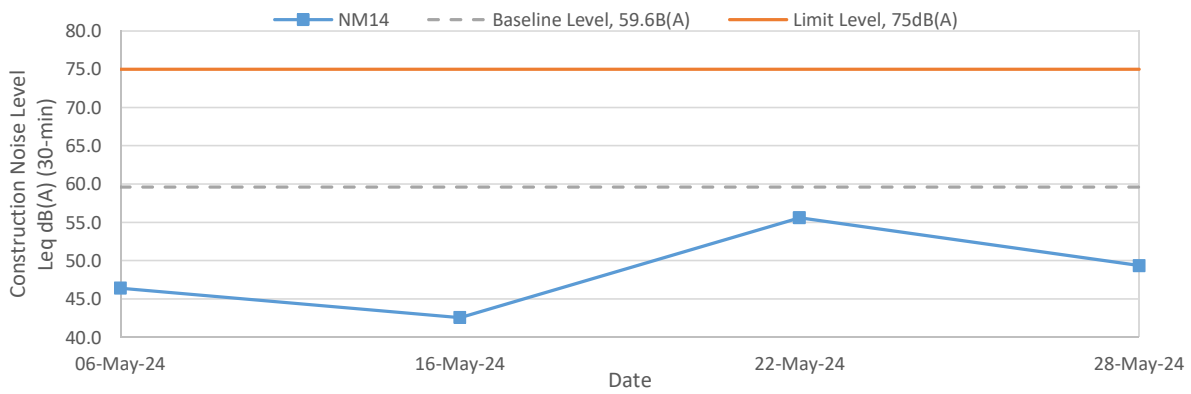
NM14 - Village House, Kong Nga Po

Location NM14 - Village House, near Man Kam To Road									
Date	Weather	Wind Speed (m/s)	Time	Unit: dB(A) (5-min)			Average	Limit Level	Baseline
				L _{eq}	L ₁₀	L ₉₀			
06-May-24	Cloudy	0.2	14:50	46.7	49.2	42.9	46.4	75.0	59.6
				47.1	49.5	43.4			
				47.3	49.7	43.6			
				46.0	48.4	42.5			
				45.4	47.2	42.1			
16-May-24	Fine	0.2	14:50	45.6	47.5	42.3	42.6	75.0	59.6
				43.4	44.7	40.2			
				42.8	44.4	39.7			
				42.7	44.3	39.5			
				41.8	43.4	38.0			
22-May-24	Cloudy	0.8	15:20	41.9	43.5	38.2	55.6	75.0	59.6
				42.5	44.0	39.8			
				54.7	58.2	46.1			
				53.3	57.1	46.3			
				56.7	60.4	47.6			
28-May-24	Fine	0.3	10:10	54.5	58.3	46.4	49.4	75.0	59.6
				57.2	61.7	48.2			
				56.0	61.4	48.0			
				49.2	51.8	46.4			
				49.5	52.0	46.8			
				49.7	52.3	47.2			
				49.9	52.5	47.5			
				48.8	51.4	45.9			
				48.9	51.5	46.0

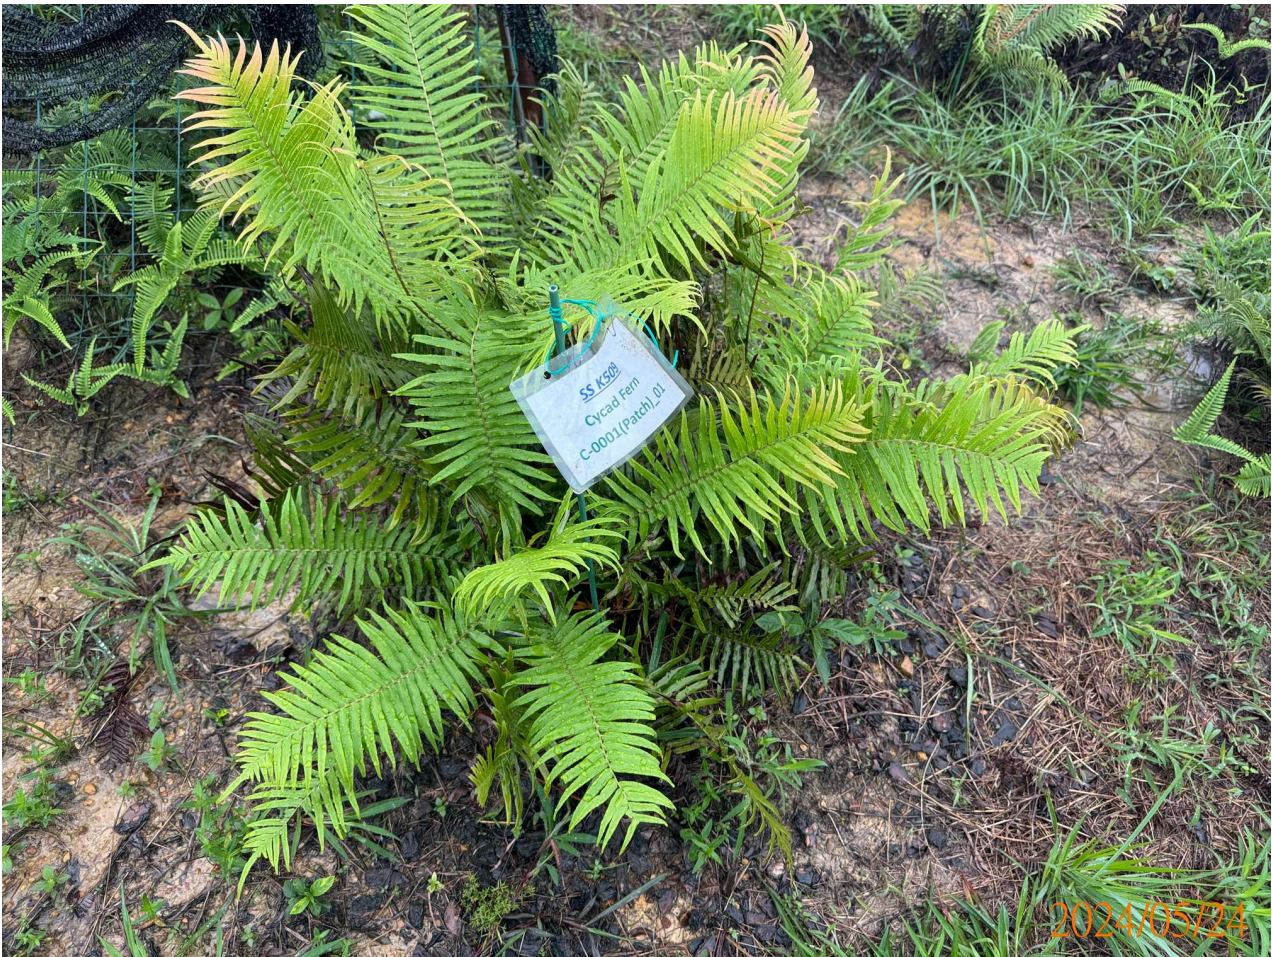
C0001(patch)_01

Tree/Plant/ Colony No.	Number of Individuals	Species Name	Form (Good/Fair/Poor)	Health (Good/Fair/Poor)	Remark
C-0001	01	<i>Brainea insignis</i>	F	F	Young leaves observed
	02	<i>Brainea insignis</i>	F	F	Young leaves observed
	03	<i>Brainea insignis</i>	F	F	Young leaves observed
	04	<i>Brainea insignis</i>	F	F	Young leaves observed
	05	<i>Brainea insignis</i>	F	F	Young leaves observed
	06	<i>Brainea insignis</i>	F	F	Young leaves observed
	07	<i>Brainea insignis</i>	F	F	Young leaves observed
	08	<i>Brainea insignis</i>	F	F	Young leaves observed
C-0002	01	<i>Brainea insignis</i>	F	F	Young leaves observed
	02	<i>Brainea insignis</i>	F	F	Young leaves observed
	03	<i>Brainea insignis</i>	F	P	Young leaves observed
	04	<i>Brainea insignis</i>	F	P	Young leaves observed
	05	<i>Brainea insignis</i>	F	F	Young leaves observed
	06	<i>Brainea insignis</i>	F	F	Young leaves observed
	07	<i>Brainea insignis</i>	F	F	Young leaves observed

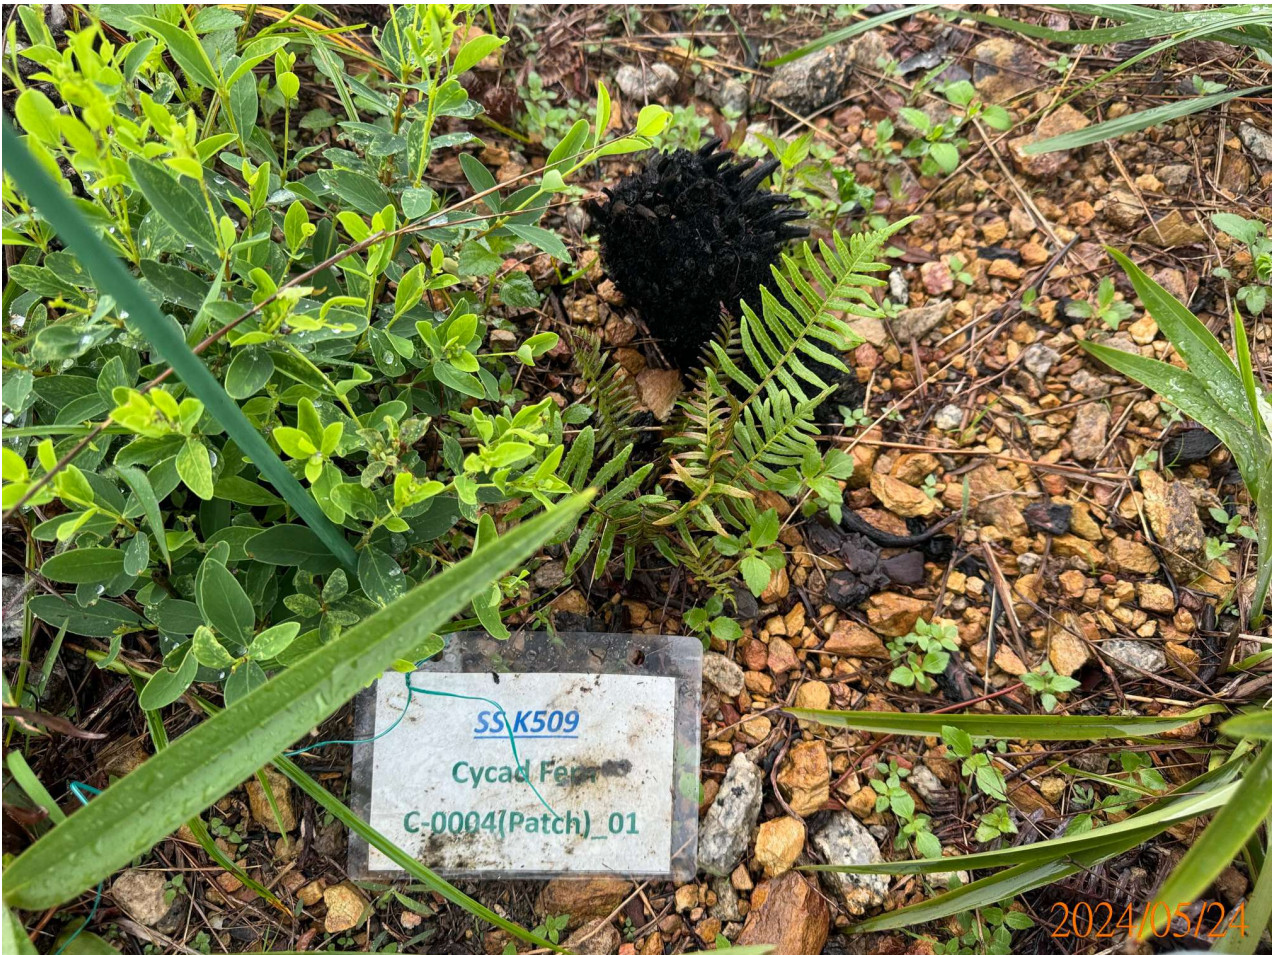
C0004(Patch)_01

08	<i>Brainea insignis</i>	F	F	Young leaves observed
C-0003	01	<i>Brainea insignis</i>	F	F	Young leaves observed
C-0004	01	<i>Brainea insignis</i>	P	P	Young leaves at base; Dry out caused by bushfire initially outside site boundary and high temperature on 2 Feb 2021
	02	<i>Brainea insignis</i>	F	F	Young leaves observed
	03	<i>Brainea insignis</i>	F	F	Young leaves observed
	04	<i>Brainea insignis</i>	F	F	Young leaves observed
	05	<i>Brainea insignis</i>	F	F	Young leaves observed
	06	<i>Brainea insignis</i>	F	F	Young leaves observed
	07	<i>Brainea insignis</i>	F	F	Young leaves observed
	08	<i>Brainea insignis</i>	F	F	Young leaves observed
	09	<i>Brainea insignis</i>	P	P	Dry out caused by bushfire initially outside site boundary and high temperature on 2 Feb 2021
	10	<i>Brainea insignis</i>	F	P	Young leaves at base
	11	<i>Brainea insignis</i>	F	F	Young leaves observed
	12	<i>Brainea insignis</i>	F	P	Young leaves observed

13	<i>Brainea insignis</i>	-	-	Stem not found Dry out caused by bushfire initially outside site boundary and high temperature on 2 Feb 2021
	14	<i>Brainea insignis</i>	F	F	Young leaves observed
	15	<i>Brainea insignis</i>	P	P	Young leaves at base; Dry out caused by bushfire initially outside site boundary and high temperature on 2 Feb 2021
	16	<i>Brainea insignis</i>	P	P	Dry out caused by bushfire initially outside site boundary and high temperature on 2 Feb 2021
	17	<i>Brainea insignis</i>	P	P	Young leaves observed
	18	<i>Brainea insignis</i>	-	-	Burned by bushfire initially outside the site boundary on 2 Feb 2021.
	19	<i>Brainea insignis</i>	F	P	-
	20	<i>Brainea insignis</i>	F	F	Young leaves observed

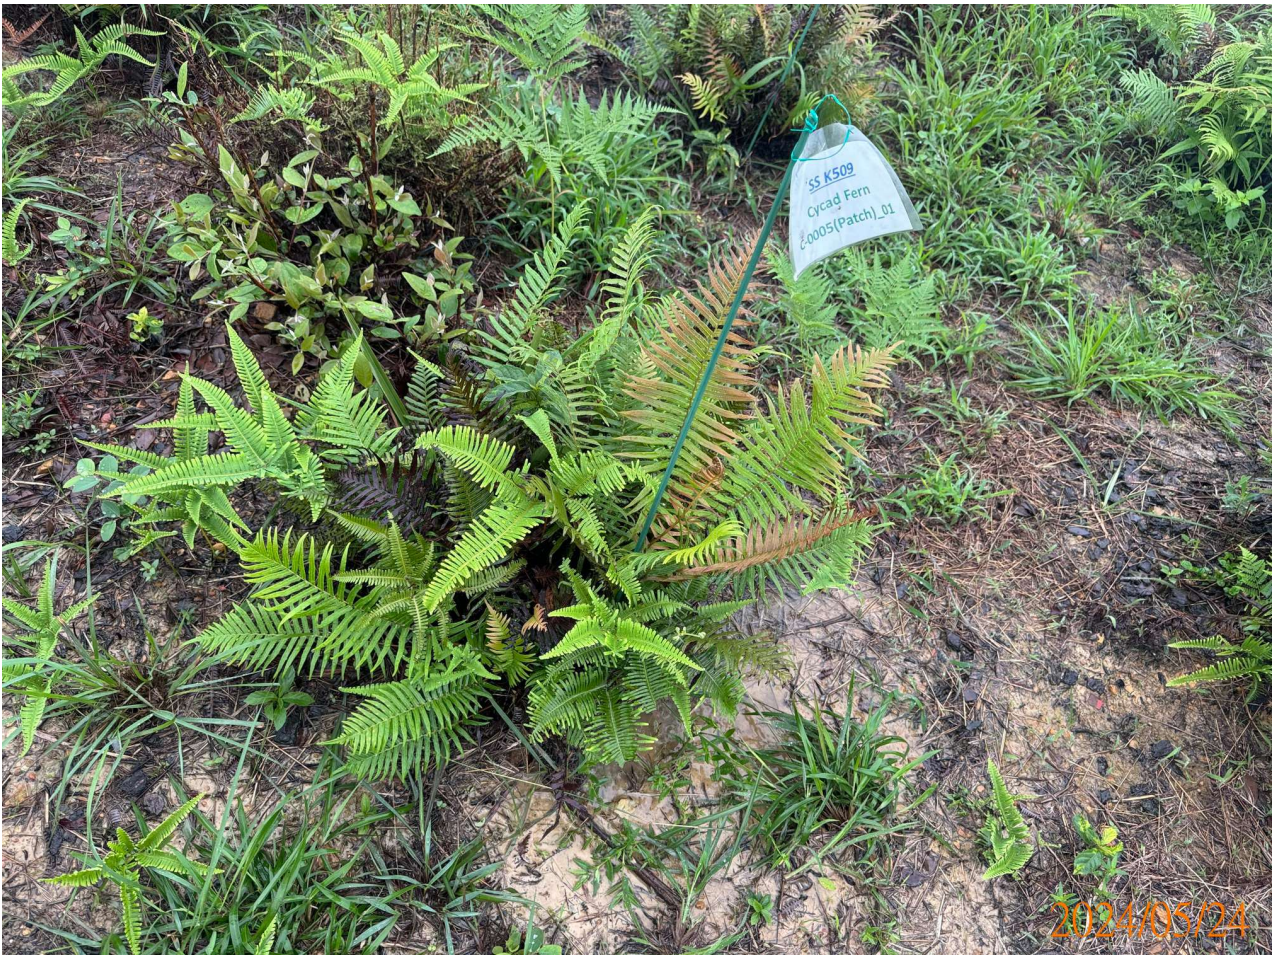
C0005(Patch)_01

Tree/Plant/ Colony No.	Number of Individuals	Species Name	Form (Good/Fair/Poor)	Health (Good/Fair/Poor)	Remark
C-0005	01	<i>Brainea insignis</i>	F	F	Young leaves observed
	02	<i>Brainea insignis</i>	F	F	Young leaves observed
	03	<i>Brainea insignis</i>	F	F	Young leaves observed
	04	<i>Brainea insignis</i>	F	F	Young leaves observed
	05	<i>Brainea insignis</i>	F	P	Young leaves observed
	06	<i>Brainea insignis</i>	F	F	Young leaves observed
	07	<i>Brainea insignis</i>	F	F	Young leaves observed
C-0006	01	<i>Brainea insignis</i>	F	F	Young leaves observed
C-0007	01	<i>Brainea insignis</i>	F	F	Young leaves observed
	02	<i>Brainea insignis</i>	F	P	-
C-0008	01	<i>Brainea insignis</i>	F	F	Young leaves observed
	02	<i>Brainea insignis</i>	F	F	Young leaves observed
	03	<i>Brainea insignis</i>	P	P	Young leaves observed
	04	<i>Brainea insignis</i>	F	F	Young leaves observed
	05	<i>Brainea insignis</i>	F	F	Young leaves observed

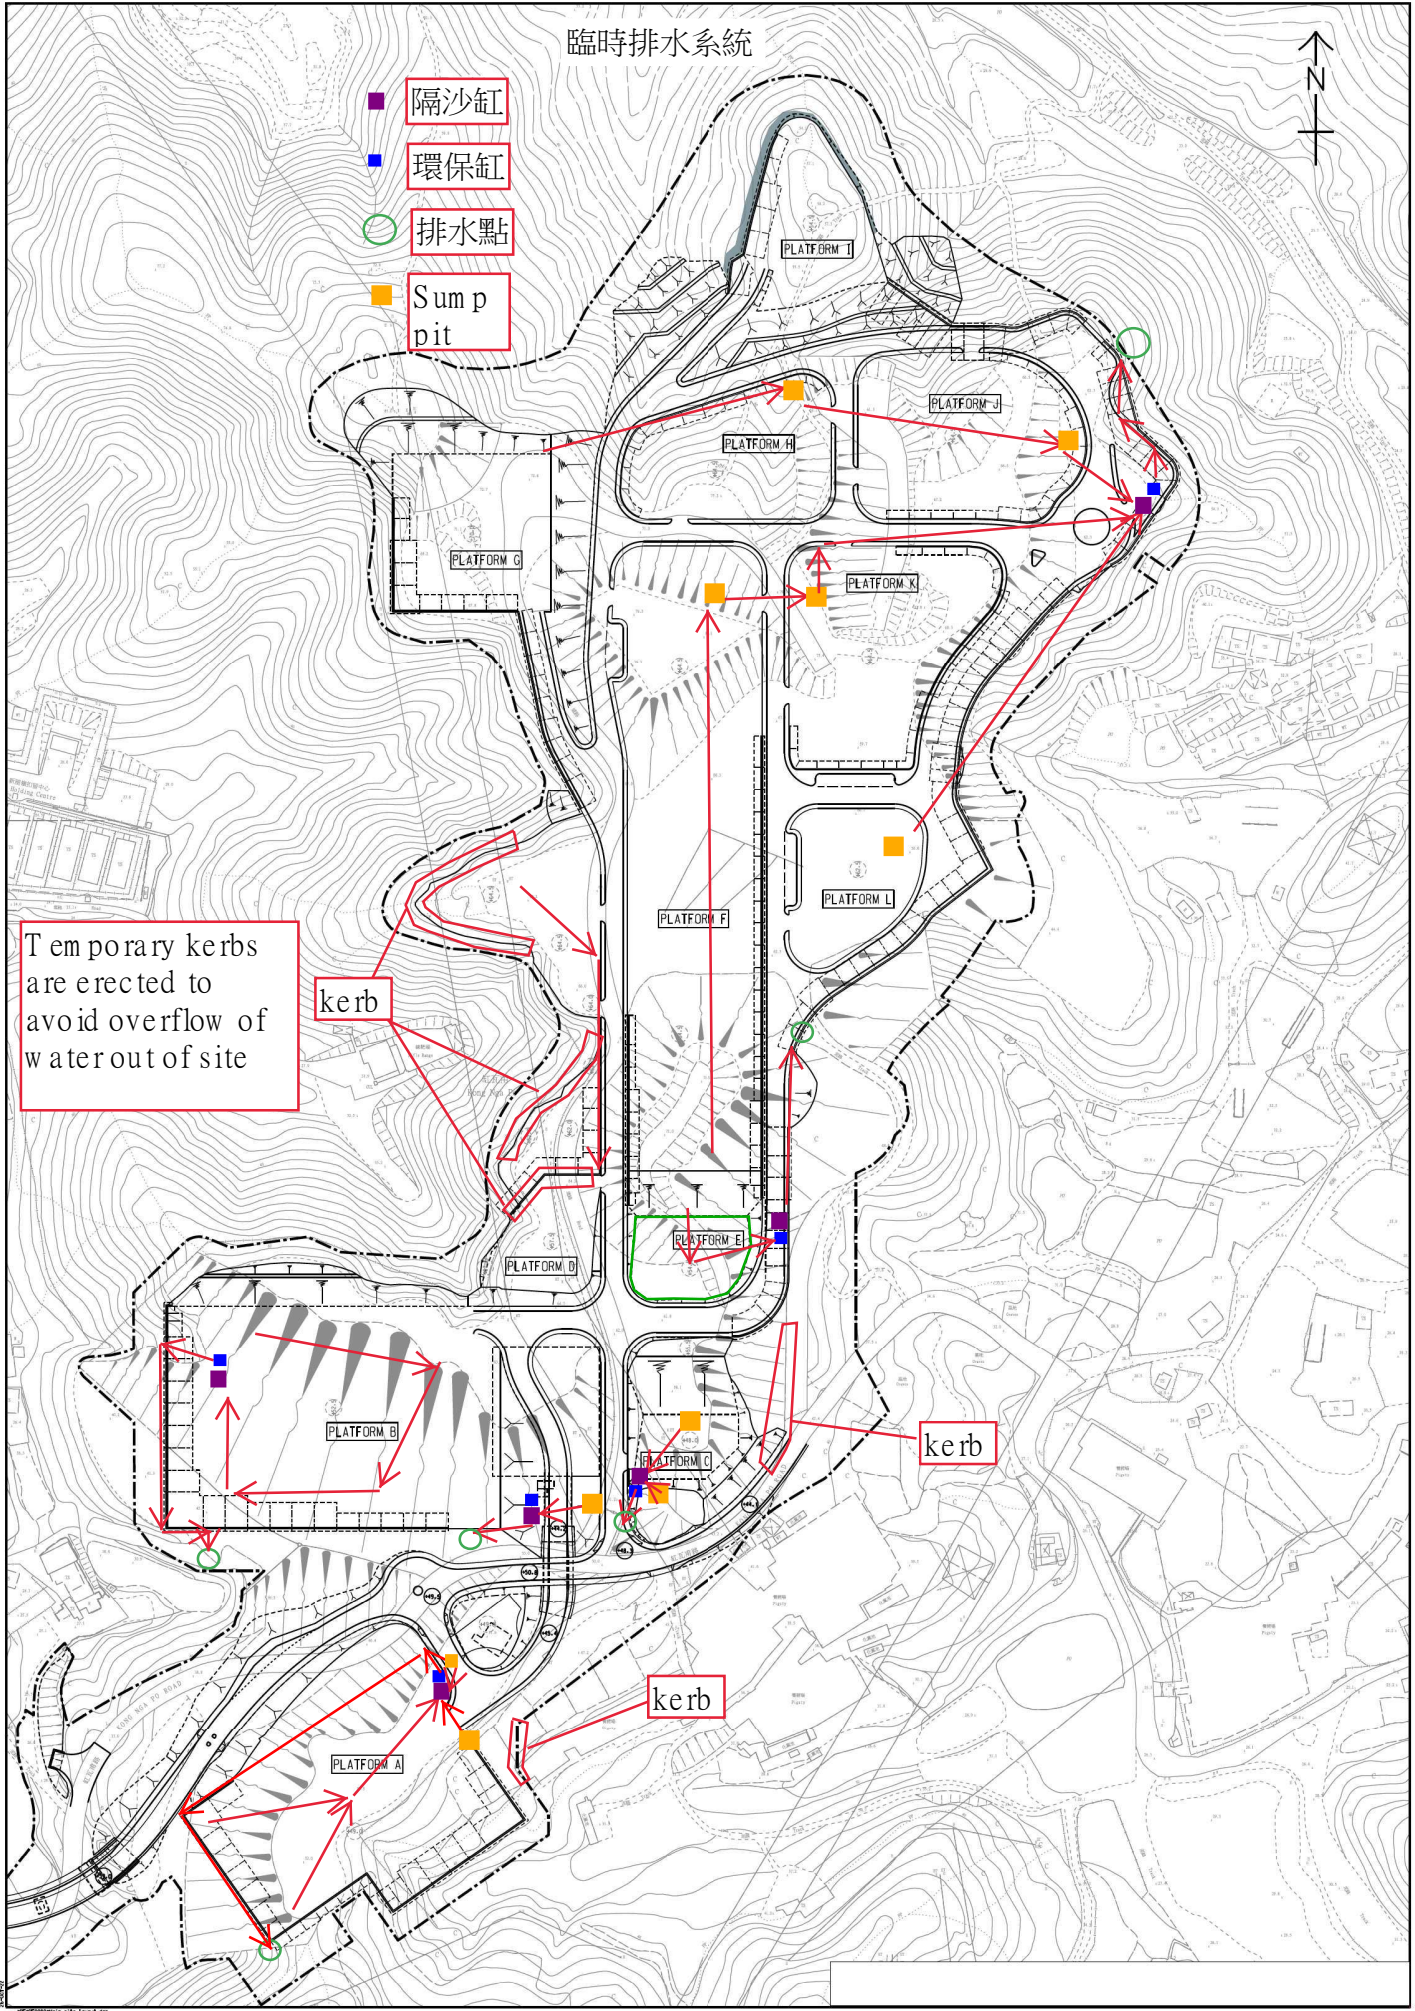
- 隔沙缸
- 環保缸
- 排水點
- Sump pit

Temporary kerbs are erected to avoid overflow of water out of site
