Re: Contract No. SS K/509
Provision of Independent Environmental Checker Consultancy for Design and Construction of Kong Nga Po Police Training Facilities
Verification of Monthly EM&A Report (January 2025)

**Provision of Environmental Team consultancy
for Design and Construction of Kong Nga Po Police
Training Facilities (Programme No. 279LP)**

**Monthly Environmental Monitoring and
Audit Report for December 2024
(Version 2)**

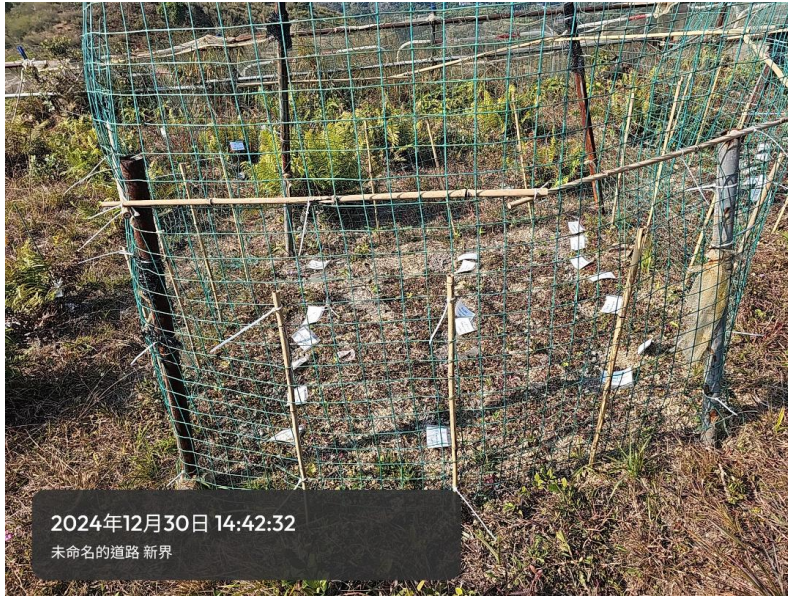
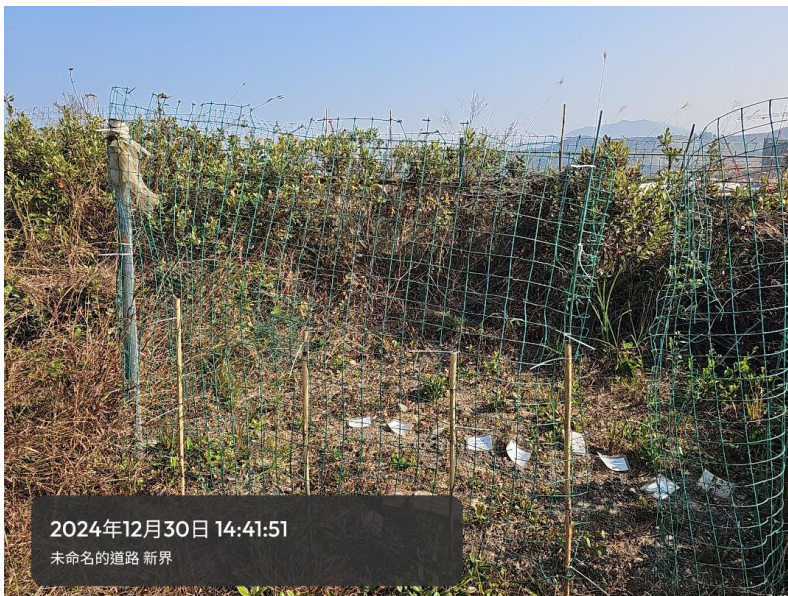
- 1) Please refer to the guidelines on soil improvement issued by the Greening, Landscape and Tree Management Section (GLTMS) of the development bureau (2022) to apply to monitoring and maintenance of transplanted flora species.
- 2) Daily watering frequency is needed to keep the soil moist.
- 3) Installation of a shaded net is provided below.
- 4) The wild plants that are growing in undesirable areas should be removed.
- 5) The Black Shade Net should be installed.

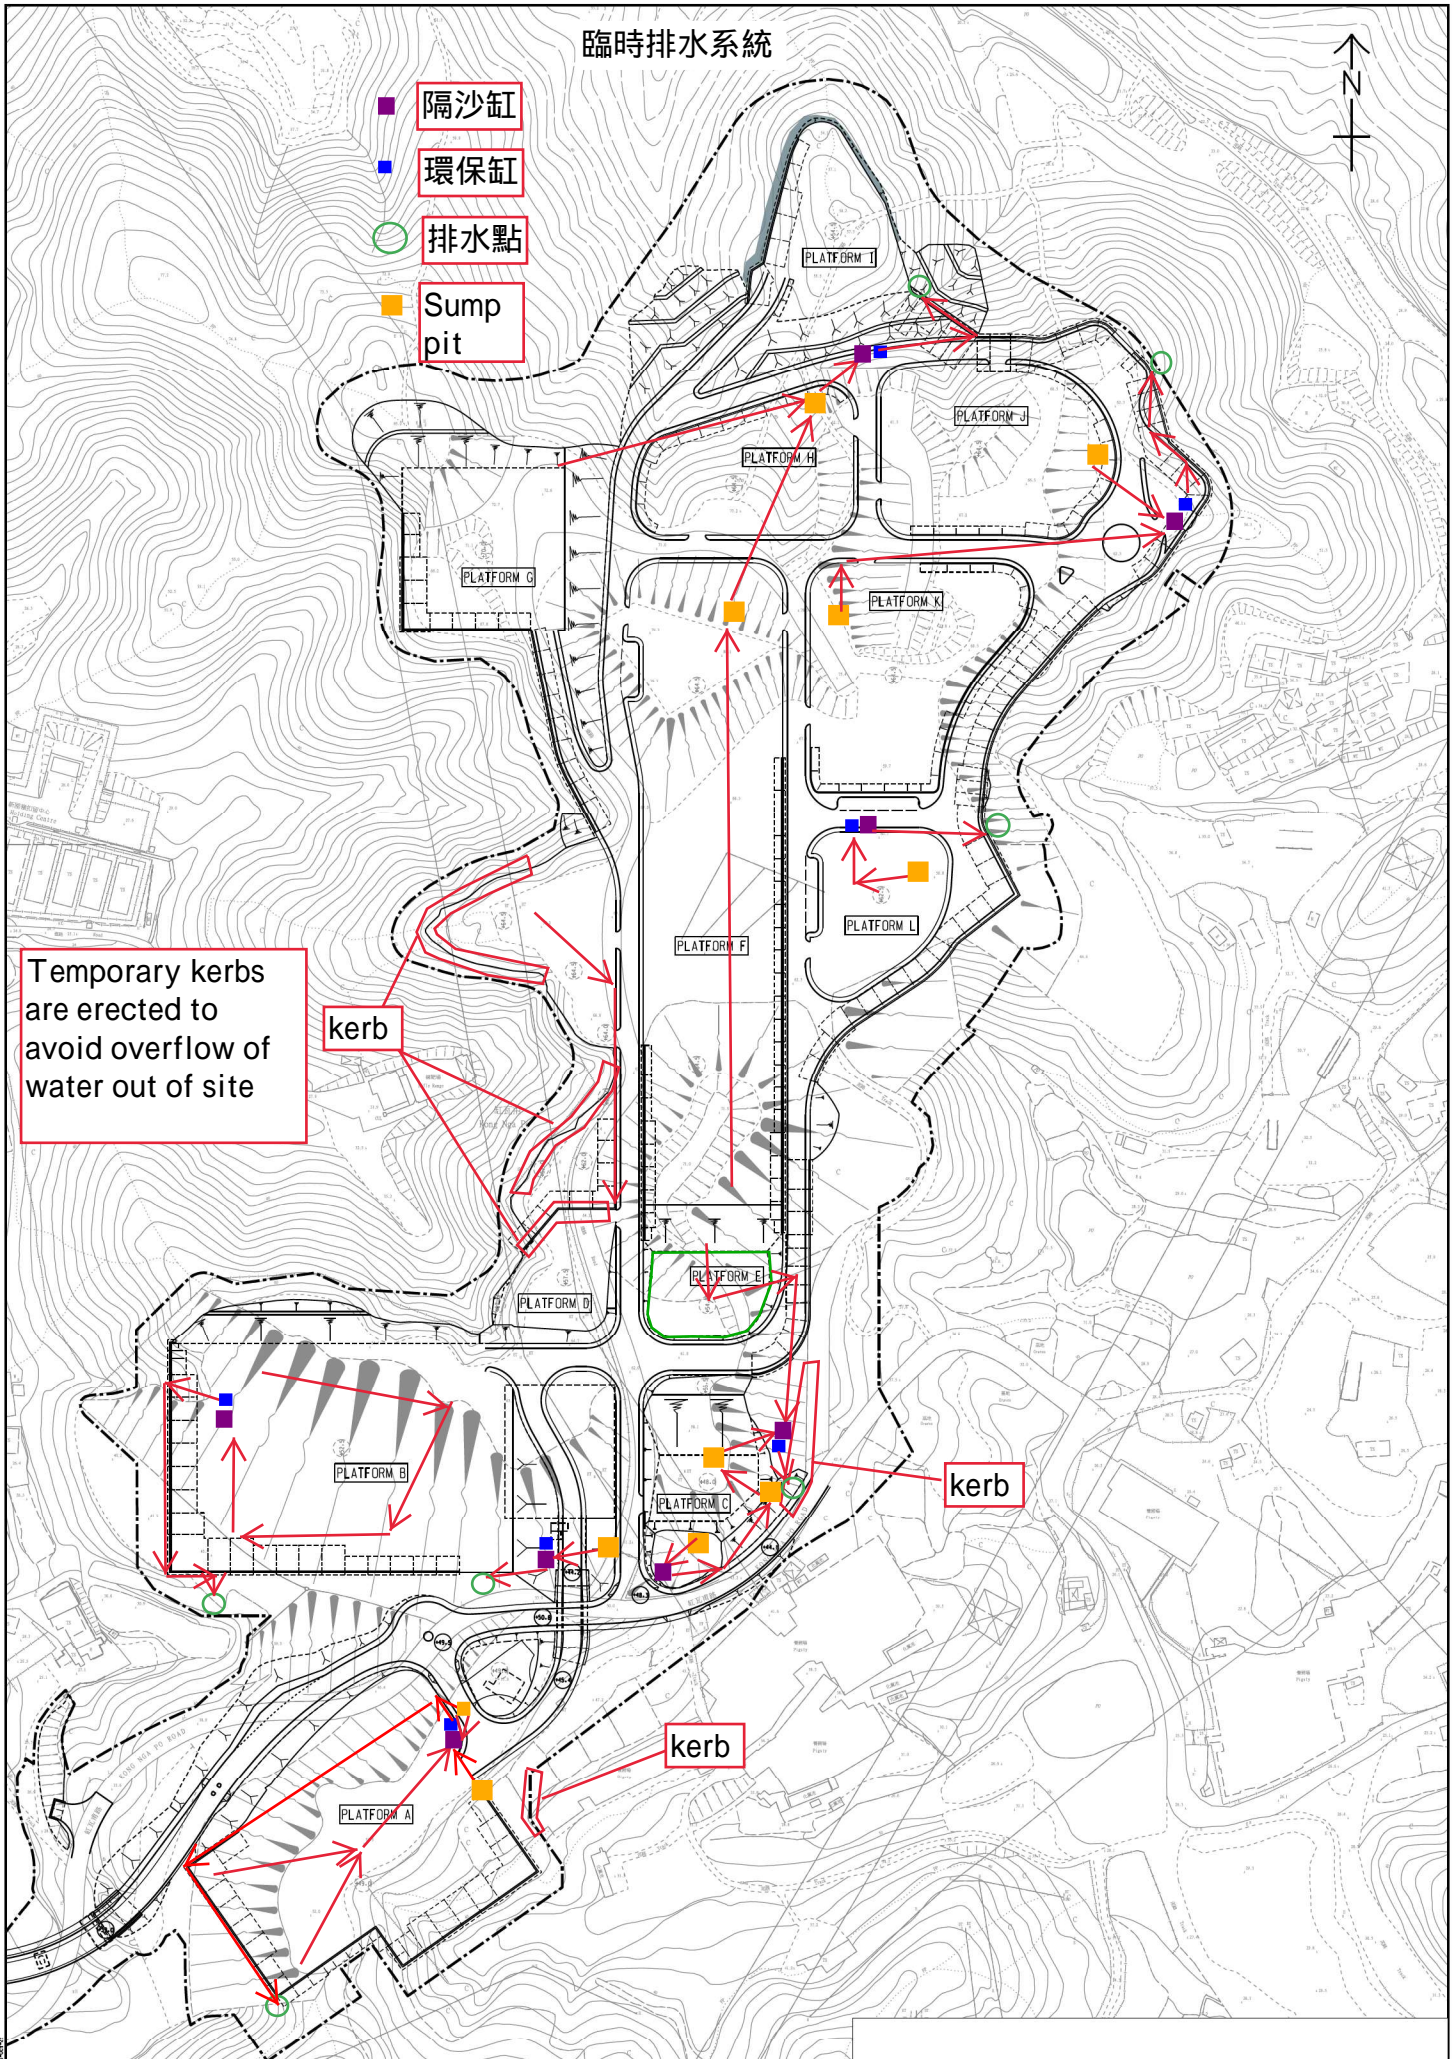
Temporary kerbs are erected to avoid overflow of water out of site
