**Re: Contract No. SS K/509**  
**Provision of Independent Environmental Checker Consultancy for Design**  
**and Construction of Kong Nga Po Police Training Facilities**  
**Verification of Monthly EM&A Report (February 2026)**

**Provision of Environmental Team consultancy  
for Design and Construction of Kong Nga Po Police  
Training Facilities (Programme No. 279LP)**

**Monthly Environmental Monitoring and  
Audit Report for February 2026  
(Version 1.1)**

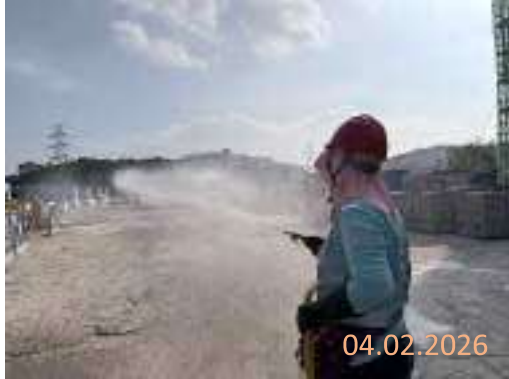
Ref*	Proposed Construction Method	Location/Working Period	Anticipated Major Impacts	Recommended Mitigation Measures	Photo Records (Partial)
EIA 3.9.1; EM&A Log 2.2	Open cut excavation	Kong Nga Po Site	Dust impact	<ul style="list-style-type: none"> <li>• Manual water spraying for dust suppression</li> <li>• Regular inspection and maintenance of plant and equipment in good condition</li> <li>• Cover stockpile with impervious sheets or grout</li> <li>• Provide wheel washing facility at site entrance</li> </ul>

<p>By subcontractor at KNP site</p>

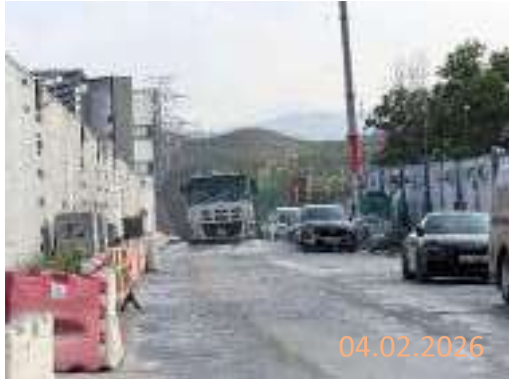
<p data-bbox="1541 638 1912 670">By subcontractor at KNP site</p>
<p data-bbox="203 735 378 863">EIA 4.4.6; EM&amp;A Log 3.2</p>			<p data-bbox="887 735 965 767">Noise</p>	<ul data-bbox="1135 735 1518 1246" style="list-style-type: none"> <li data-bbox="1135 735 1518 911">• Regular inspection and maintenance of plant &amp; equipment in good condition</li> <li data-bbox="1135 927 1518 1054">• Deploy Quality Powered Mechanical Equipment (QPME) if possible</li> <li data-bbox="1135 1070 1518 1246">• Valid construction noise permit should be displayed at site entrance.</li> </ul>

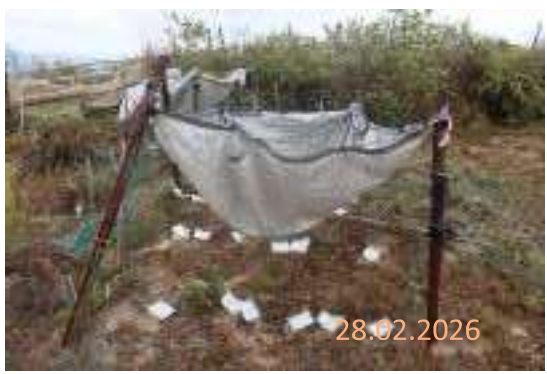
<p>By subcontractor at KNP site</p>
EIA 3.9.1; EM&A Log 2.2	Soil Removal	Kong Nga Po Site	Air	<ul style="list-style-type: none"> <li>• Deploy water bowser for regular water spraying to enhance dust suppression</li> <li>• Cover dusty materials with impervious sheets</li> <li>• Exposed slopes covered with waterproof layers such as tarpaulin sheets or grout to reduce the potential for sediment laden runoff entering</li> </ul>

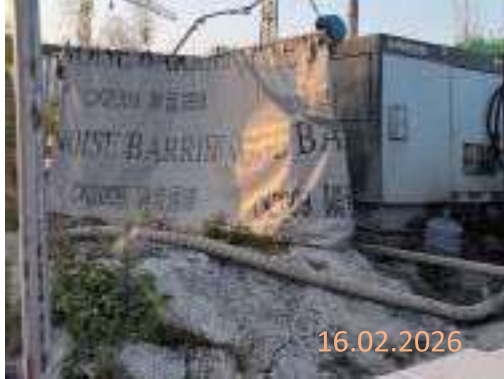
EIA 5.6.1.2  
and EM&A  
Log 4.2

Water Quality

- Cover exposed slopes with impervious sheets or cement grout.
- Wastewater pumped out of the excavation areas shall be treated to remove suspended solid prior to discharge.
- Provide desilting/ sedimentation devices for wastewater treatment prior to discharge.
- Provide drip tray to prevent spillage of fuels

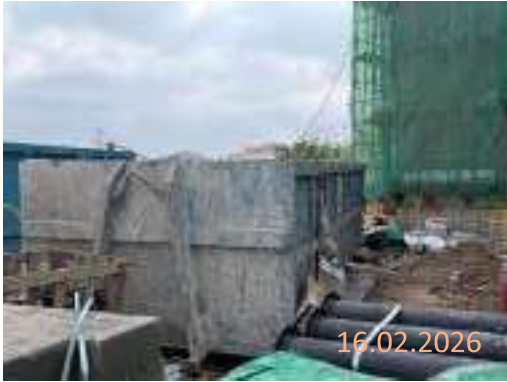
<p>16.02.2026</p> <p>By main contractor at KNP site</p>

<p>EIA 7.5.1.2 and EM&amp;A Log 6.2</p>			<p>Waste Management</p>	<ul style="list-style-type: none"><li>• Segregation and storage of different types of waste in different containers or skips or stockpiles to enhance reuse or recycling of materials and their proper disposal</li><li>• Sort non-inert C&amp;D materials to recover any recyclable portions</li></ul>

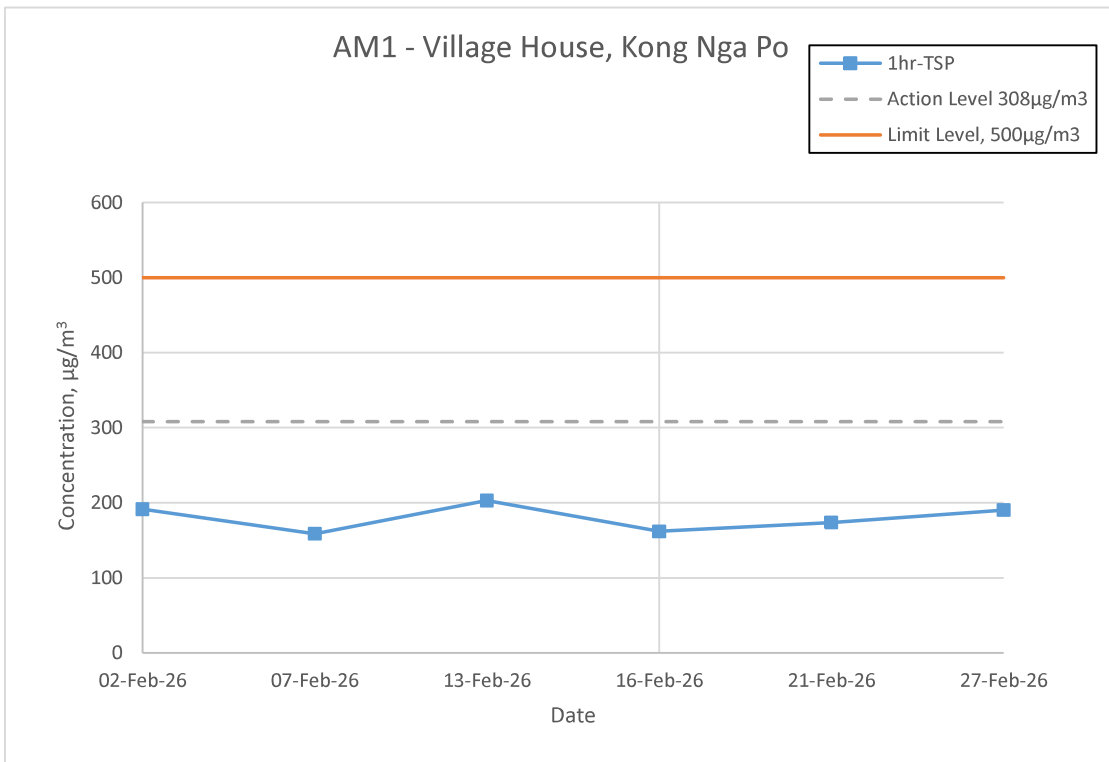
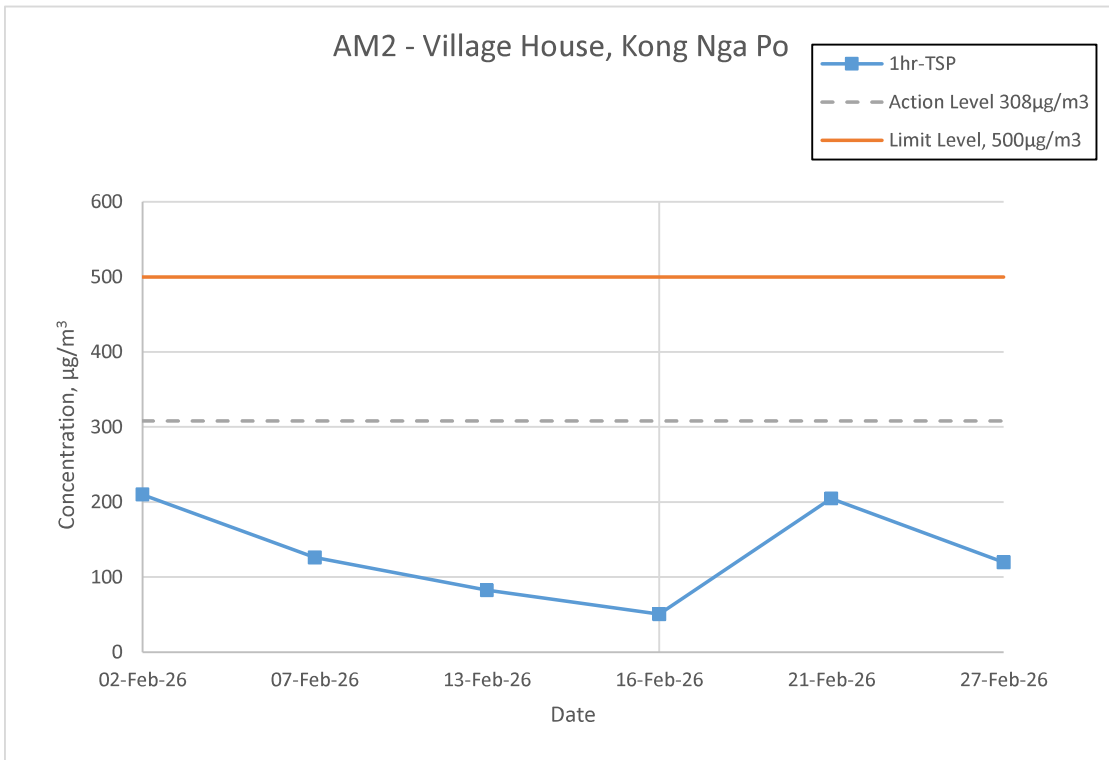
# 1-hr TSP Concentration Levels

<b>Location AM2 - Village House, Kong Nga Po</b>			
<b>Date</b>	<b>Time</b>	<b>Weather</b>	<b>Particulate Concentration (<math>\mu\text{g}/\text{m}^3</math>)</b>
02-Feb-26	13:17	Sunny	210
	14:17		78
	15:17		145
07-Feb-26	8:30	Sunny	126
	9:30		164
	10:30		85
13-Feb-26	13:18	Sunny	83
	14:18		157
	15:18		101
16-Feb-26	13:08	Sunny	51
	14:08		35
	15:08		84
21-Feb-26	8:25	Sunny	205
	9:25		204
	10:25		175
27-Feb-26	13:41	Sunny	120
	14:41		97
	15:41		21
		Minimum	21
		Maximum	210
		Average	119

4.12 The outcomes of the 1-hour TSP monitoring are condensed in **Table 4.4**. For a comprehensive view, detailed results and graphical representations of the 1-hour TSP monitoring data can be found in **Appendix E**.

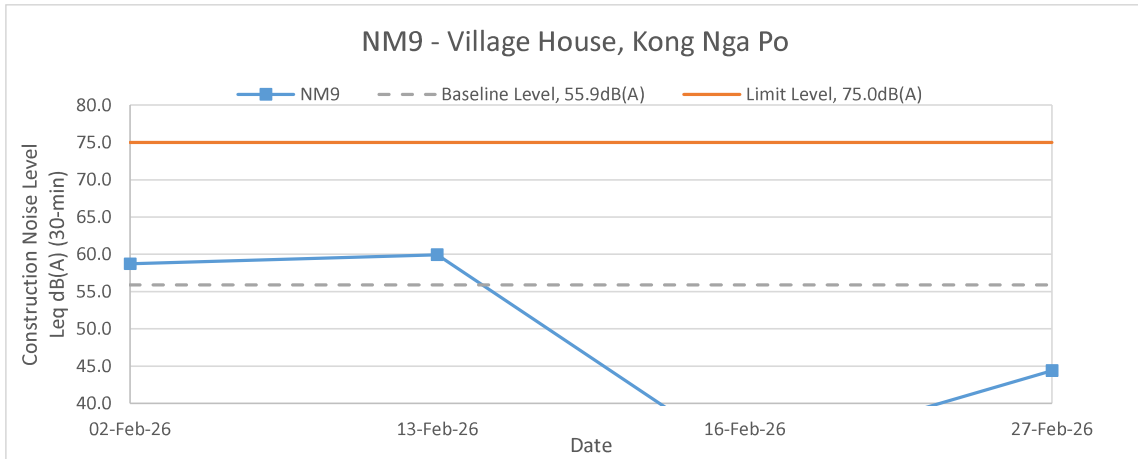
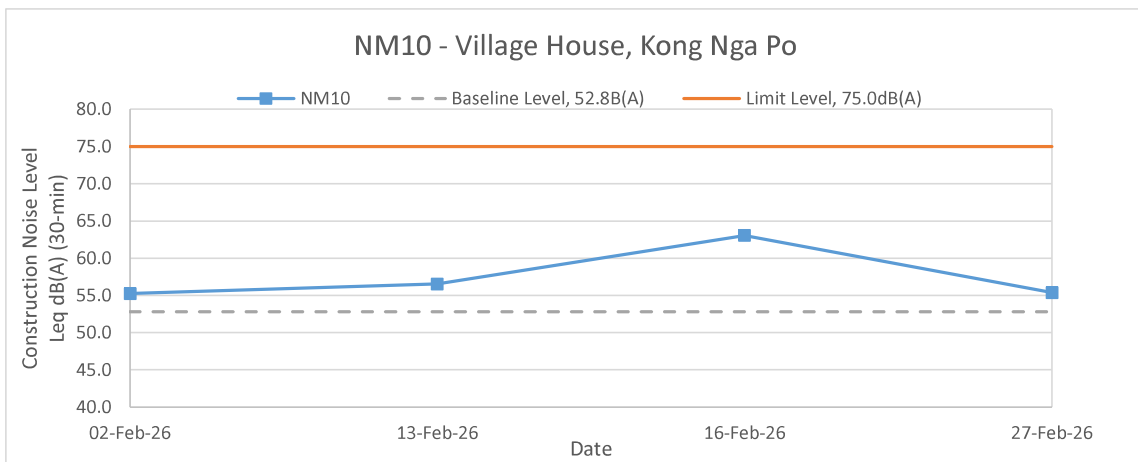
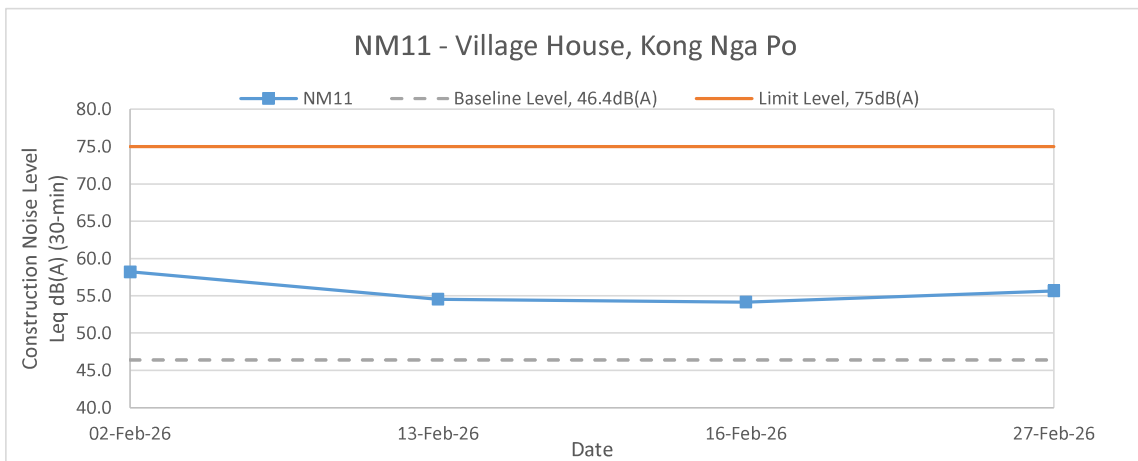
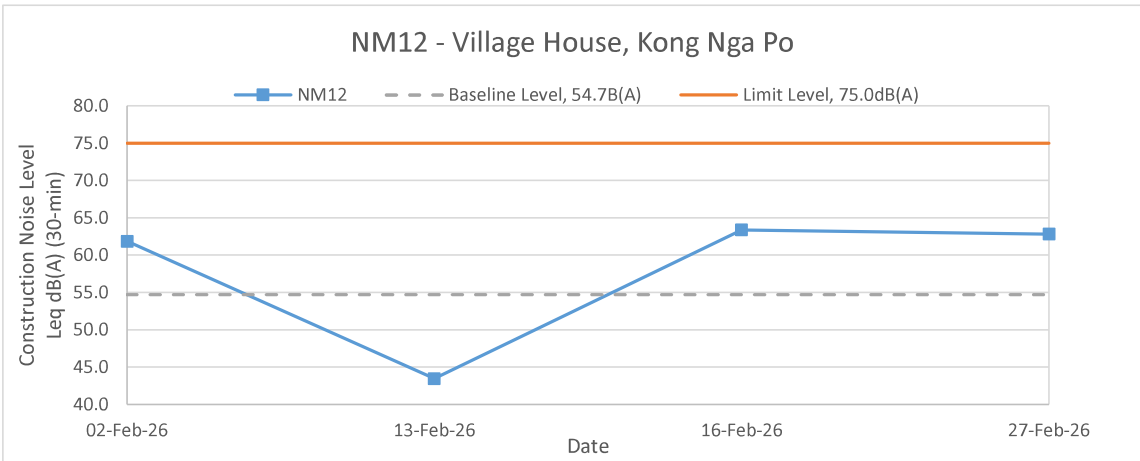
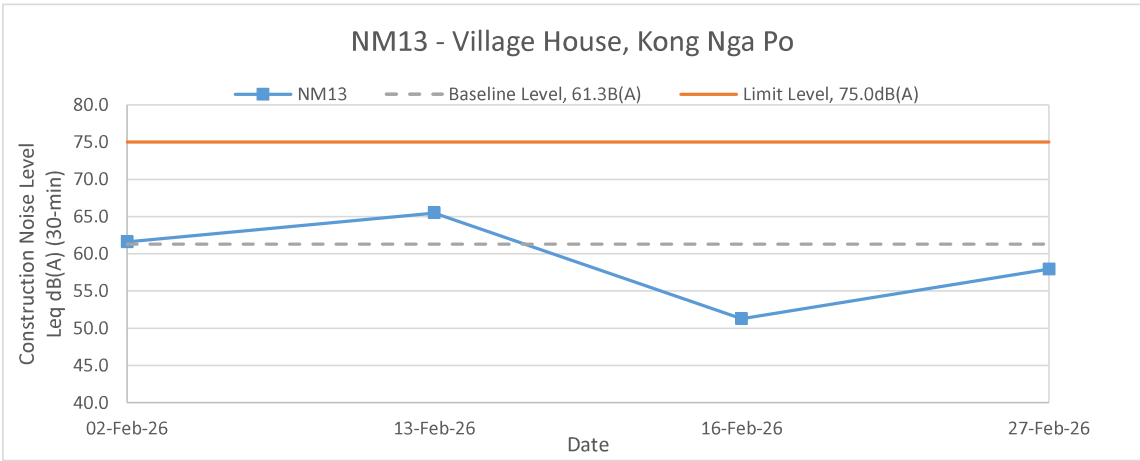
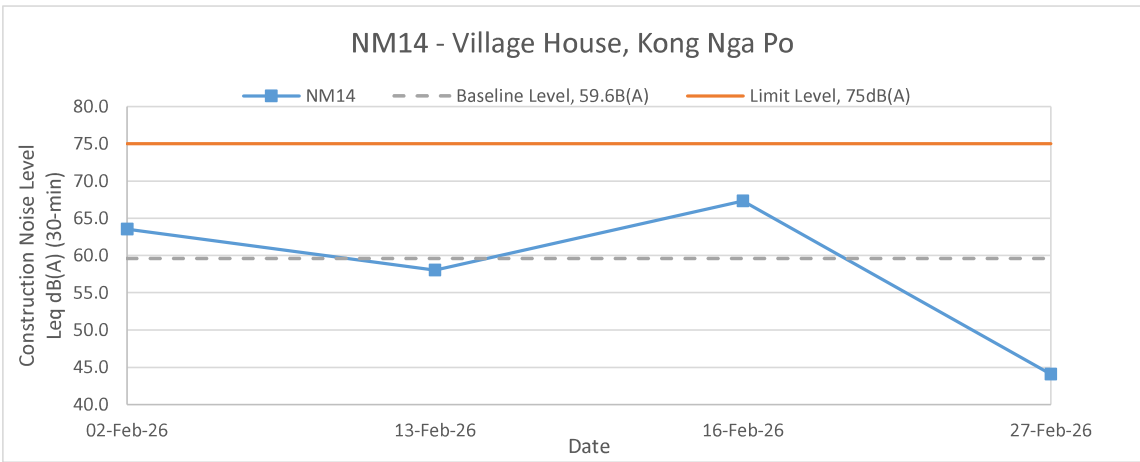
## Noise Levels

44.0	47.7	31.1			
				42.9	45.9	31.9			
				46.7	46.3	33.1			
				45.3	47.0	31.9			
				31.7	32.6	30.7

3.10 Noise monitoring related to construction activities took place according to the planned schedule for the month reported. There were no instances where the Action/Limit Levels were surpassed. A summary of exceedance records for the reporting month can be found in **Appendix J**.

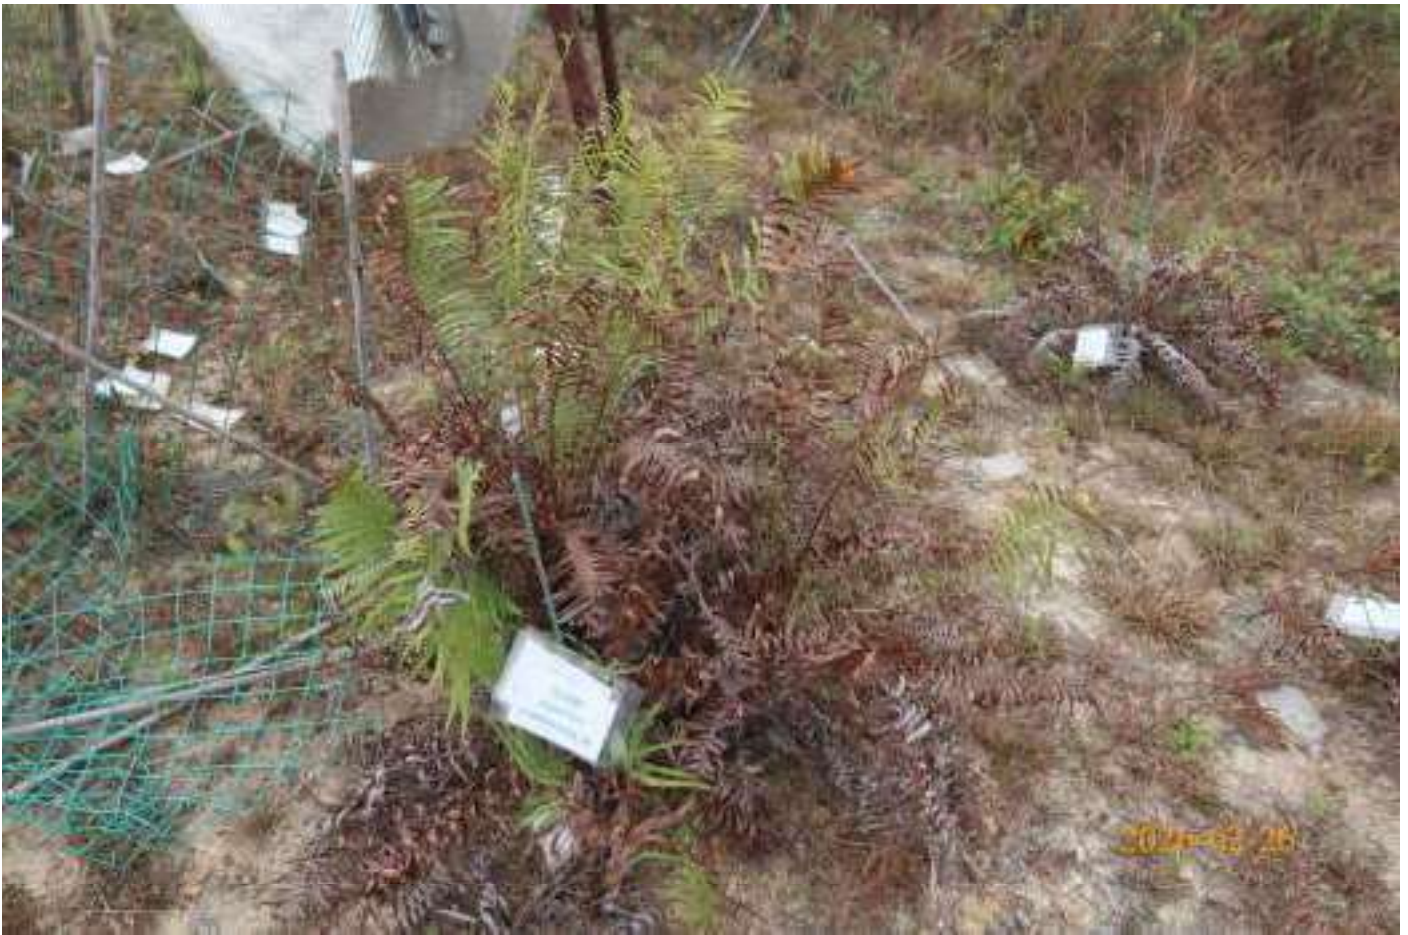
C-0001(Patch)\_01

12	<i>Brainea insignis</i>	P	P	-
	13	<i>Brainea insignis</i>	F	F	Young leaves observed

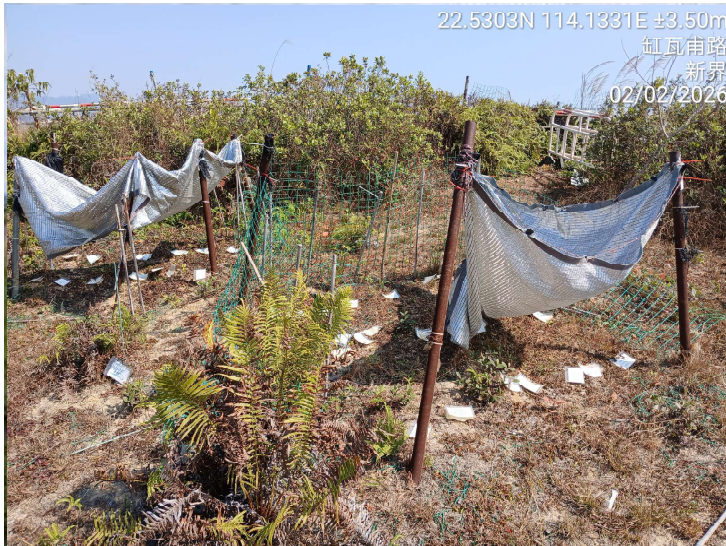
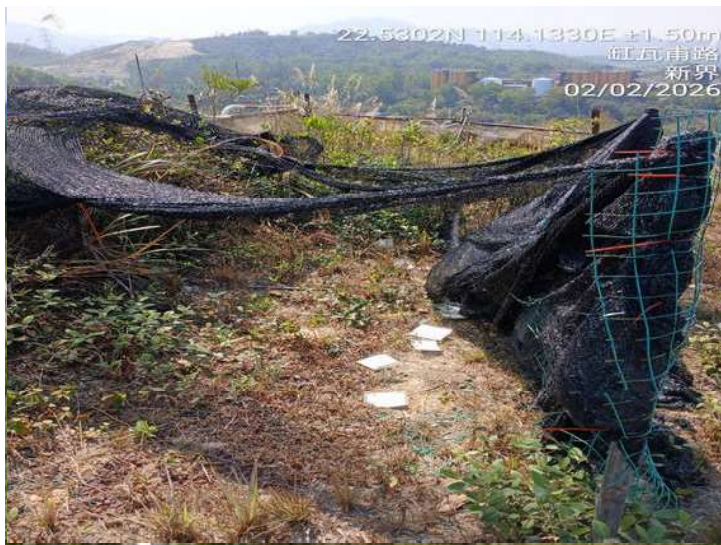
- 1) Please refer to the guidelines on soil improvement issued by the Greening, Landscape and Tree Management Section (GLTMS) of the development bureau (2022) to apply to monitoring and maintenance of transplanted flora species.
- 2) Daily watering frequency is needed to keep the soil moist.
- 3) The Damaged Sun Shade Net is replaced
- 4) The installation of a shaded net is shown as a sample below

- To maintain soil moisture, daily watering is required;
- To install a shaded net;
- To refer to the Guidelines on Soil Improvement issued by the Greening, Landscape and Tree Management Section (GLTMS) of the Development Bureau (2022) for the effective monitoring and maintenance of transplanted flora species; and
- The wild plants that are growing in undesirable areas should be removed, as they compete with the cultivated flora species of conservation interest.

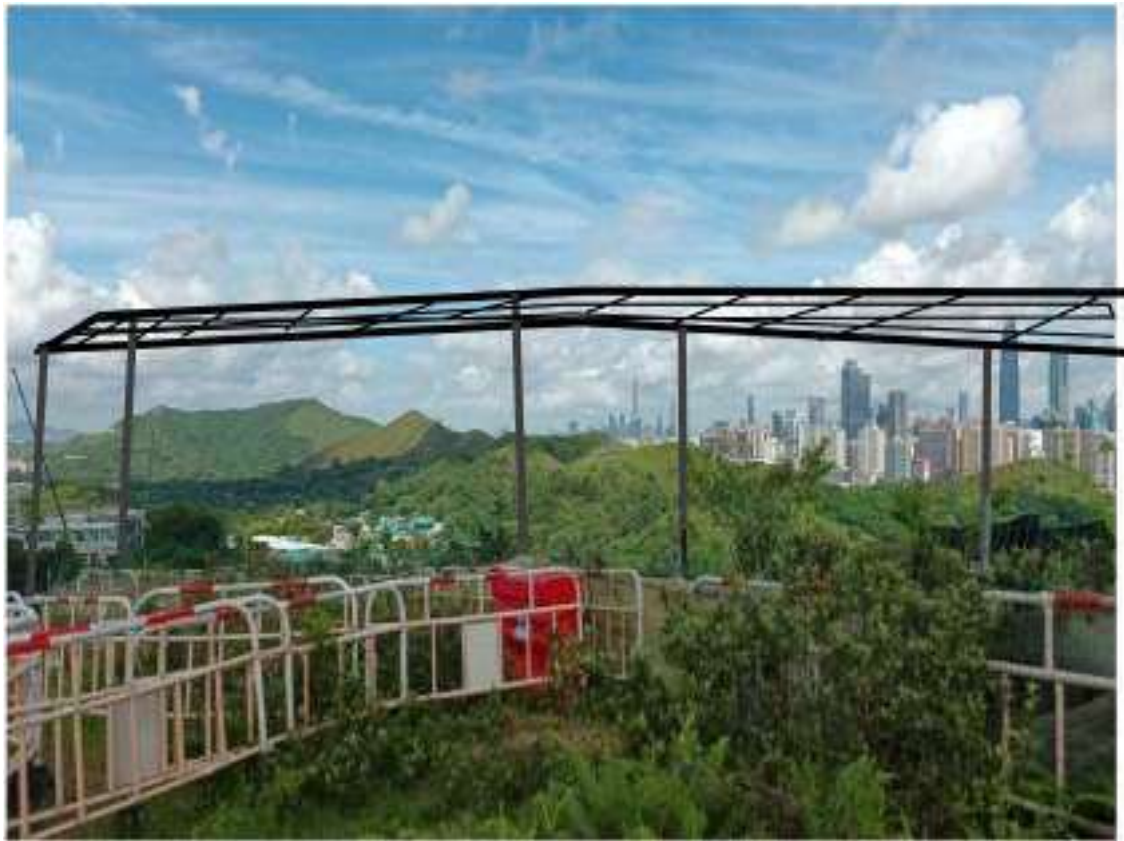
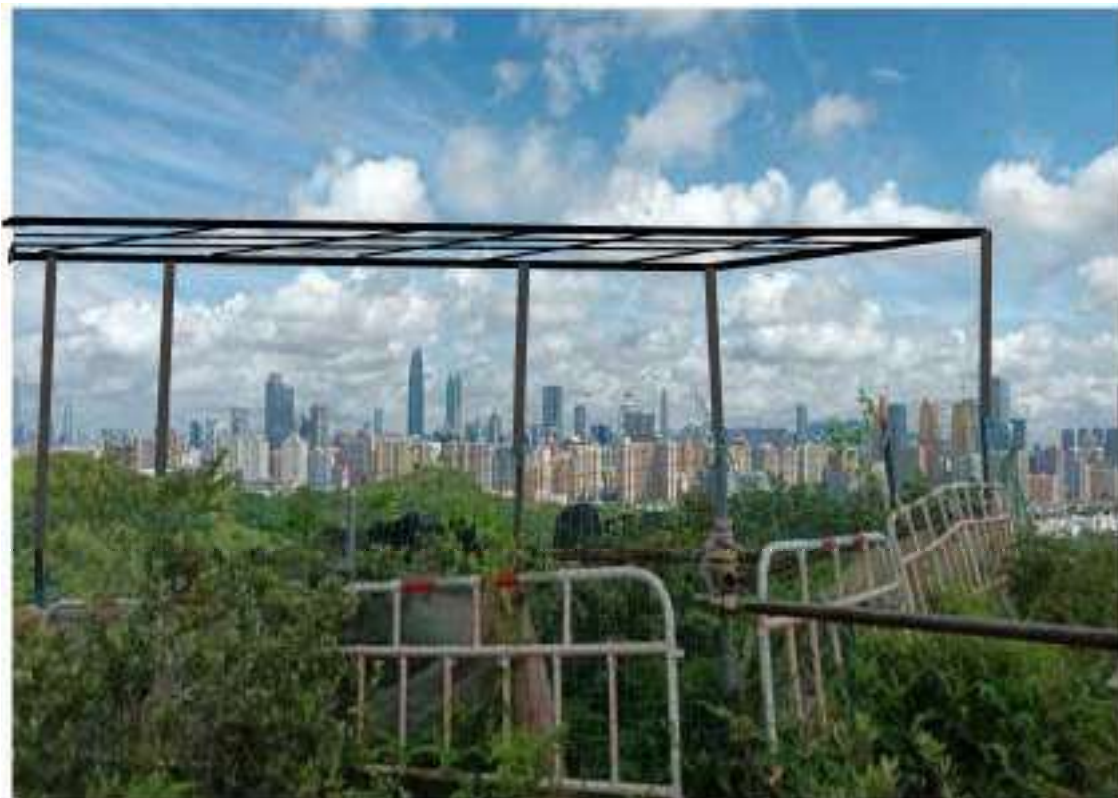
**The installation of a shaded net**

Remark: Non scale & Conceptual drawing

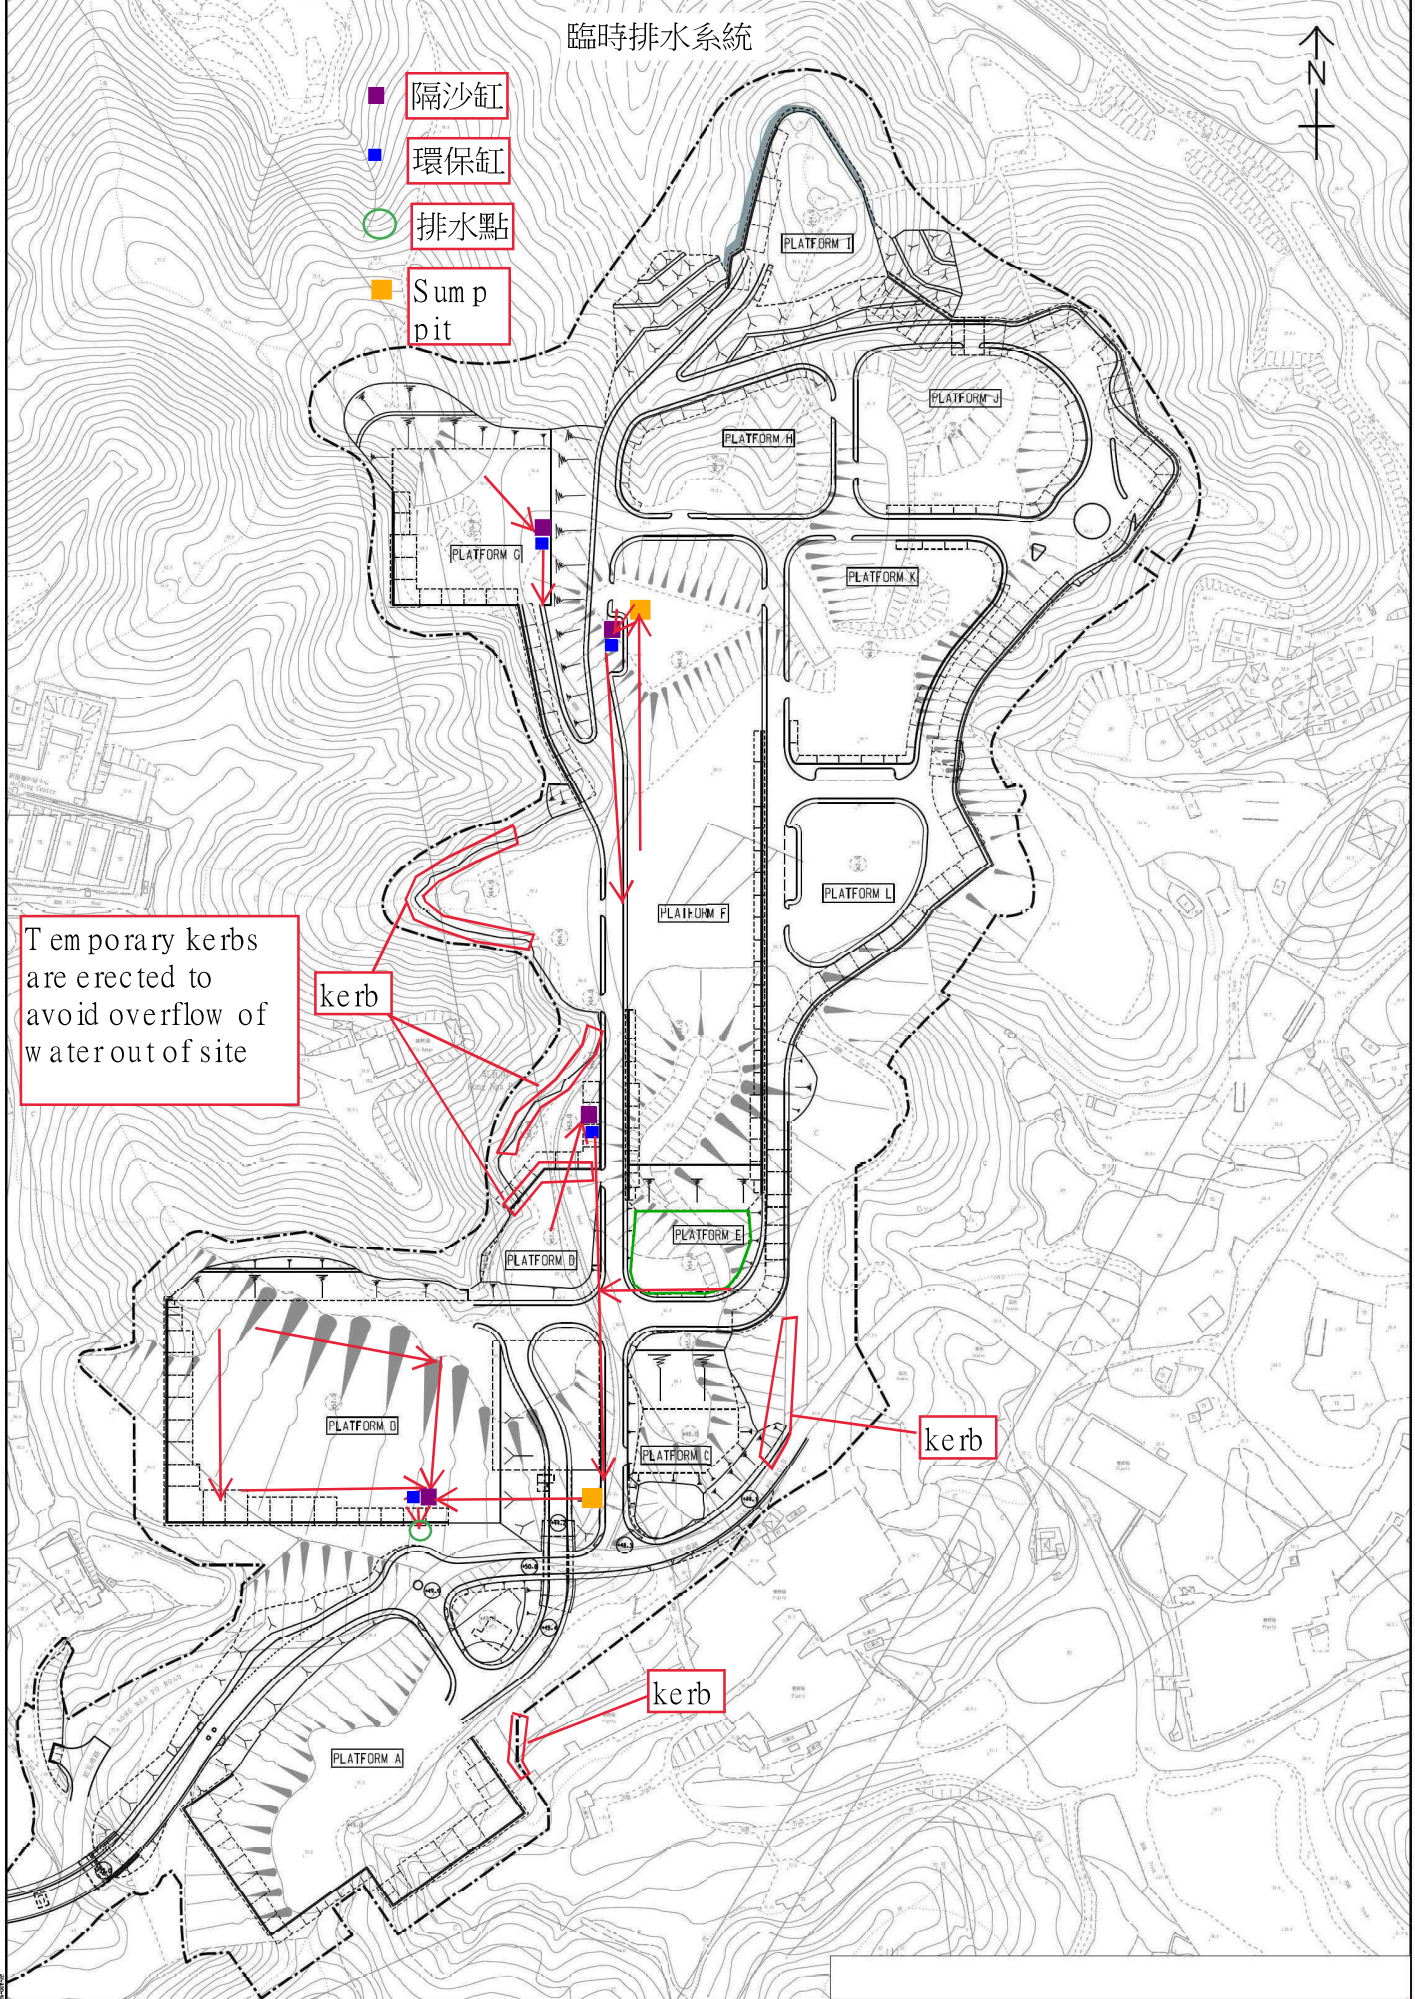
Temporary kerbs are erected to avoid overflow of water out of site
