**Agreement No. CE 64/2020 (EP)
Environmental Team for
Tung Chung New Town
Extension (West) –
Design and Construction**

Monthly Environmental Monitoring & Audit Report
for November 2022

Environmental Permit No. EP-519/2016

Tung Chung New Town Extension (West)

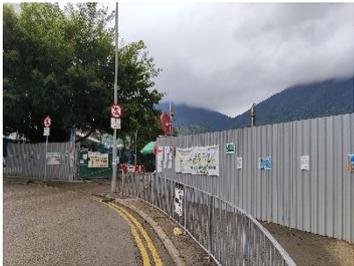
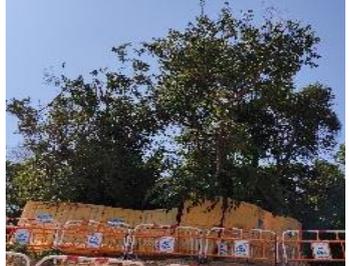
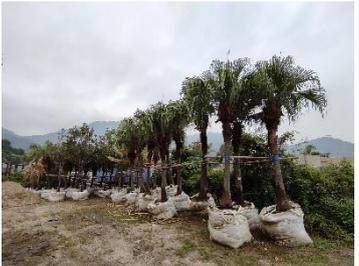
Table 7.3: Examples of Landscape and Visual Mitigation Measures in the Reporting Period

<p>Erection of site hoardings around works area in unobtrusive colours</p>	<p>General view of tree protection zone for retained tree</p>	<p>Transplanting of existing trees to temporary nursery site</p>

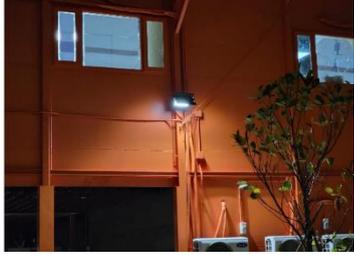
<p>Control of night-time lighting using light hooding</p>

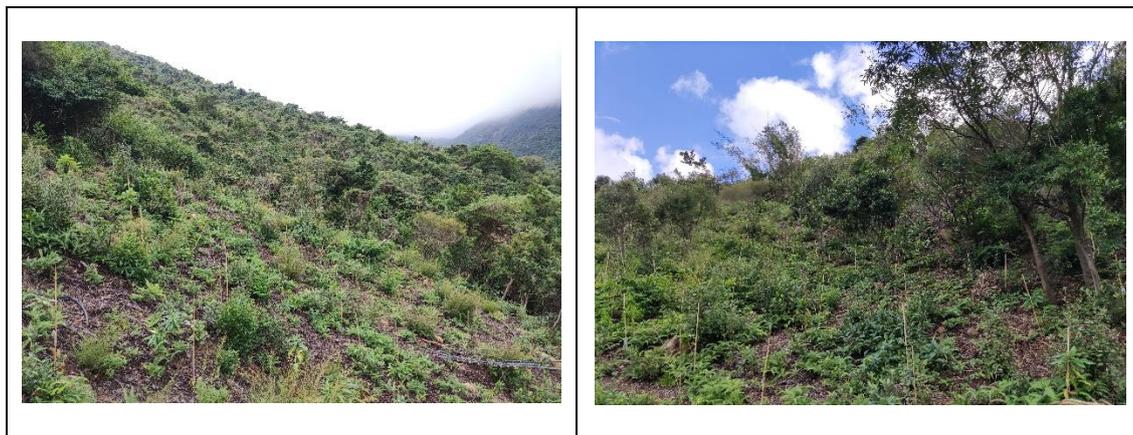
Table 7.6: Photos of the Compensation Woodland Planting

Compensation Woodland Planting was completed in May 2022. With the approval from EPD on the monitoring proposal in October 2022, the monitoring for Compensation Woodland was commenced in November 2022. Photos of the Compensation Woodland planting are shown in **Table 7.6**.

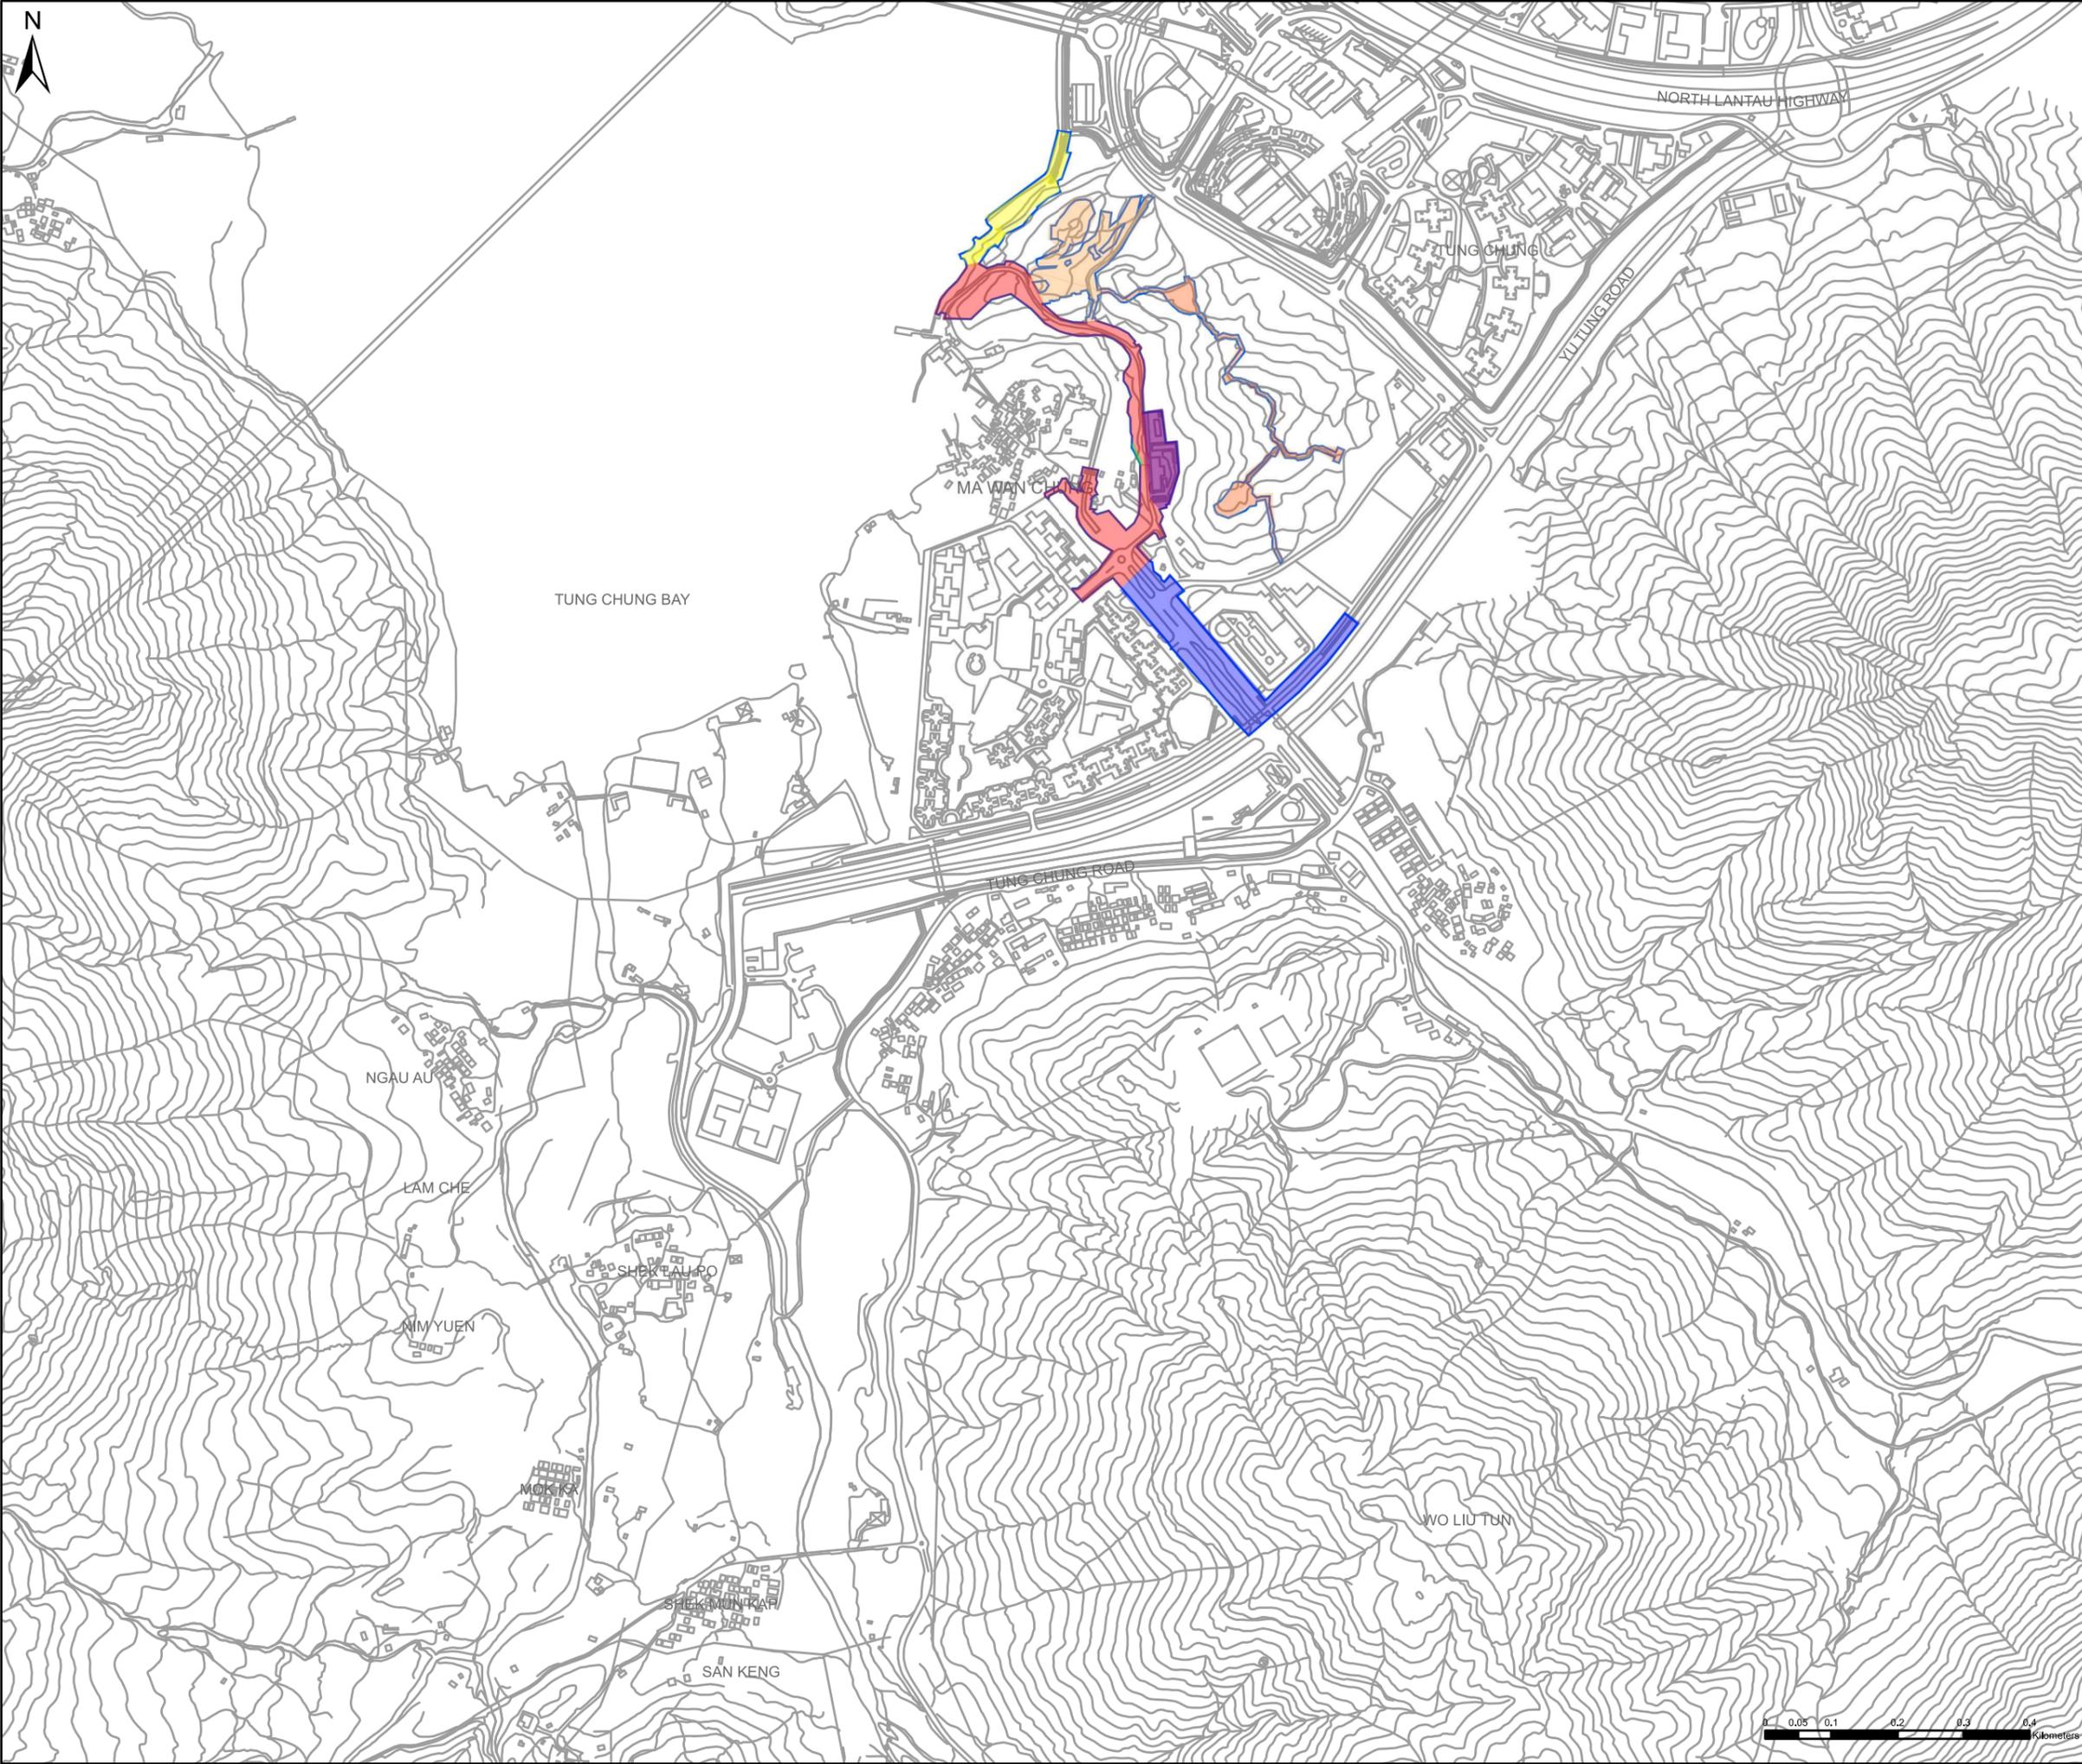
Drawing Number **FIGURE 1.1**

The locations of Contracts 5 and 6 are shown in **Figures 1.1 and 1.2** respectively.

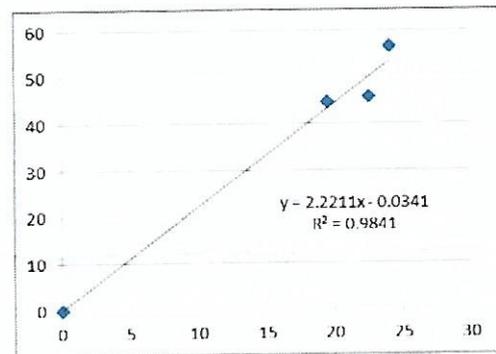
Correlation Coefficient (R) 0.9920

1. **Strong Correlation (R>0.8)**
2. Factor 2.2211 (µg/m³)/CPM should be applied for TSP monitoring

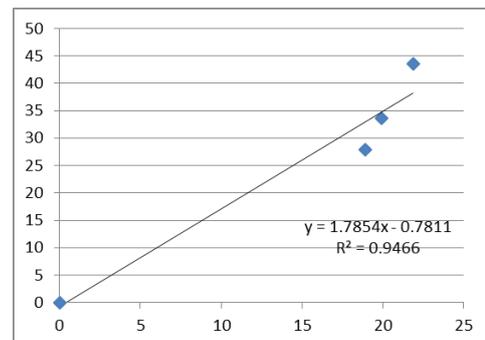
Slope (K-factor): 1.7854 (µg/m³)/CPM
Correlation Coefficient (R) 0.9729
Date of Issue 26 October 2022

- Strong** Correlation (R>0.8)
- Factor 1.7854 (µg/m³)/CPM should be applied for TSP monitoring

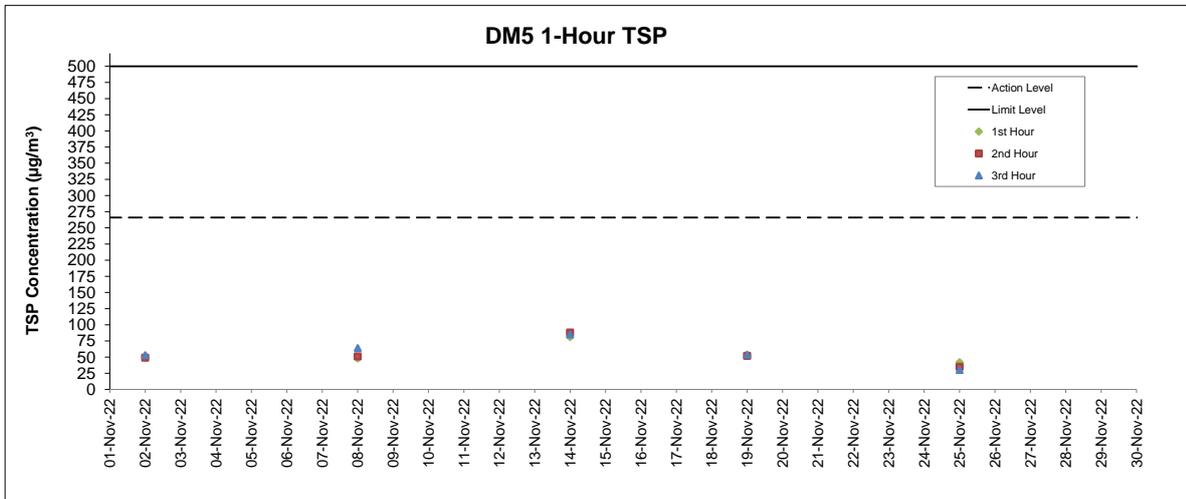
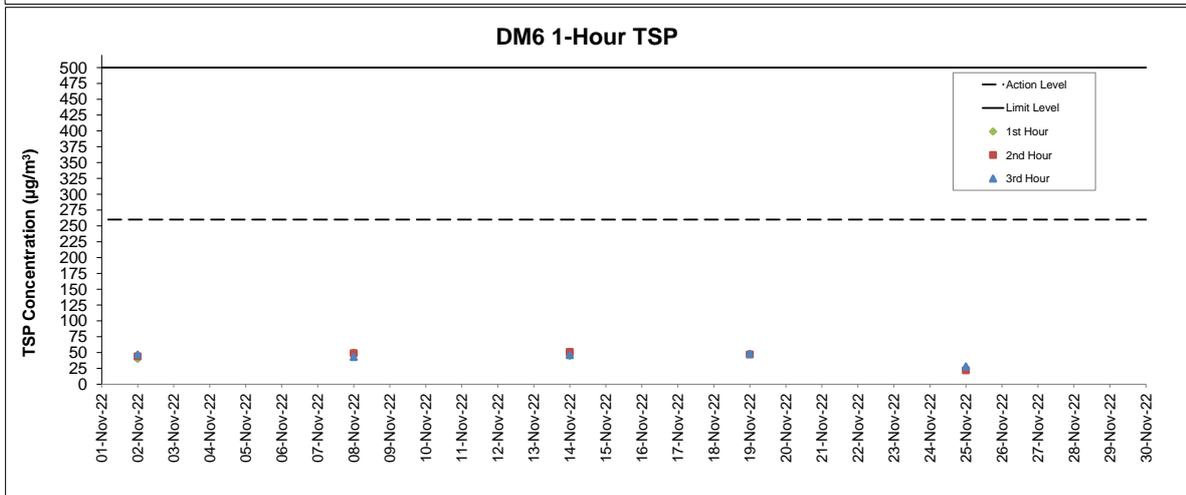
Date	Start Time	Finish Time	Weather	1-hr TSP ($\mu\text{g}/\text{m}^3$)	Action Level ($\mu\text{g}/\text{m}^3$)	Limit Level ($\mu\text{g}/\text{m}^3$)
02-Nov-22	8:47	9:47	Cloudy	40.0	260	500
02-Nov-22	9:47	10:47	Cloudy	44.0	260	500
02-Nov-22	10:47	11:47	Cloudy	47.0	260	500
08-Nov-22	8:20	9:20	Cloudy	50.0	260	500
08-Nov-22	9:20	10:20	Cloudy	49.0	260	500
08-Nov-22	10:20	11:20	Cloudy	43.0	260	500
14-Nov-22	8:27	9:27	Sunny	45.0	260	500
14-Nov-22	9:27	10:27	Sunny	51.0	260	500
14-Nov-22	10:27	11:27	Sunny	46.0	260	500
19-Nov-22	8:32	9:32	Sunny	48.0	260	500
19-Nov-22	9:32	10:32	Sunny	47.0	260	500
19-Nov-22	10:32	11:32	Sunny	48.0	260	500
25-Nov-22	9:22	10:22	Fine	24.0	260	500
25-Nov-22	10:22	11:22	Fine	22.0	260	500
25-Nov-22	11:22	12:22	Fine	28.0	260	500

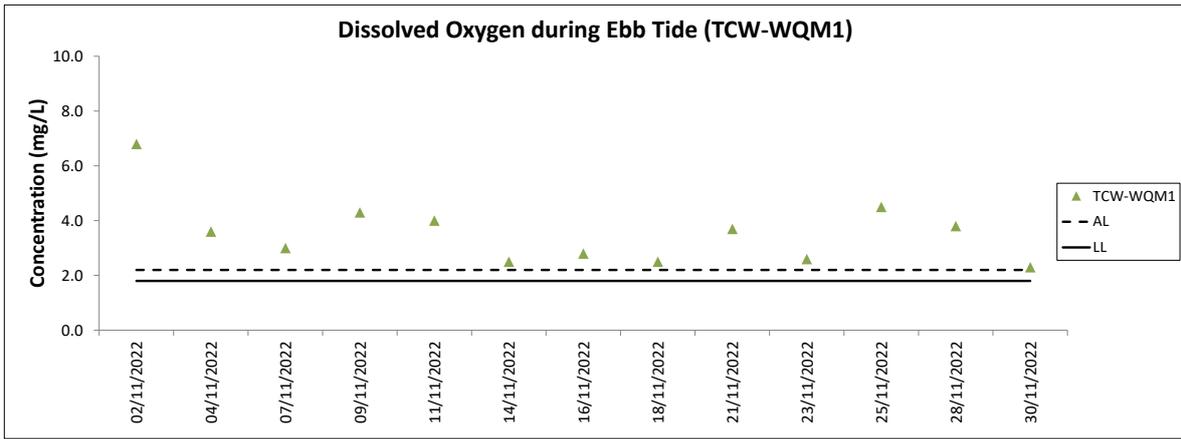
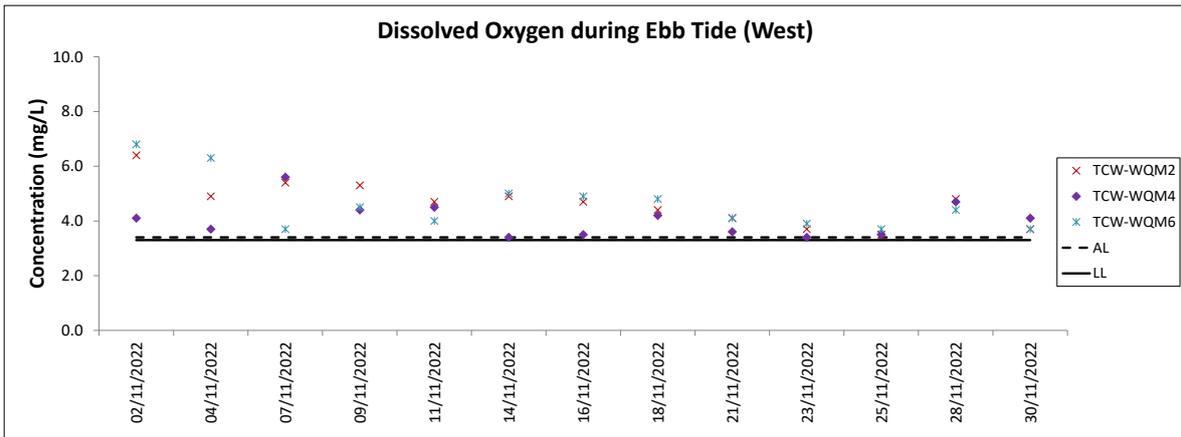
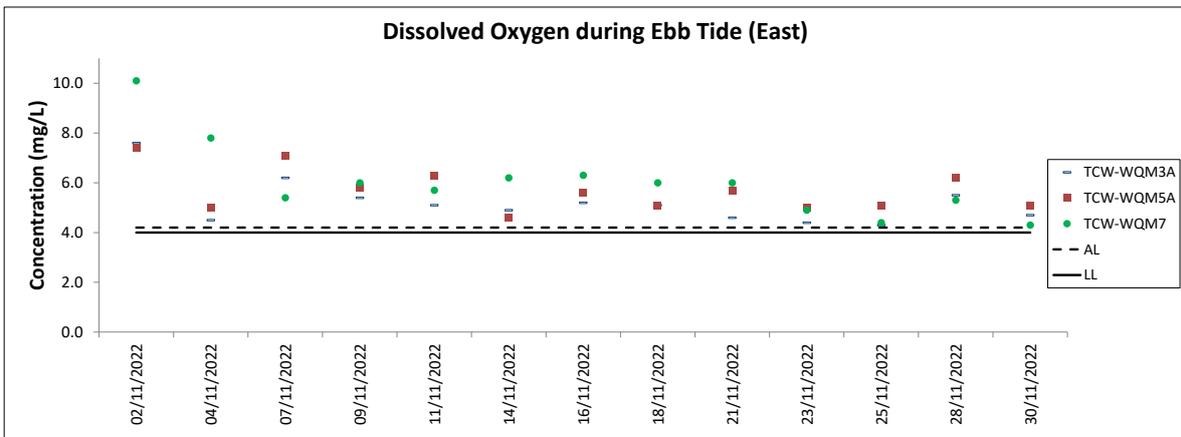
Note: The Action and Limit Level of dissolved oxygen can be referred to Table 4.3 of the monthly EM&A report.
 Major site activities carried out during the reporting period are summarized in Section 1.4 of the monthly EM&A report.
 Weather conditions during monitoring are presented in the data tables above.
 QA/ QC requirements as stipulated in the EM&A Manual were carried out during measurement.

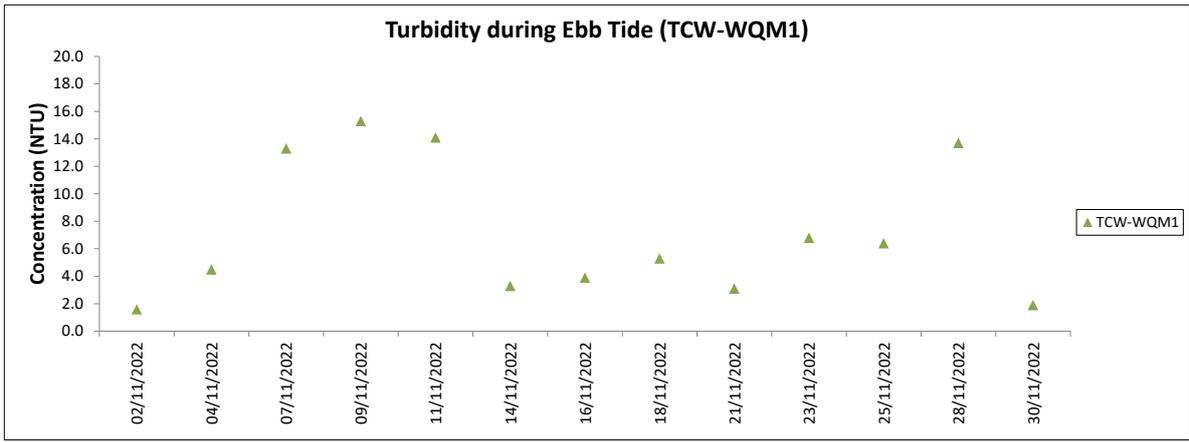
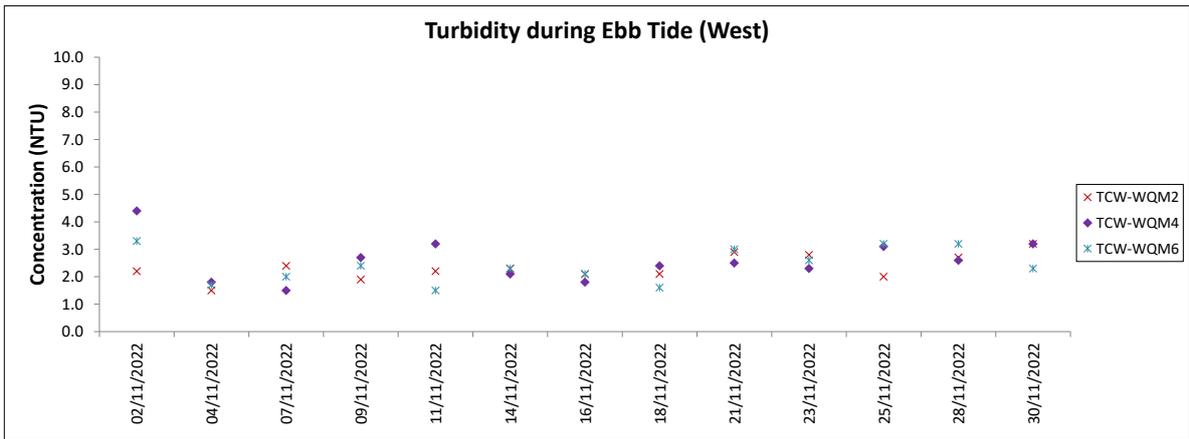
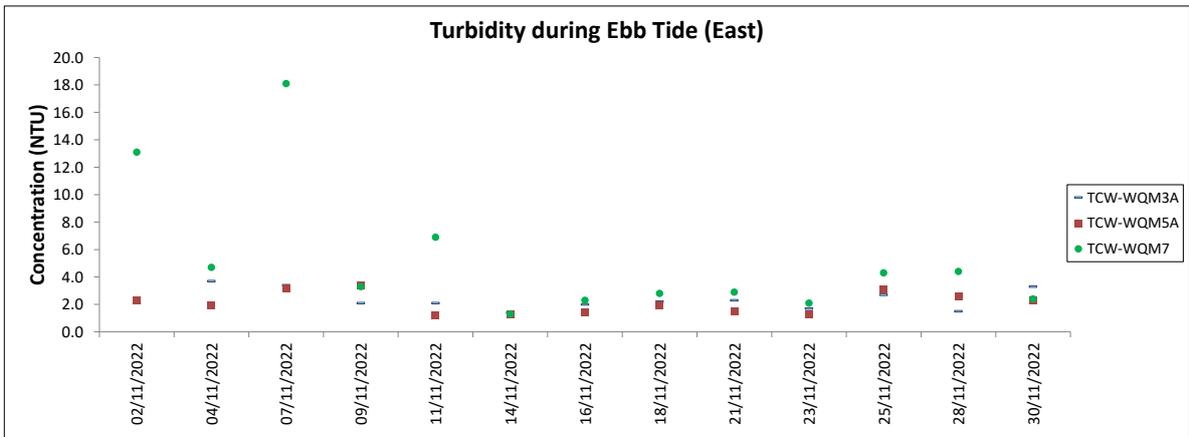
Note: The Action and Limit Level of turbidity can be referred to Table 4.3 of the monthly EM&A report.
 Major site activities carried out during the reporting period are summarized in Section 1.4 of the monthly EM&A report.
 Weather conditions during monitoring are presented in the data tables above.
 QA/ QC requirements as stipulated in the EM&A Manual were carried out during measurement.

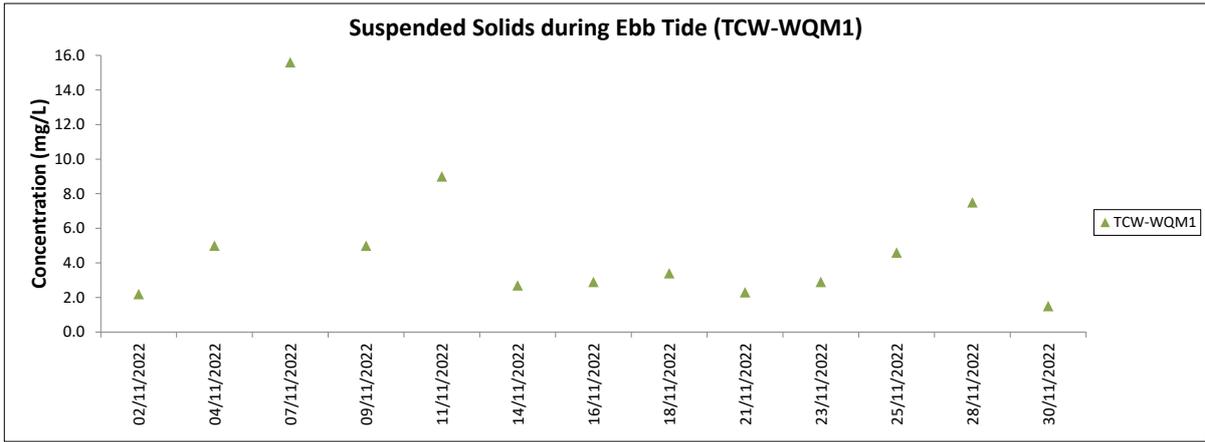
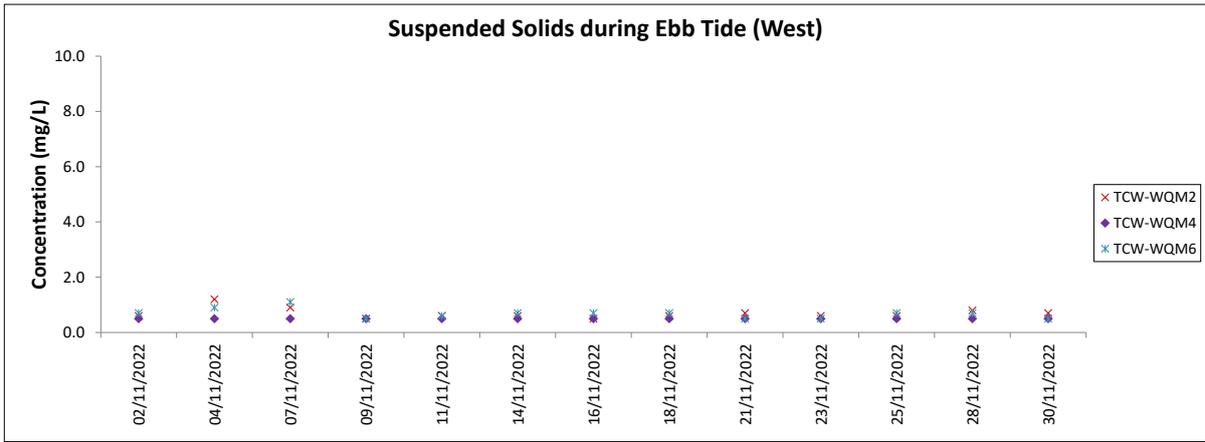
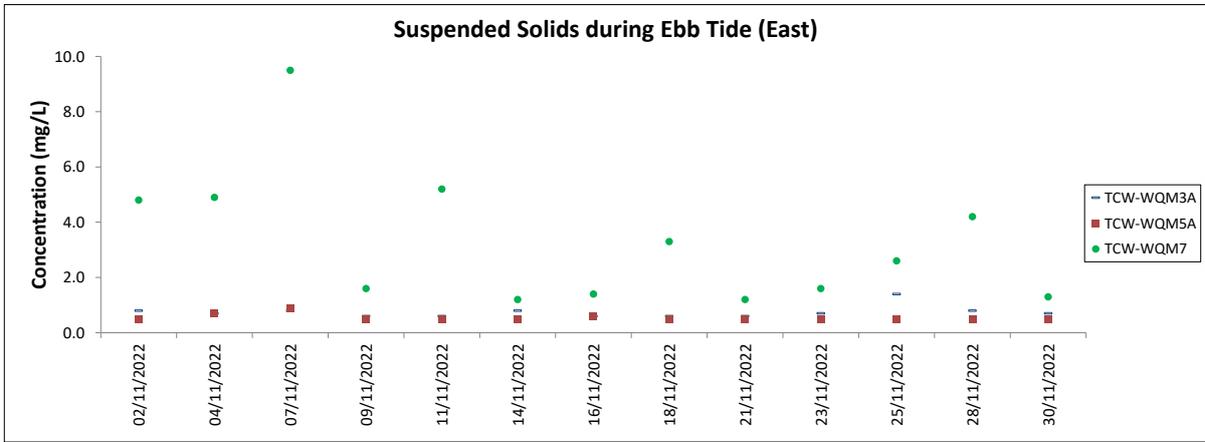
Note: The Action and Limit Level of suspended solids can be referred to Table 4.3 of the monthly EM&A report.
 Major site activities carried out during the reporting period are summarized in Section 1.4 of the monthly EM&A report.
 Weather conditions during monitoring are presented in the data tables above.
 QA/ QC requirements as stipulated in the EM&A Manual were carried out during measurement.

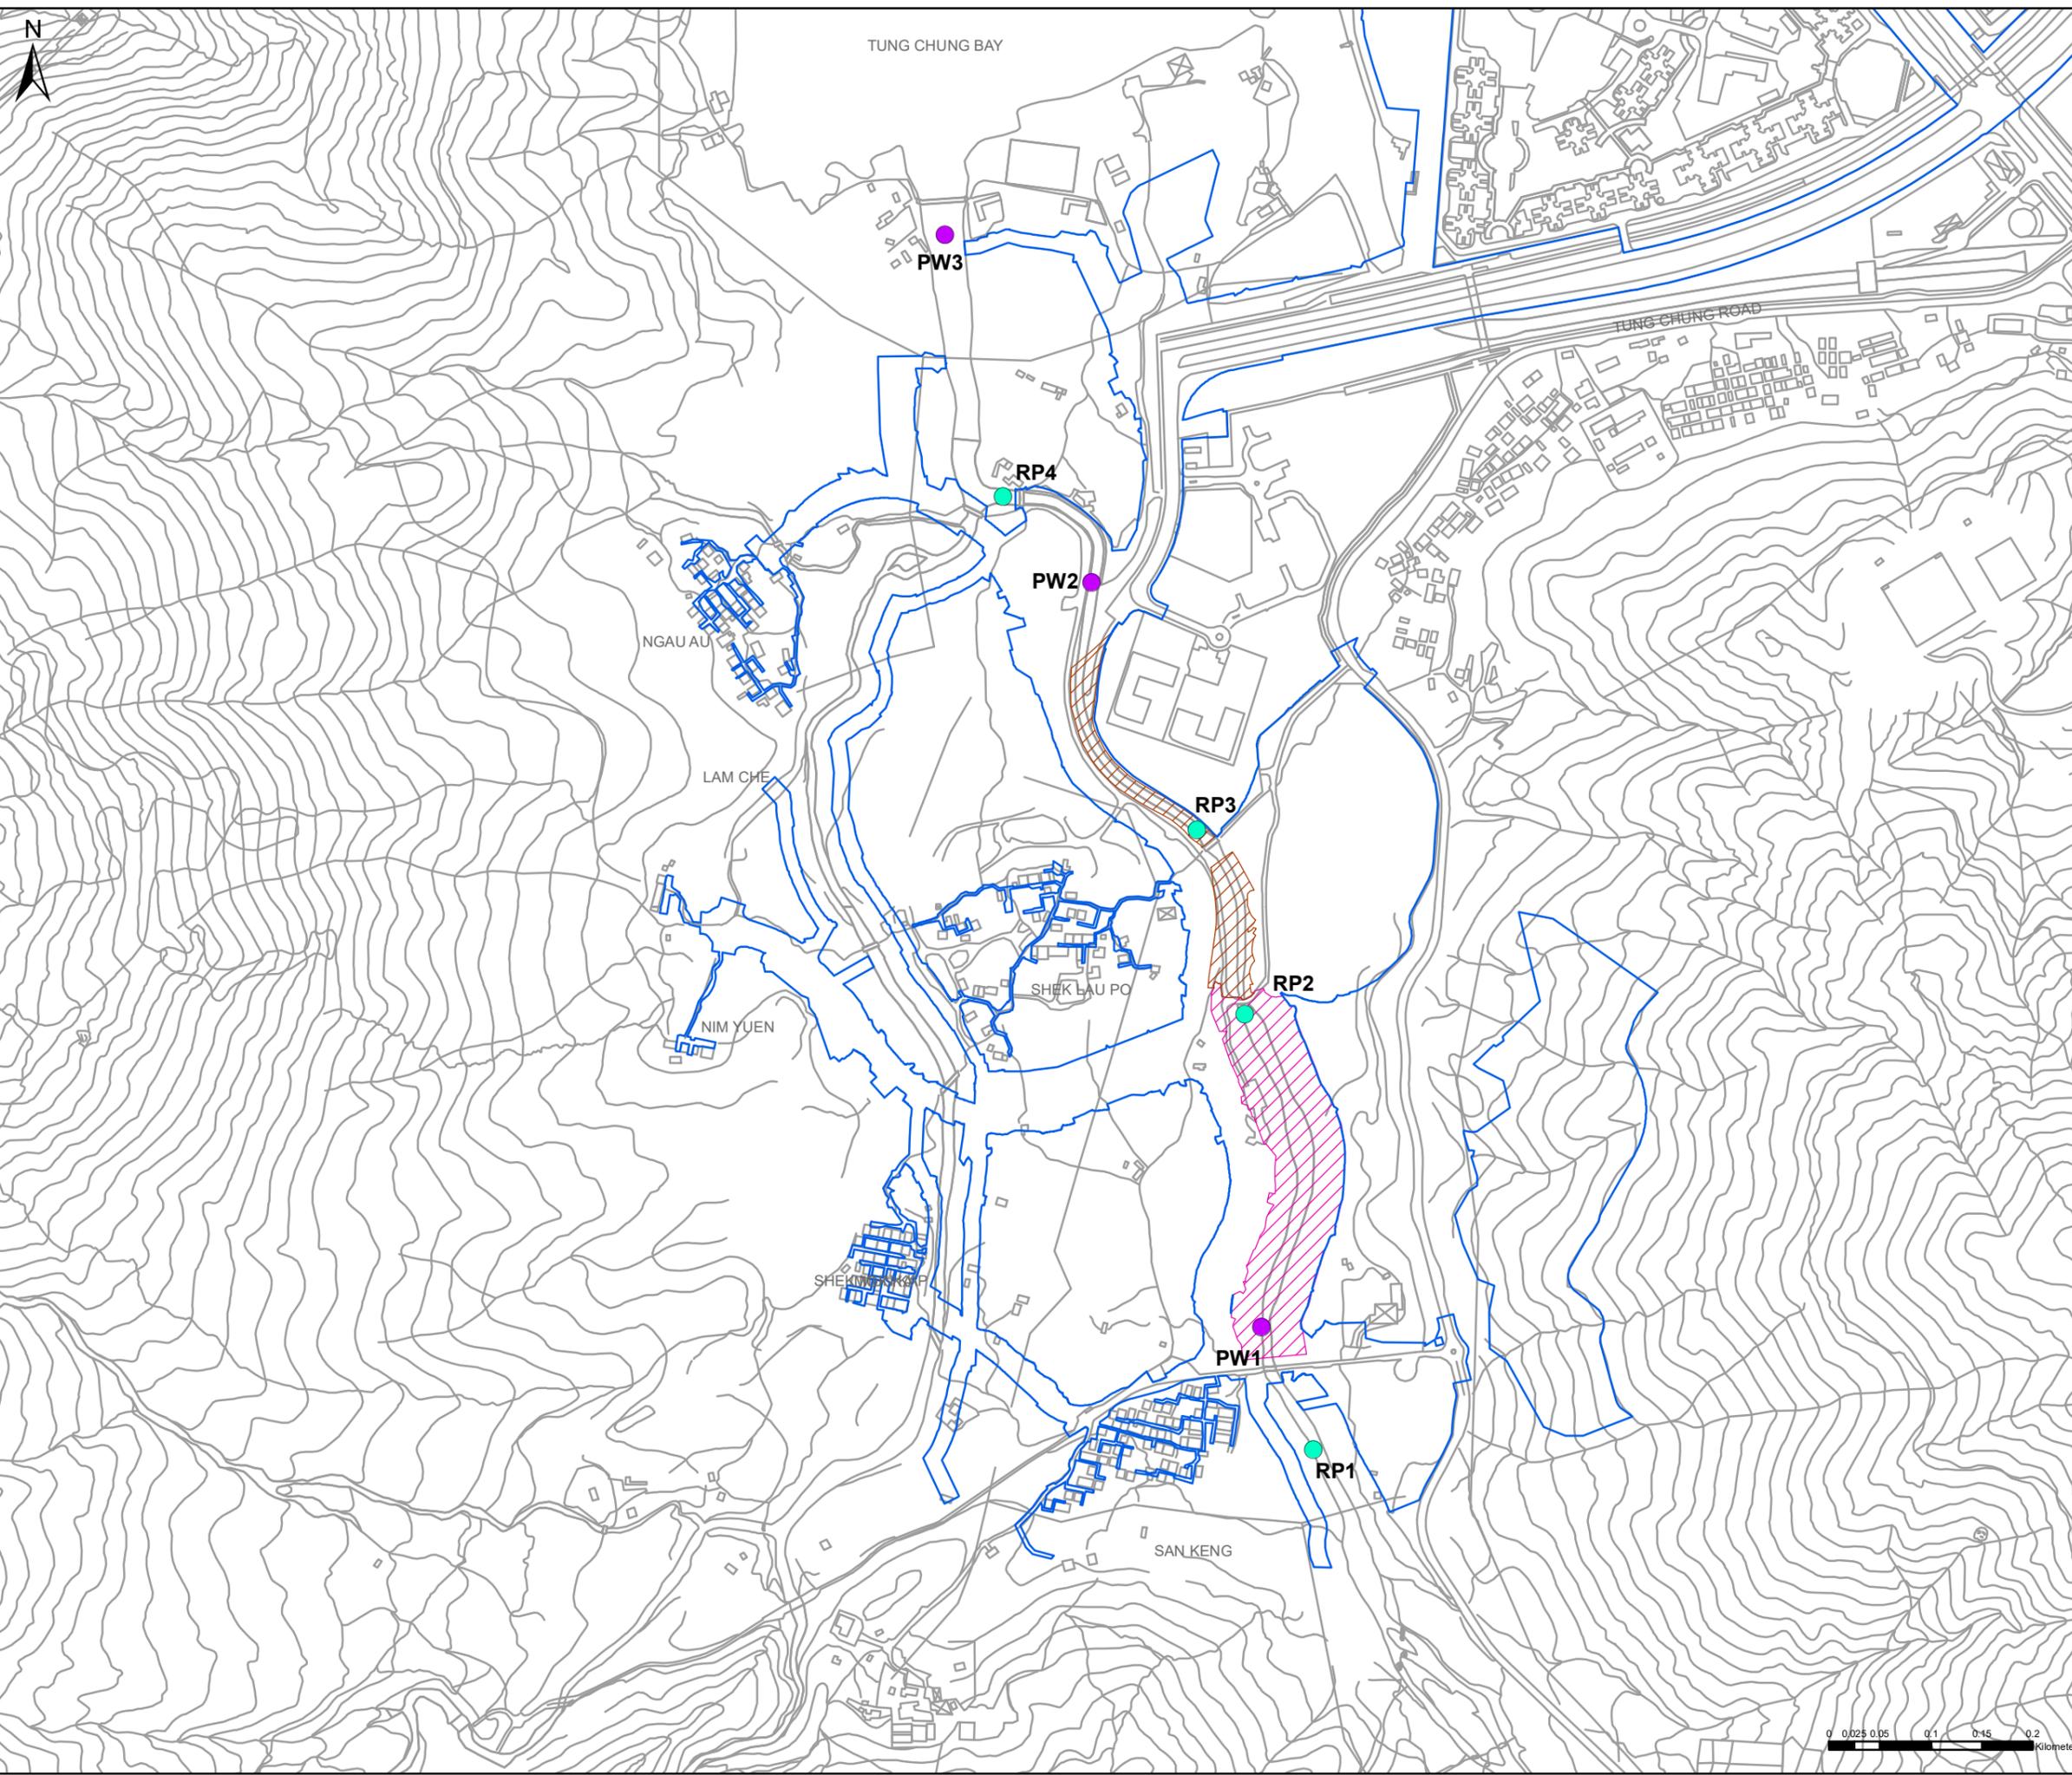
I1. Location of Ecological Impact Monitoring Stations

- Key to symbols:
- LEGEND**
- PROJECT AREA
 - ECOLOGICAL MONITORING STATION (FOR RIVER PARK)
 - ECOLOGICAL MONITORING STATION (FOR OTHER PUBLIC WORKS)
 - RIVER PARK PHASE 1
 - RIVER PARK PHASE 2

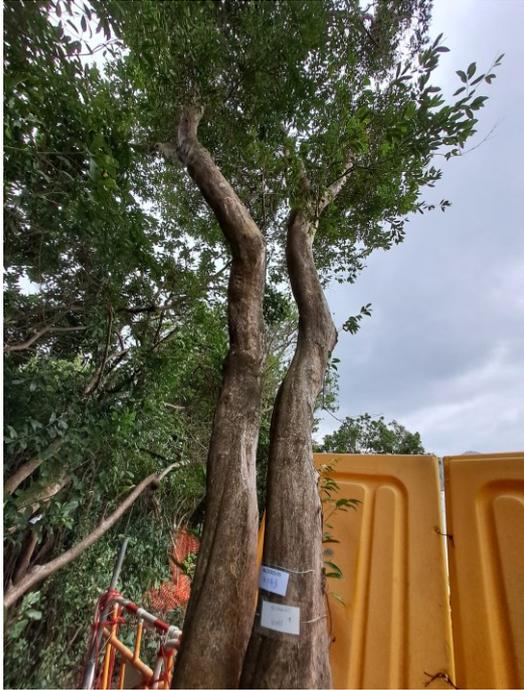
U043	<i>Aquilaria sinensis</i>	土沉香	RPPHK; Cap.586; IUCN:VU	9	310	4	M	A	P	A	Retain	Termite track with live termites was found, application of insecticide is recommended and completed	Located closed to cut slope and fenced off by 2m high barrier

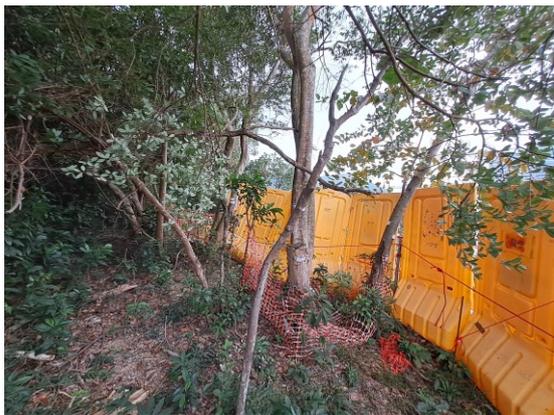
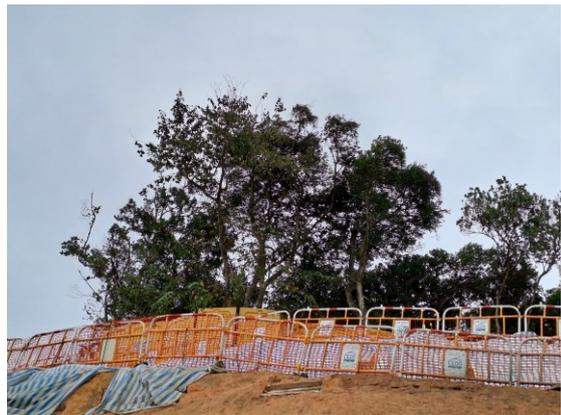
temporary protective fencing for U041, U042 & U043

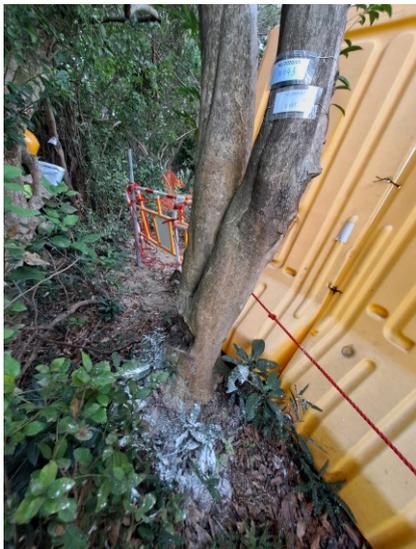
Application of insecticide for U043

Monthly monitoring of the *in-situ* preserved plant species of conservation importance by the Qualified Botanist (QB) appointed under Contract 5 and Contract 6 respectively were implemented in the reporting period. Termite track with live termites was recorded at one (1) individual of *Aquilaria sinensis* (Tree No. U043) under Contract 5. Insecticide was applied for the concerned plant as recommended by the QB appointed under Contract 5.

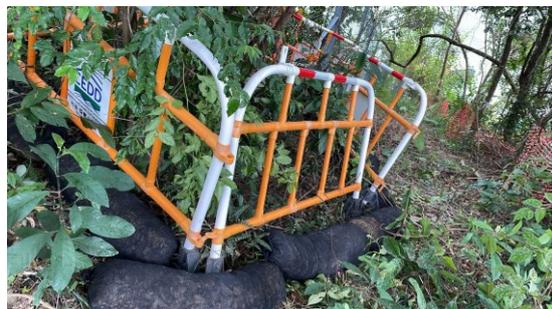
protective fence sealed by sand bag
