## Environmental Permit No. FEP-01/571/2019/A

### Proposed Golf Course Development at Tai Po Lot No. 246 Shuen Wan

Document to be Certified: Monthly EM&A Report (Nov 2024)

Date of Report: December 2024

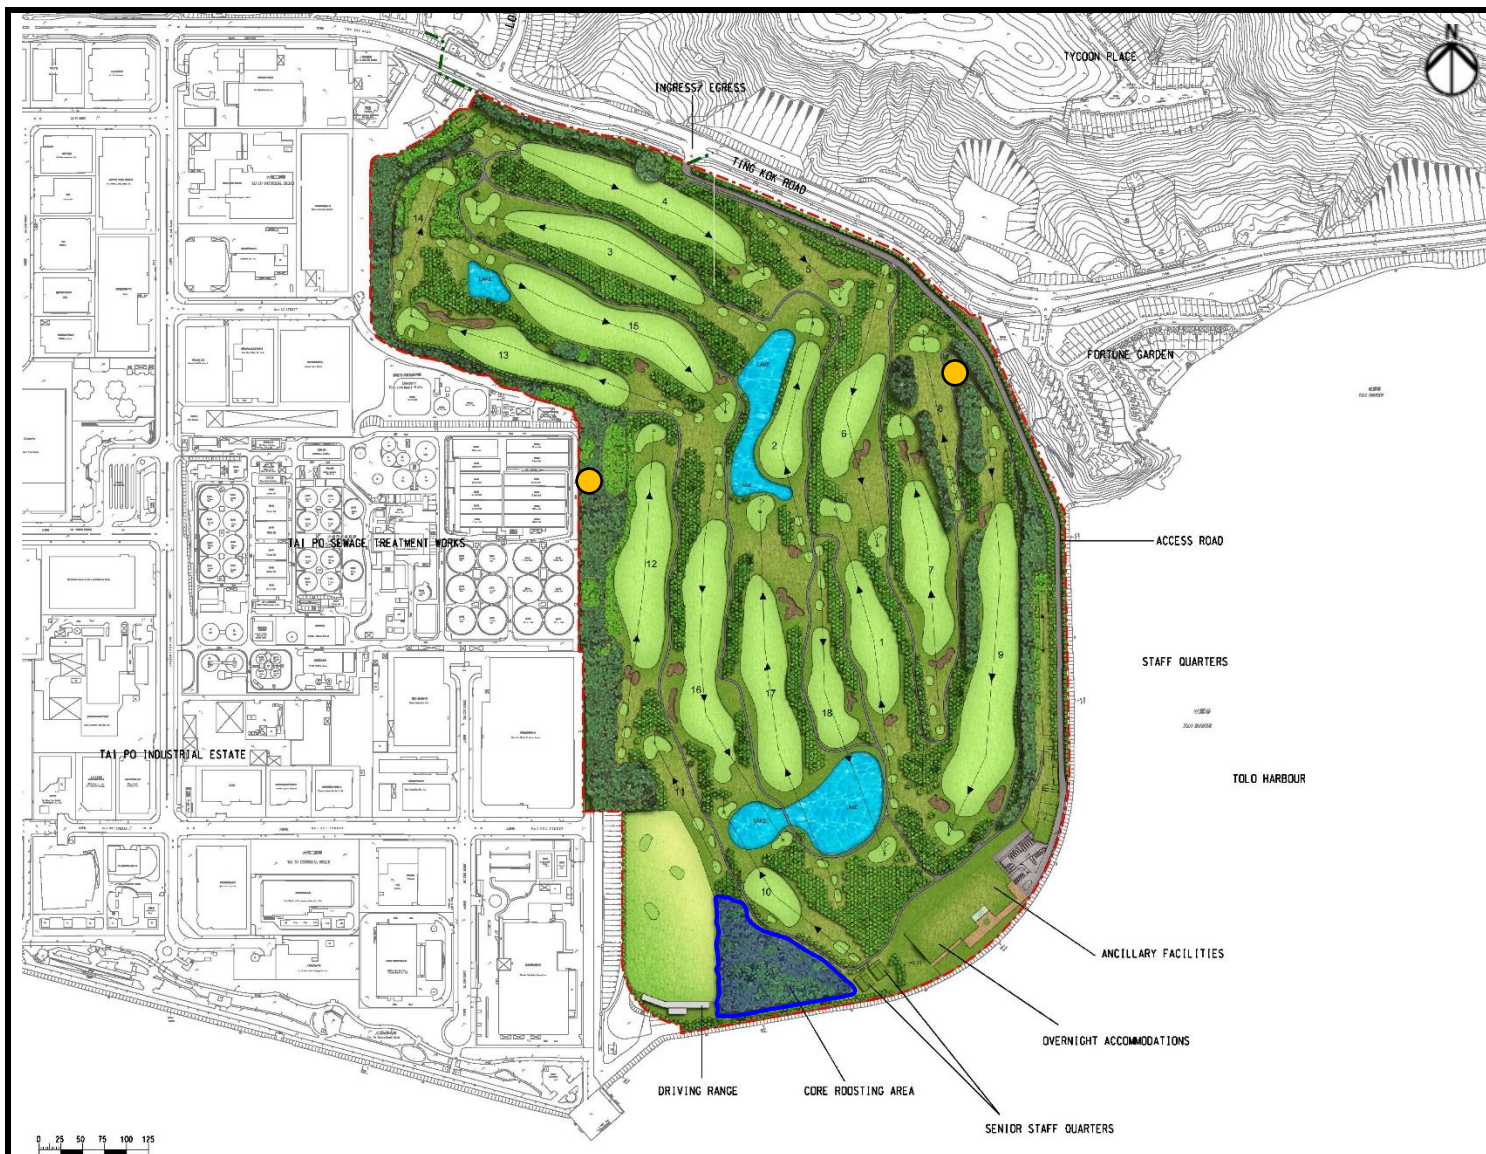
**Figure 1**  
圖一

- Project Location  
工程項目位置
- 1.2 ha Core Roosting Area  
1.2 公頃核心夜間棲息地
- *Aquilaria sinensis*  
土沉香

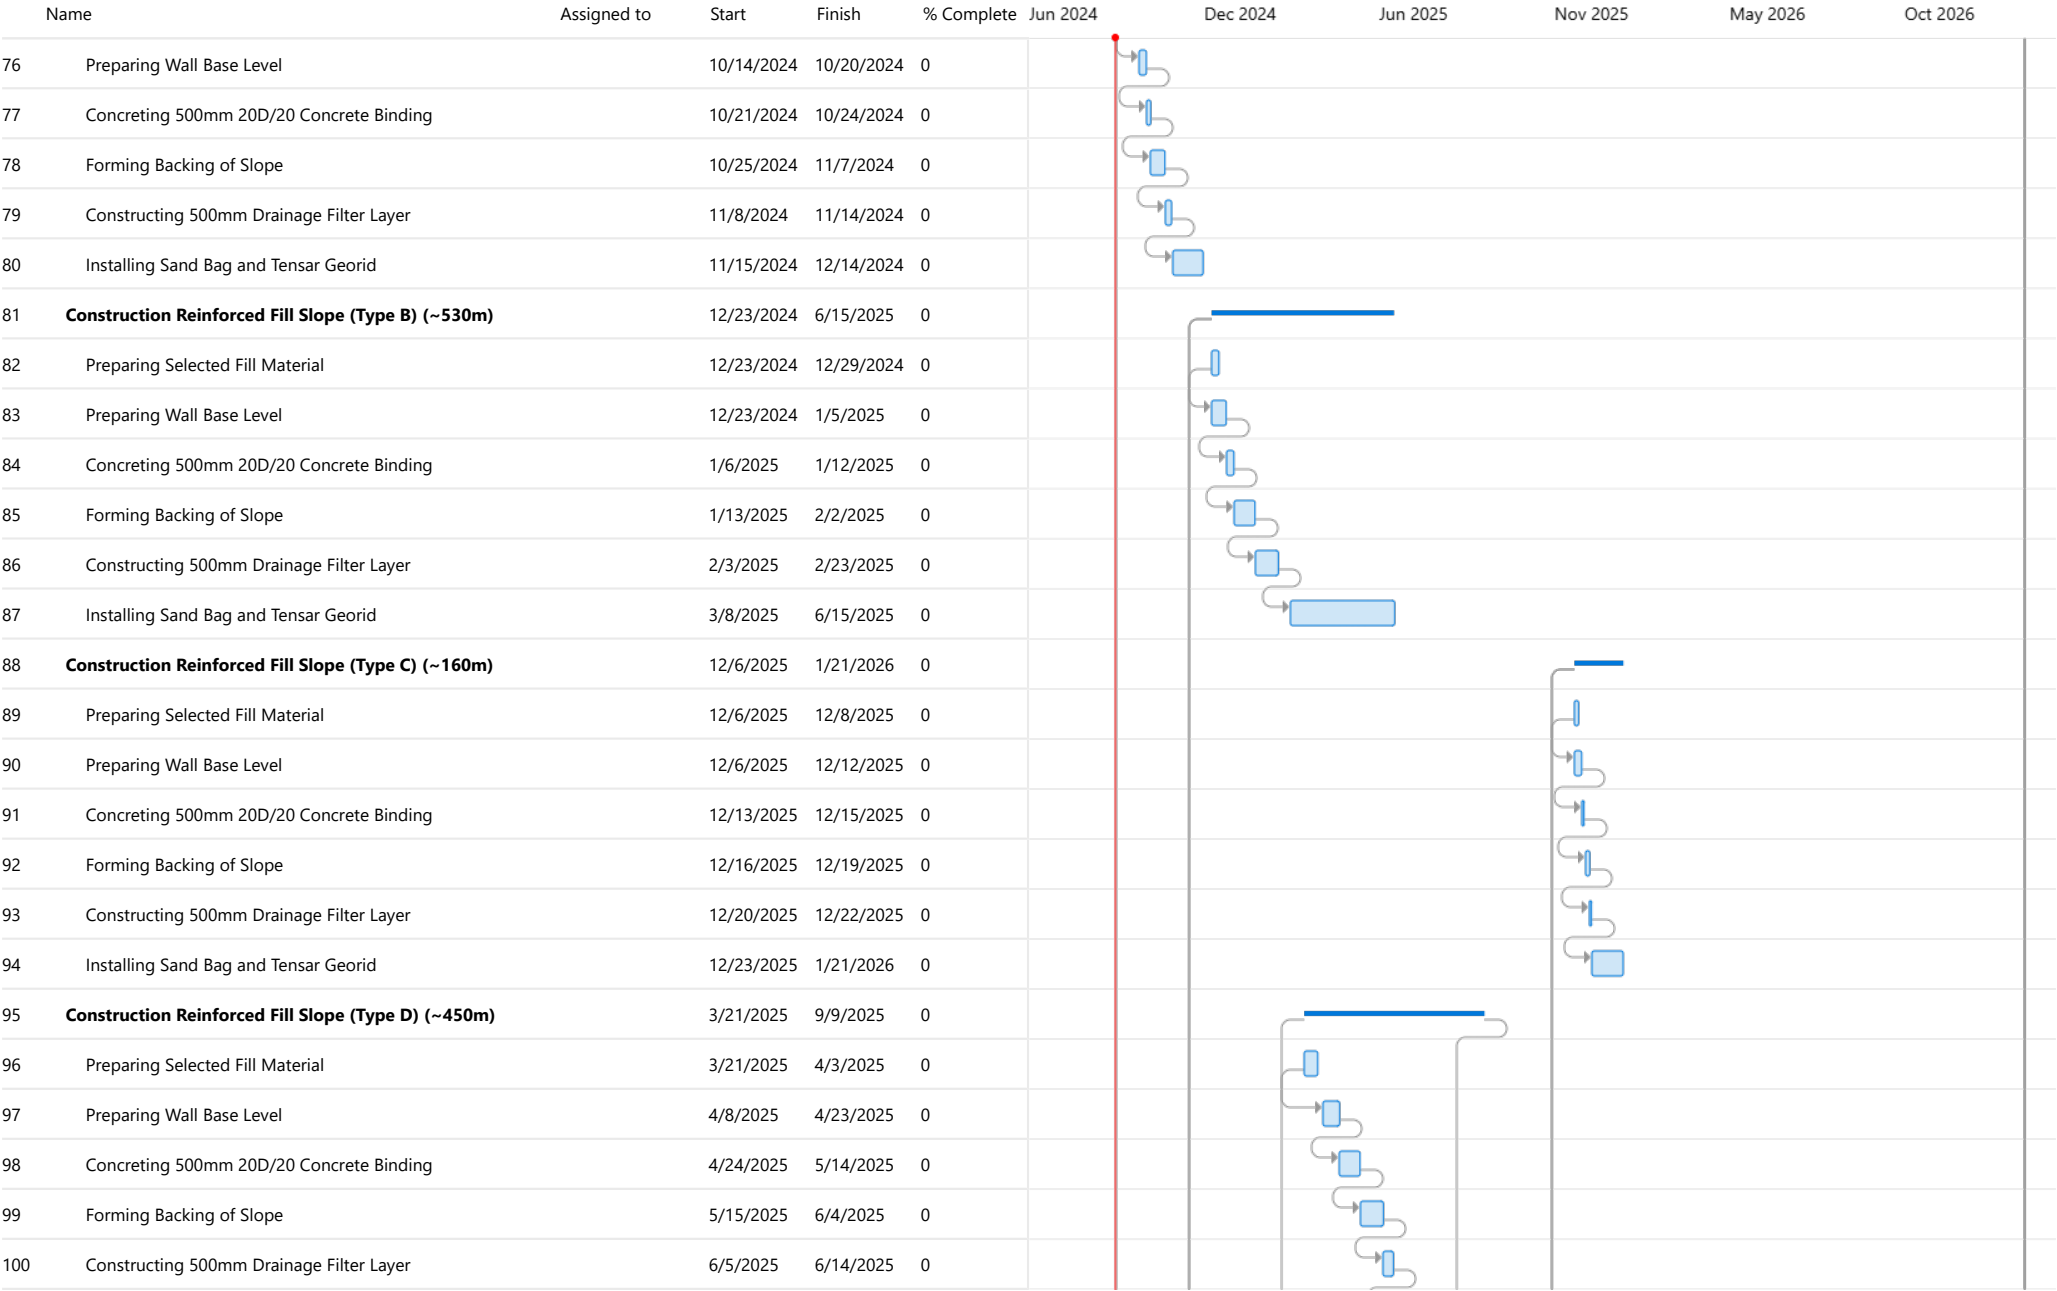
Tai Po Golf Course Programme v6 (Calendar Day)

Name	Apr 2027	Sep 2027	Mar 2028	Aug 2028	Feb 2029	Jul 2029
76	Preparing Wall Base Level					
77	Concreting 500mm 20D/20 Concrete Binding					
78	Forming Backing of Slope					
79	Constructing 500mm Drainage Filter Layer					
80	Installing Sand Bag and Tensar Georid					
81	Construction Reinforced Fill Slope (Type B) (~530m)					
82	Preparing Selected Fill Material					
83	Preparing Wall Base Level					
84	Concreting 500mm 20D/20 Concrete Binding					
85	Forming Backing of Slope					
86	Constructing 500mm Drainage Filter Layer					
87	Installing Sand Bag and Tensar Georid					
88	Construction Reinforced Fill Slope (Type C) (~160m)					
89	Preparing Selected Fill Material					
90	Preparing Wall Base Level					
91	Concreting 500mm 20D/20 Concrete Binding					
92	Forming Backing of Slope					
93	Constructing 500mm Drainage Filter Layer					
94	Installing Sand Bag and Tensar Georid					
95	Construction Reinforced Fill Slope (Type D) (~450m)

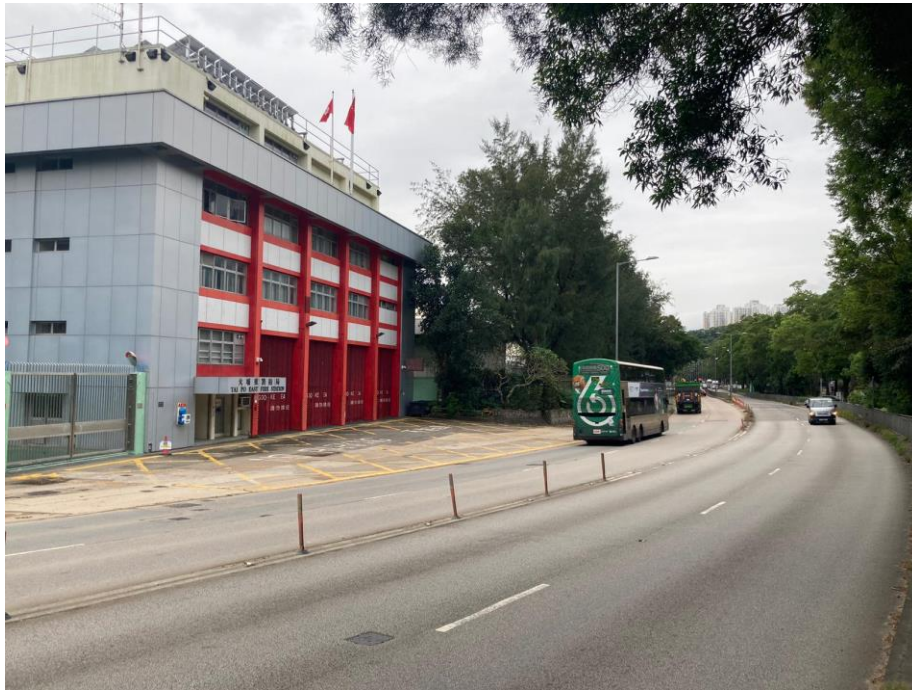
No mud is observed on the road surface near the section closed to Tai Po East Fire Station at 13:45. **(Location 1 in Appendix 3)**

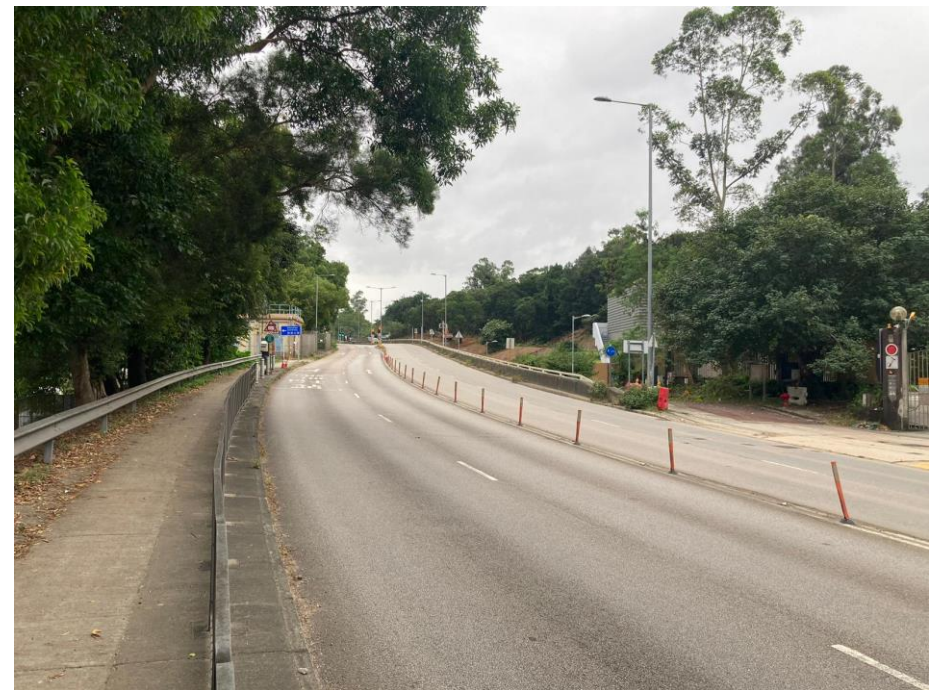
Another angle of view. Also, no mud is observed on the road surface. **(Location 1 in Appendix 3)**

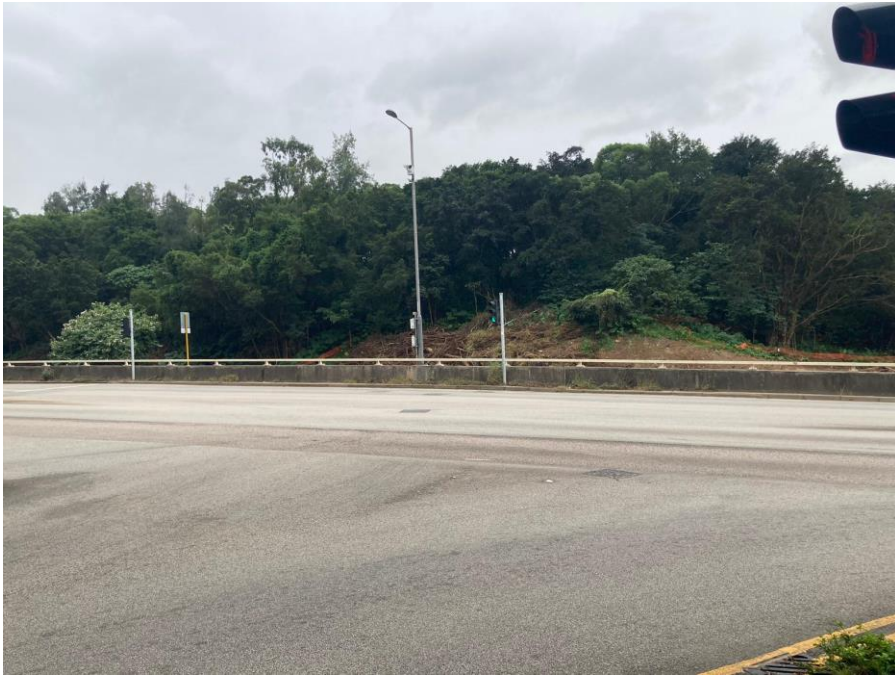
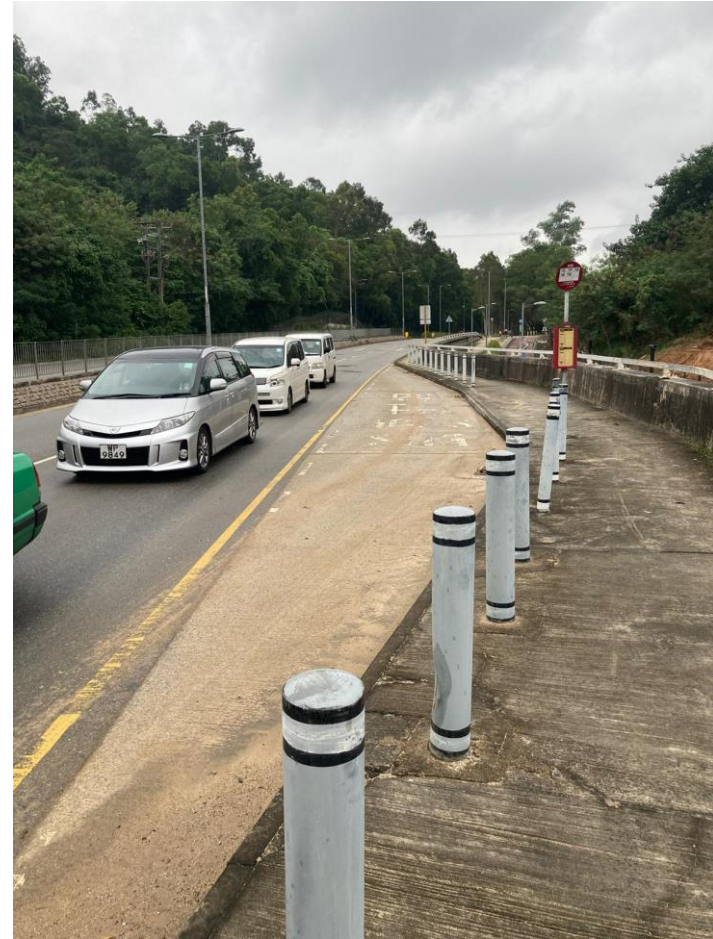
7.3.1.2. These complaints were related to muddy road observed at the section of Ting Kok Road outside the site. Upon receipt of the complaint on 18 November 2024, the Environmental Team (ET) requested the Contractor (CR-Tapbo JV) to provide necessary information for investigation on 18 November 2024. Special site inspection was conducted by the representative of ET, IEC, Contractor and EPD on 19 November 2024. Subsequent site inspection was conducted by ET and the Contractor on 21 November 2024. Photo records with location map are attached in **Appendix 7.1**. The first interim report issued by the Contractor was submitted to EPD on 29 November 2024 and the Contractor will submit the revised version to EPD for further clarification. More details will be reported in the next reporting period.

No mud is observed on the road surface at Ting Kok Road/Lo Fai Road junction. Mud is observed at the Lo Fai Road Bus Stop (Tai Po Centre Bound). This is the bound where the leaving dump truck passed by. **(Location 2 in Appendix 3)**

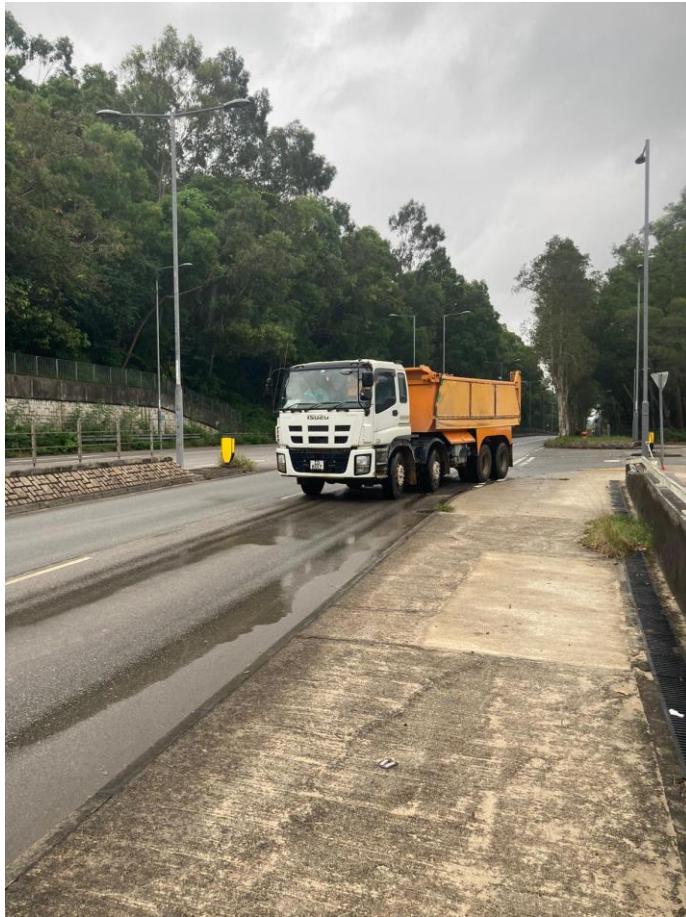
An empty dump truck is leaving from the site. Vehicle washing facilities are provided at site exit. No dusty materials from vehicle body and wheels are observed. **(Location 4 in Appendix 3)**

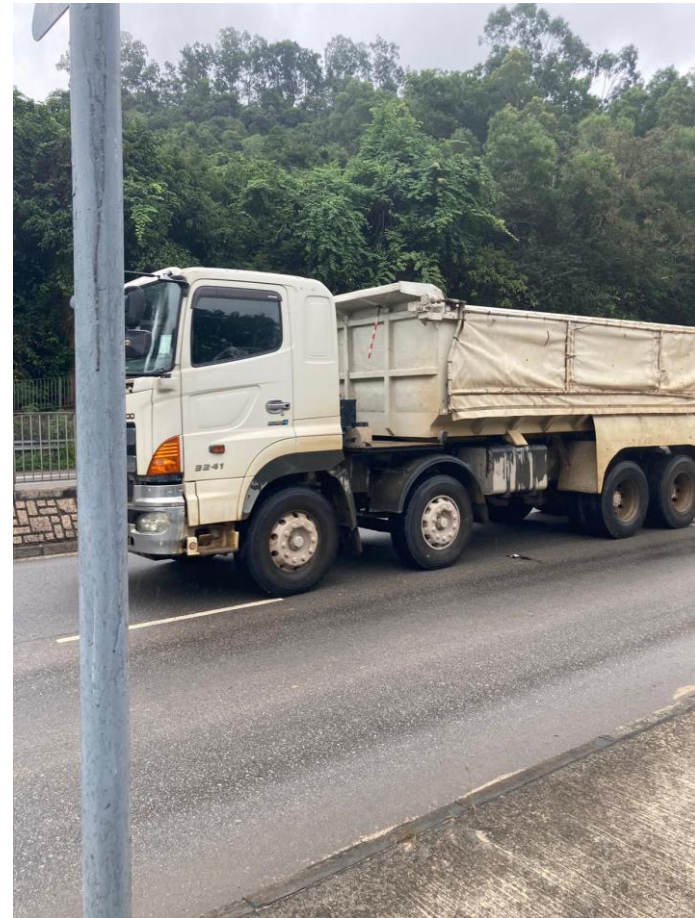
Another empty dump truck is leaving the site. No dusty materials from vehicle body and wheels are observed. **(Location 4 in Appendix 3)**

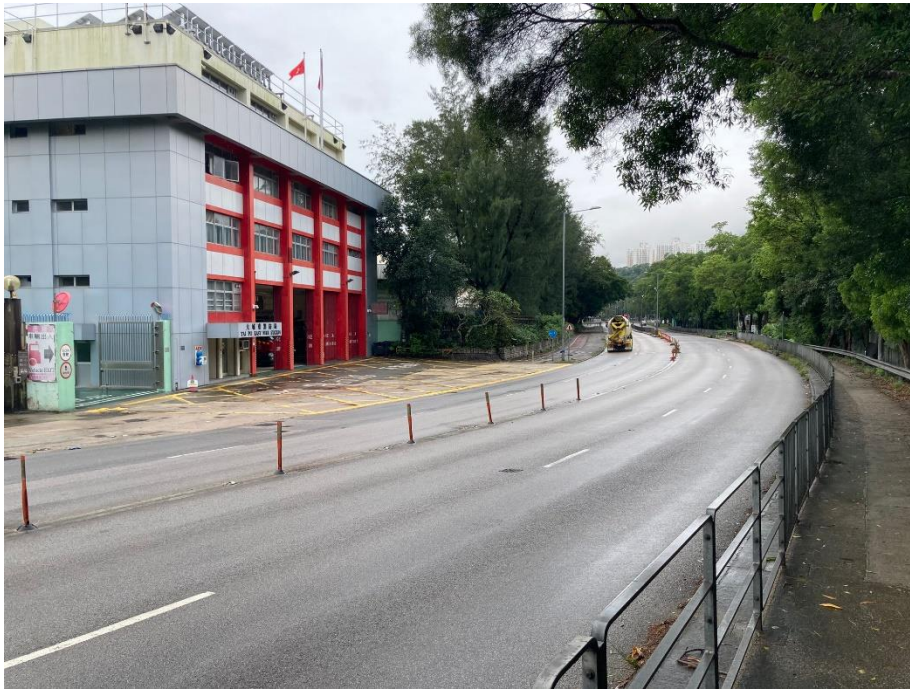
No mud/debris is observed on the road surface near the section closed to Tai Po East Fire Station at 09:30. **(Location 1 in Appendix 3)**

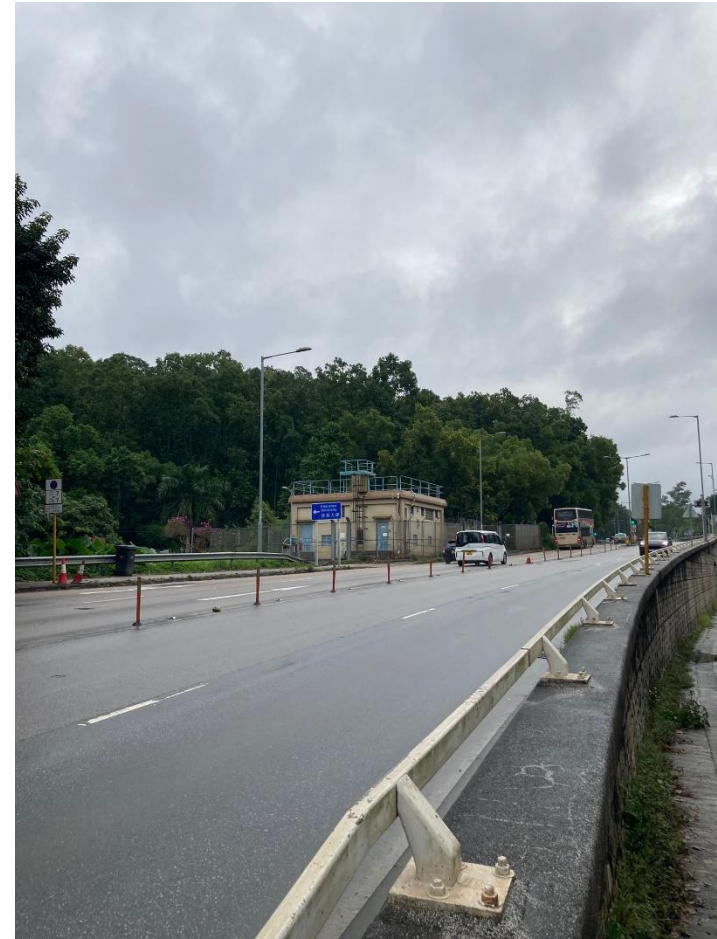
Also, no mud/debris is observed on the road surface. **(Location 1 in Appendix 3)**

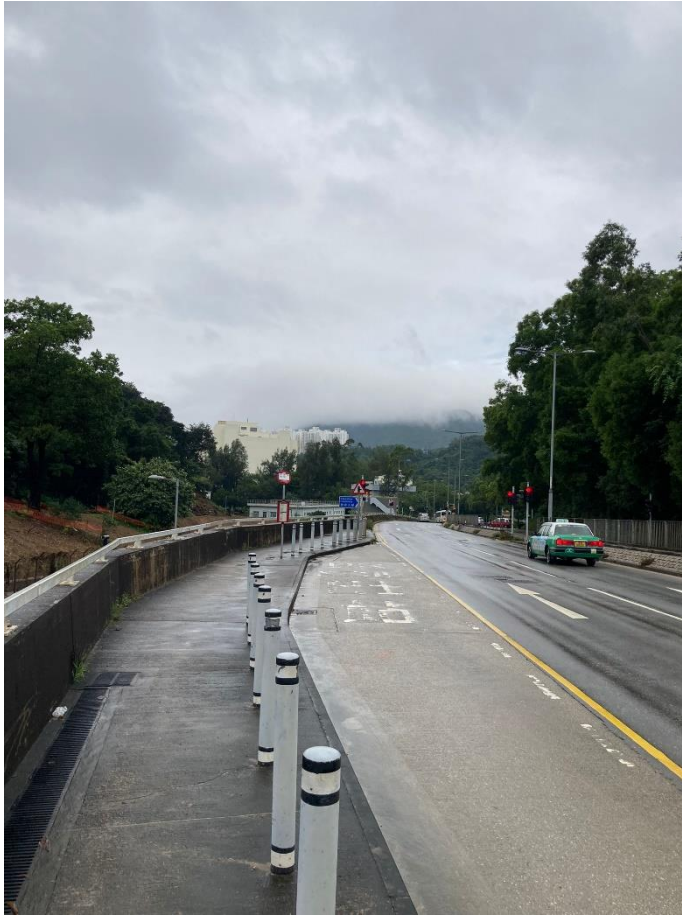
No mud/debris is observed at the Lo Fai Road Bus Stop (Tai Po Centre Bound). **(Location 3 in Appendix 3)**

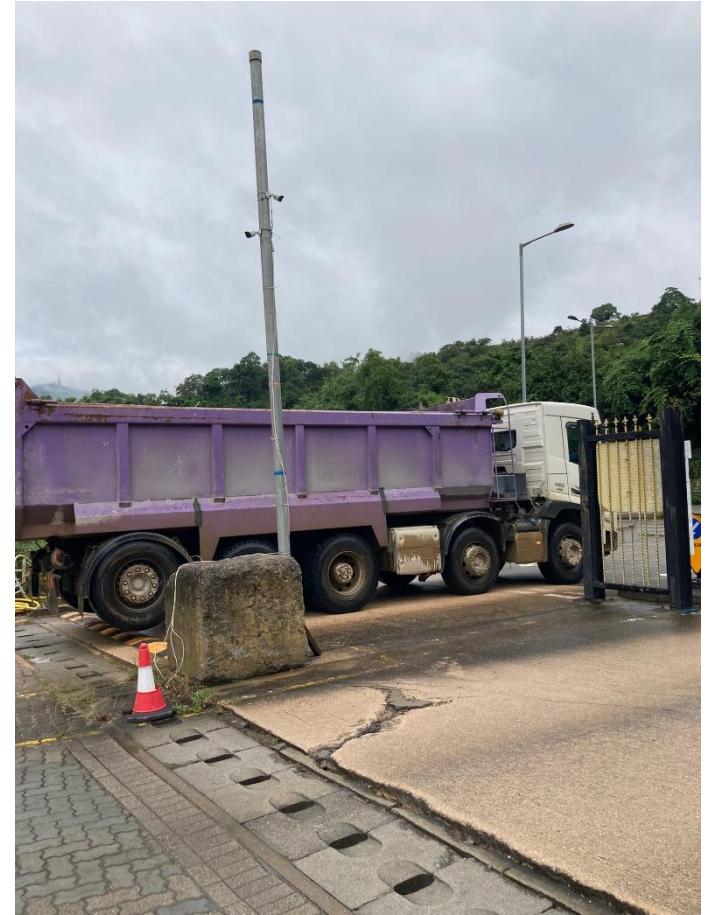
An empty dump truck is leaving the site. No dusty materials from vehicle body and wheels are observed. **(Location 4 in Appendix 3)**
