Proposed Golf Course Development at Tai Po Lot No. 246 Shuen Wan

Document to be Certified: Monthly EM&A Report (May 2025)

Document to be Verified: Monthly EM&A Report (June 2025)

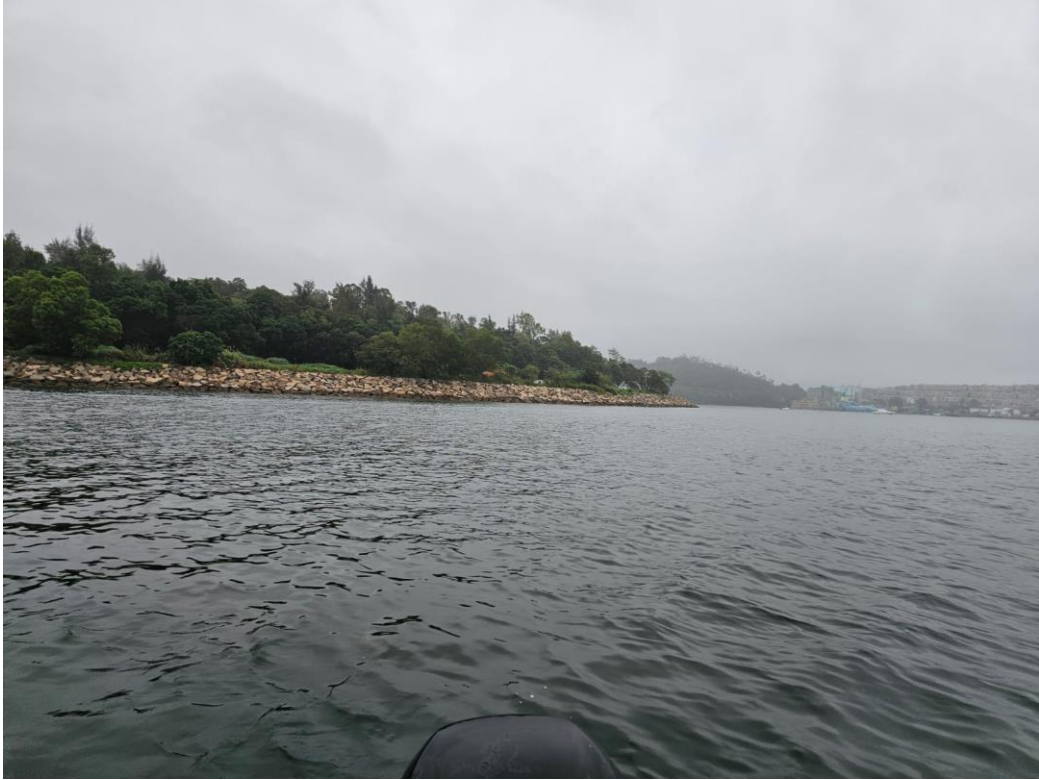
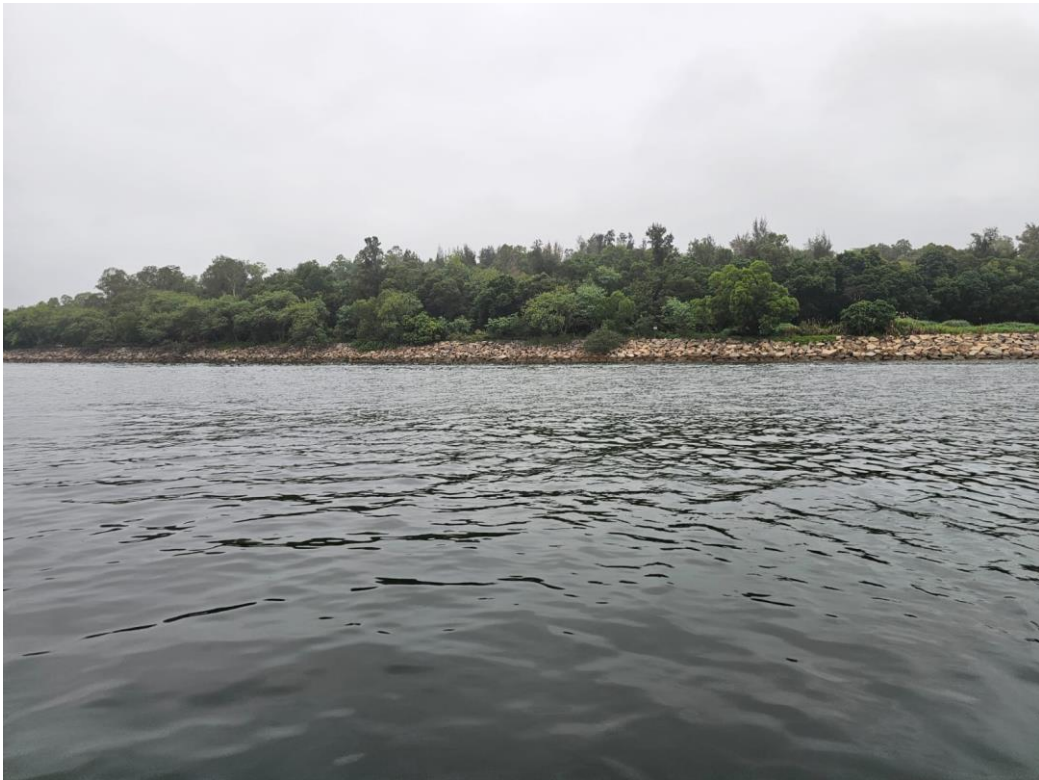
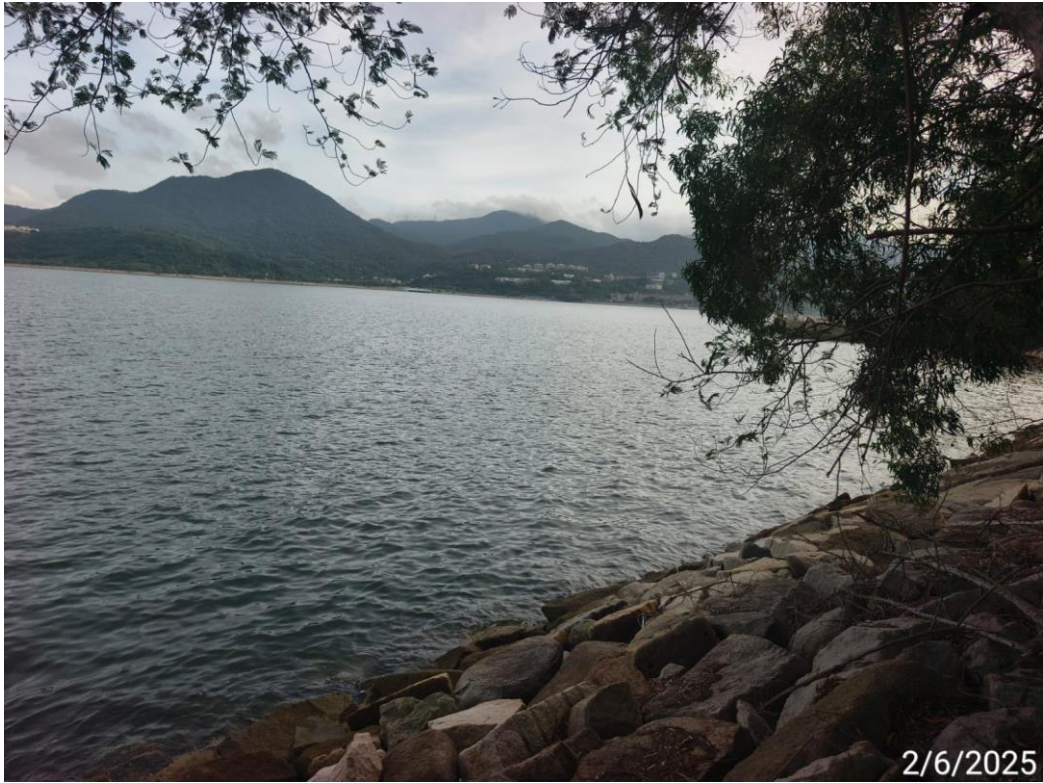
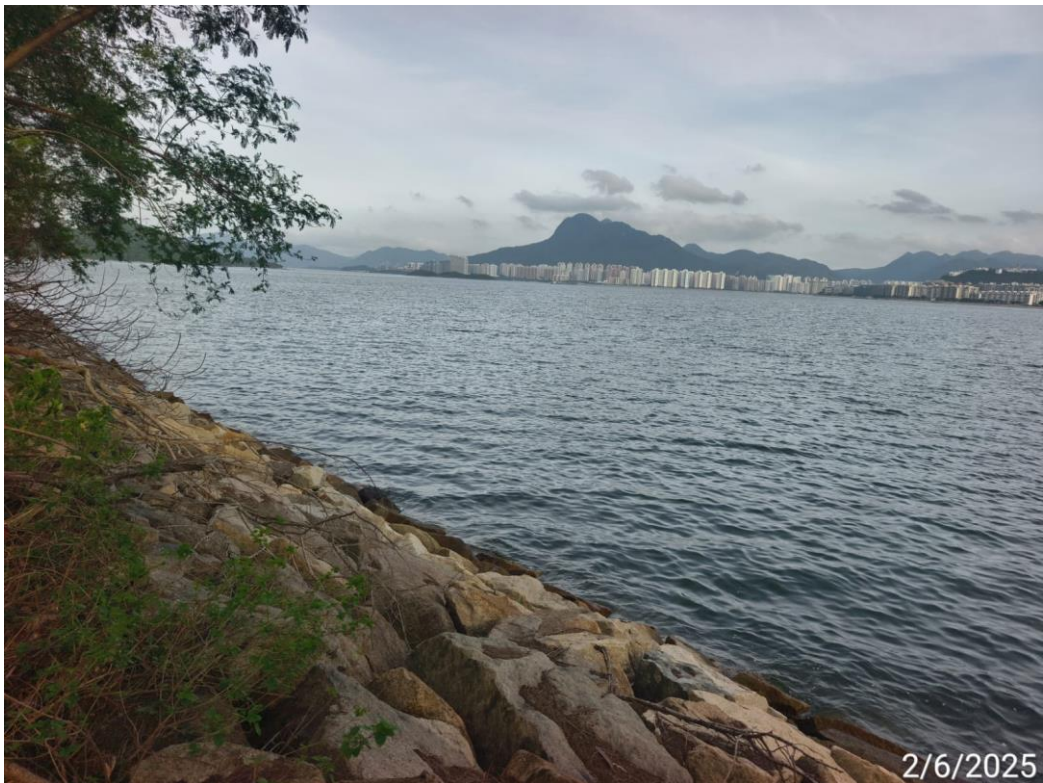
Photos taken by the Environmental Team on 2/6/2025

5.3.1.3 The number of Dissolved Oxygen (DO) monitoring results triggering the corresponding Action Level during this reporting period was 17. All DO (Dissolved Oxygen) monitoring result were within the corresponding Limit Levels at all monitoring stations throughout the reporting period. **Table 5.4** presents the summary of the DO compliance status at WM-1 and WM-2 stations during mid-ebb and mid-flood for the reporting period. Seasonal fluctuation may be the cause of non-compliance on 2, 16, 20, 23, 25 and 27 June 2025. Heavy rainfall may be the cause of non-compliance on 13th June 2025. Photo records during water sampling days are presented in **Appendix 5.3**.

5.3.1.5. The number of turbidity monitoring results triggering the corresponding Action Level during this reporting period was 8. All turbidity monitoring results were within the corresponding Limit Levels at all monitoring stations throughout the reporting period. **Table 5.6** presents the summary of the turbidity compliance status at WM-1 and WM-2 stations during mid-ebb and mid-flood for the reporting period. Seasonal fluctuation may be the cause of non-compliance on 4, 11, 20 and 27 June 2025. Heavy rainfall may be the cause of non-compliance on 13th June 2025. In addition, algal blooming was observed during water sampling on 18th June 2025. Photo records during water sampling days are presented in **Appendix 5.3**.

5.3.1.4 All Suspended Solids (SS) monitoring results triggering the corresponding Limit Level during this reporting period. In accordance with Event and Action Plan stipulated in the Manual, IEC and the Contractor were informed when the corresponding Action or Limit Levels were triggered. **Table 5.5** presents the summary of the SS compliance status at WM-1 and WM-2 stations during mid-ebb and mid-flood for the reporting period. Seasonal fluctuation may be the cause of non-compliance on 2, 4, 11, 16, 20, 23, 25 and 27 June 2025. Heavy rainfall may be the cause of non-compliance on 13th June 2025. In addition, algal blooming was observed during water sampling on 6, 9, 18 and 30 June 2025. All exceedances were not related to the Project as no marine construction works being carried out according to the Environmental Permit (EP) Condition 2.38. In addition, no marine construction works were observed by the Environmental Team during weekly site inspections and marine water samplings throughout the reporting period. Photo records during water sampling days are presented in **Appendix 5.3**. In the meantime, the Contractor was reminded to implement and maintain all mitigation measures during weekly site inspection. Bund wall has been constructed along the seawall by the Contractor for extra protection of water quality.
