Proposed Golf Course Development at Tai Po Lot No. 246 Shuen Wan

Document to be Certified: Monthly EM&A Report (August 2025)

Monthly EM&A Report No. 11 (for Aug 2025)

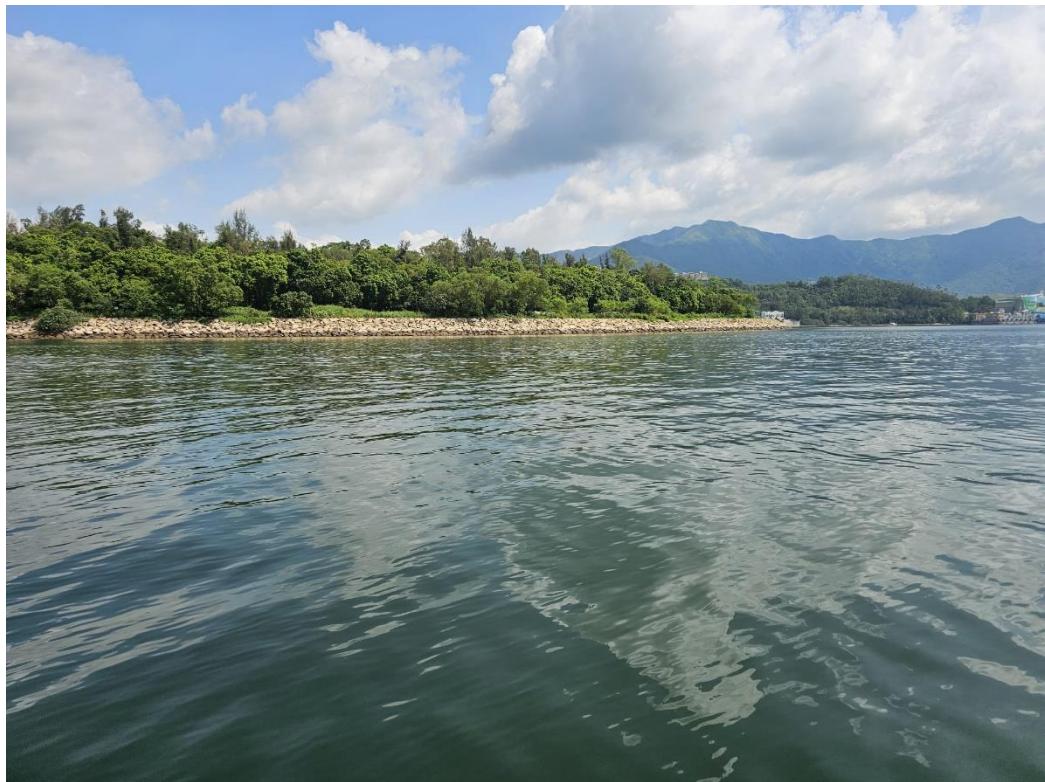
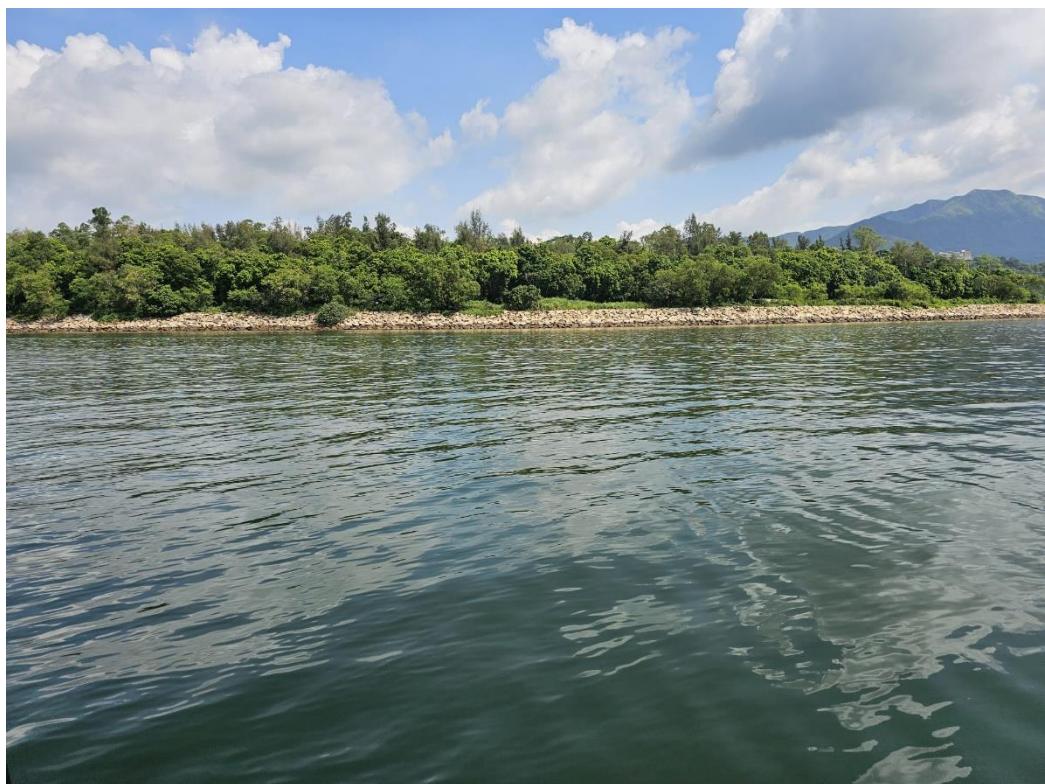
Photos taken by the Environmental Team on 1/8/2025
