Proposed Golf Course Development at Tai Po Lot No. 246 Shuen Wan

Document to be Certified: Monthly EM&A Report (November 2025)

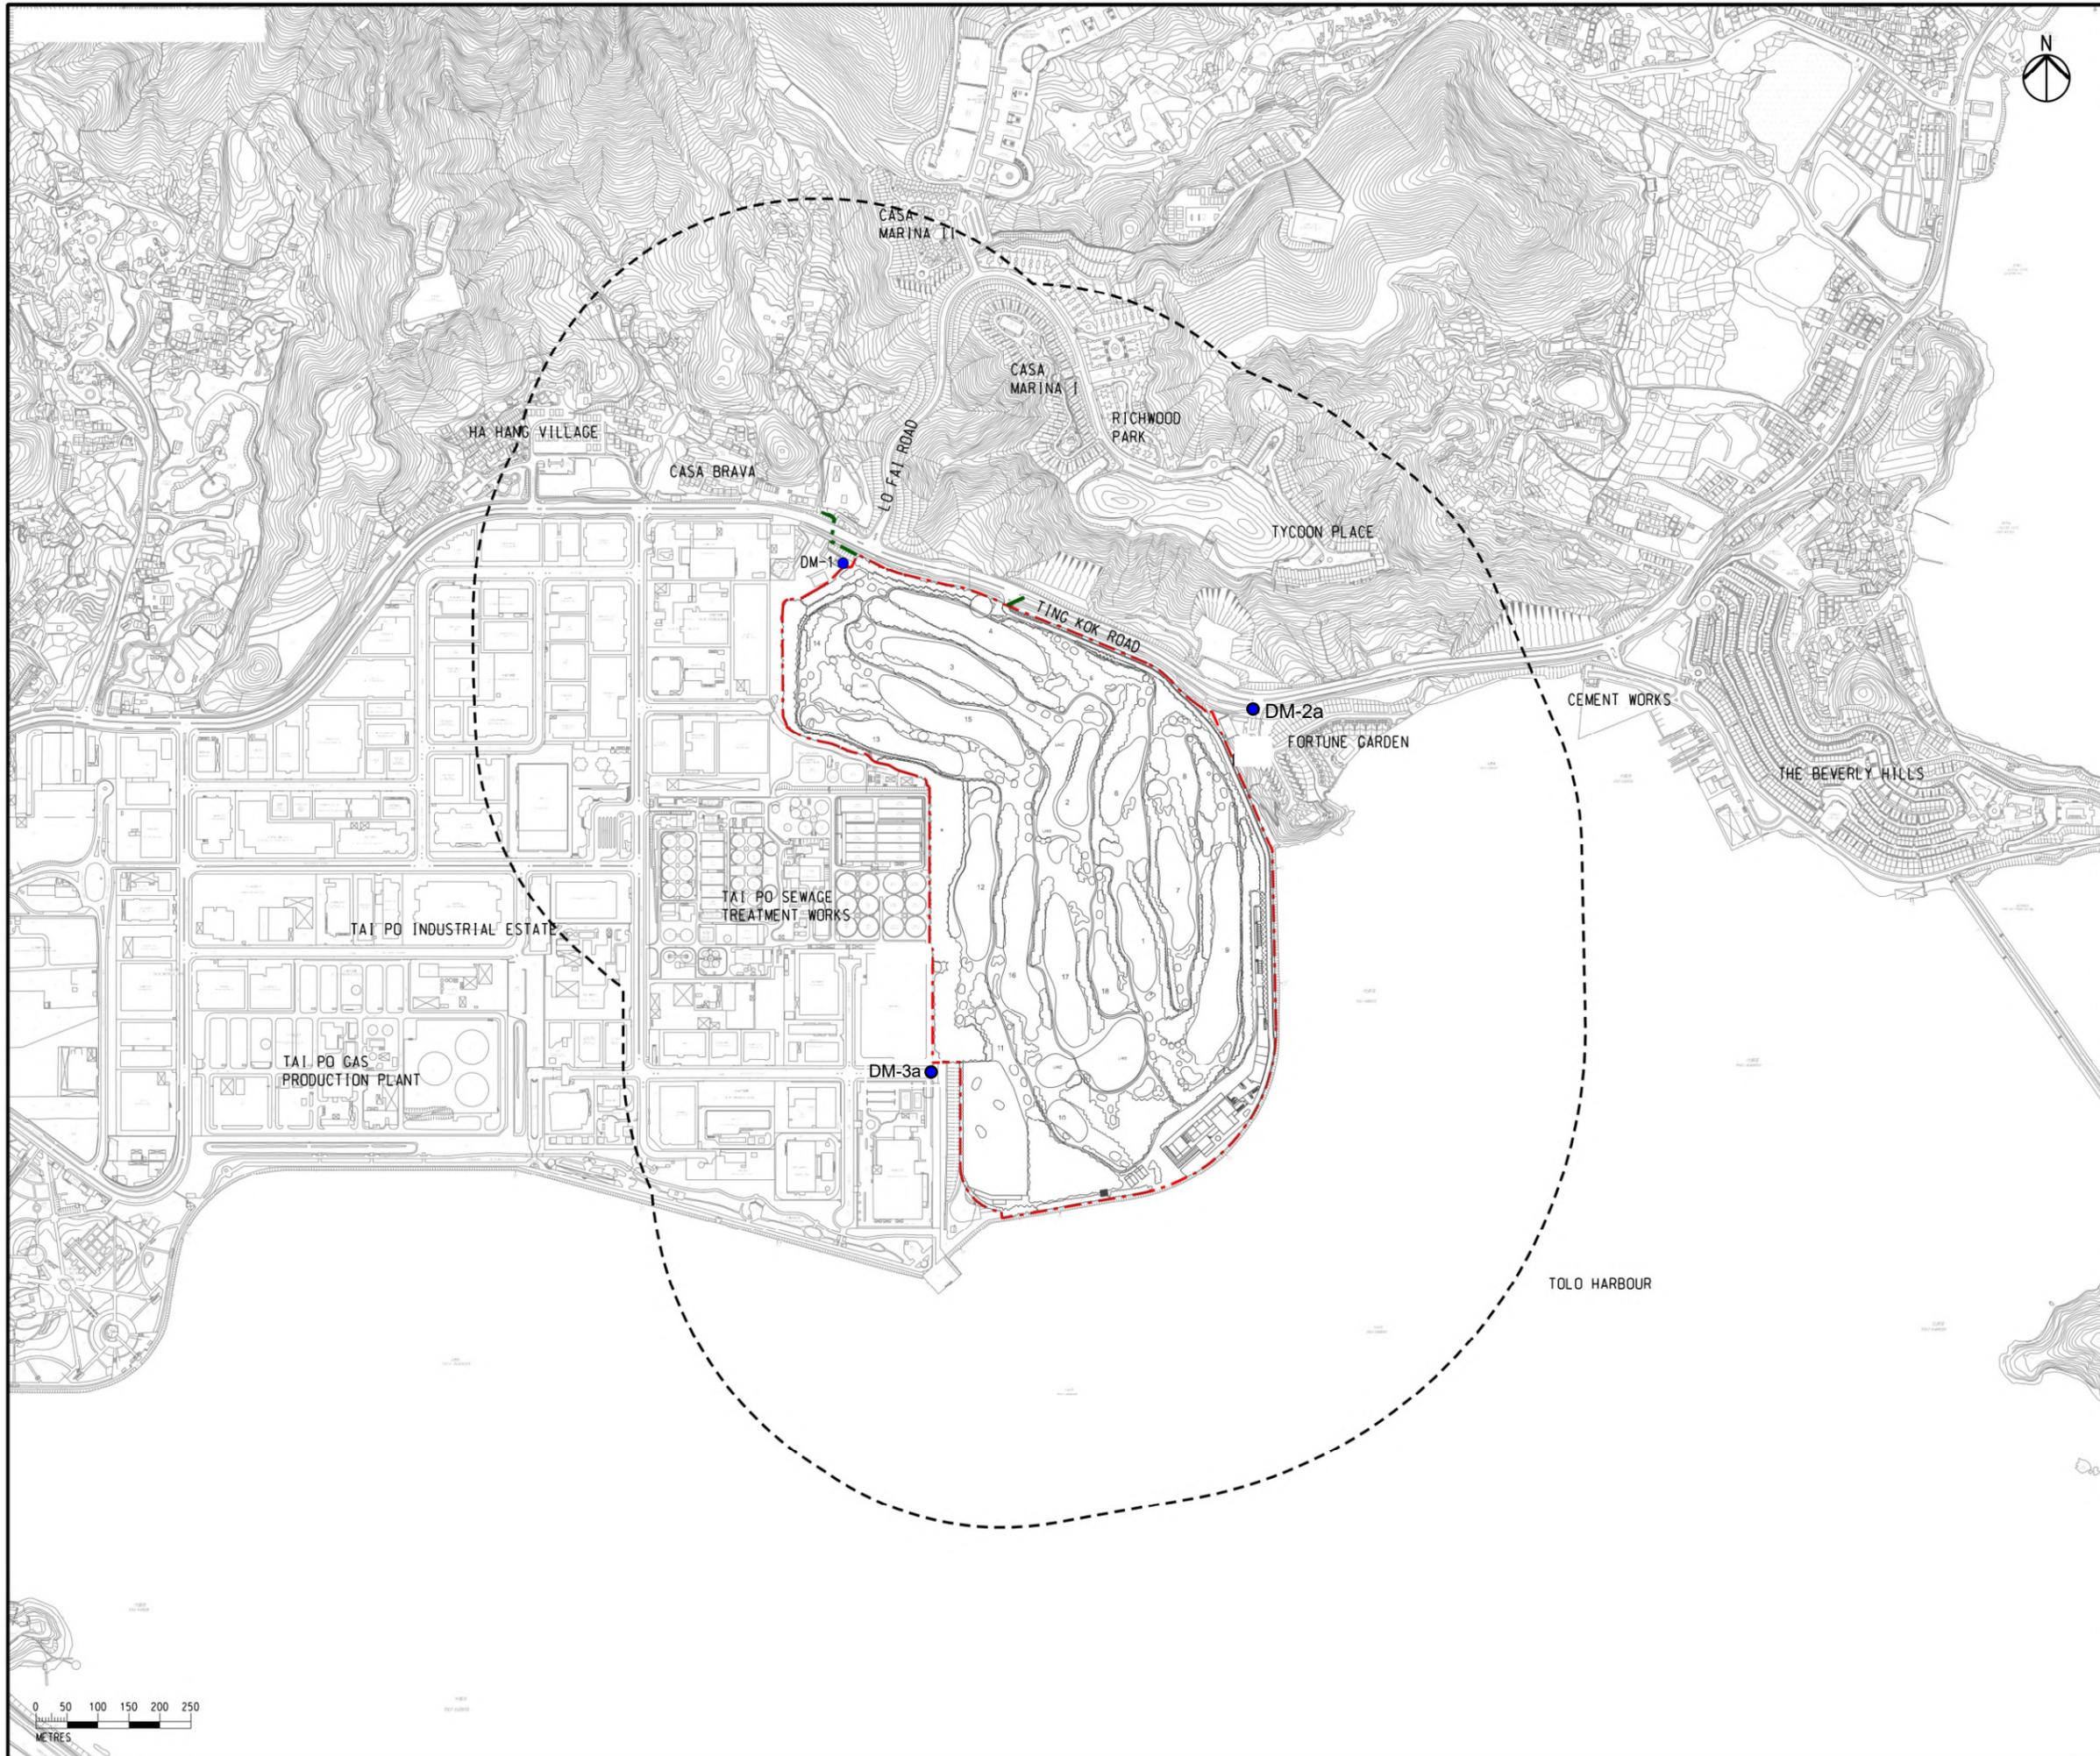
- LEGEND**
- PROJECT BOUNDARY
 - 500m ASSESSMENT AREA
 - PROPOSED DRAINAGE / SEWERAGE / WATERWORKS OUTSIDE SITE BOUNDARY
 - DUST MONITORING STATION

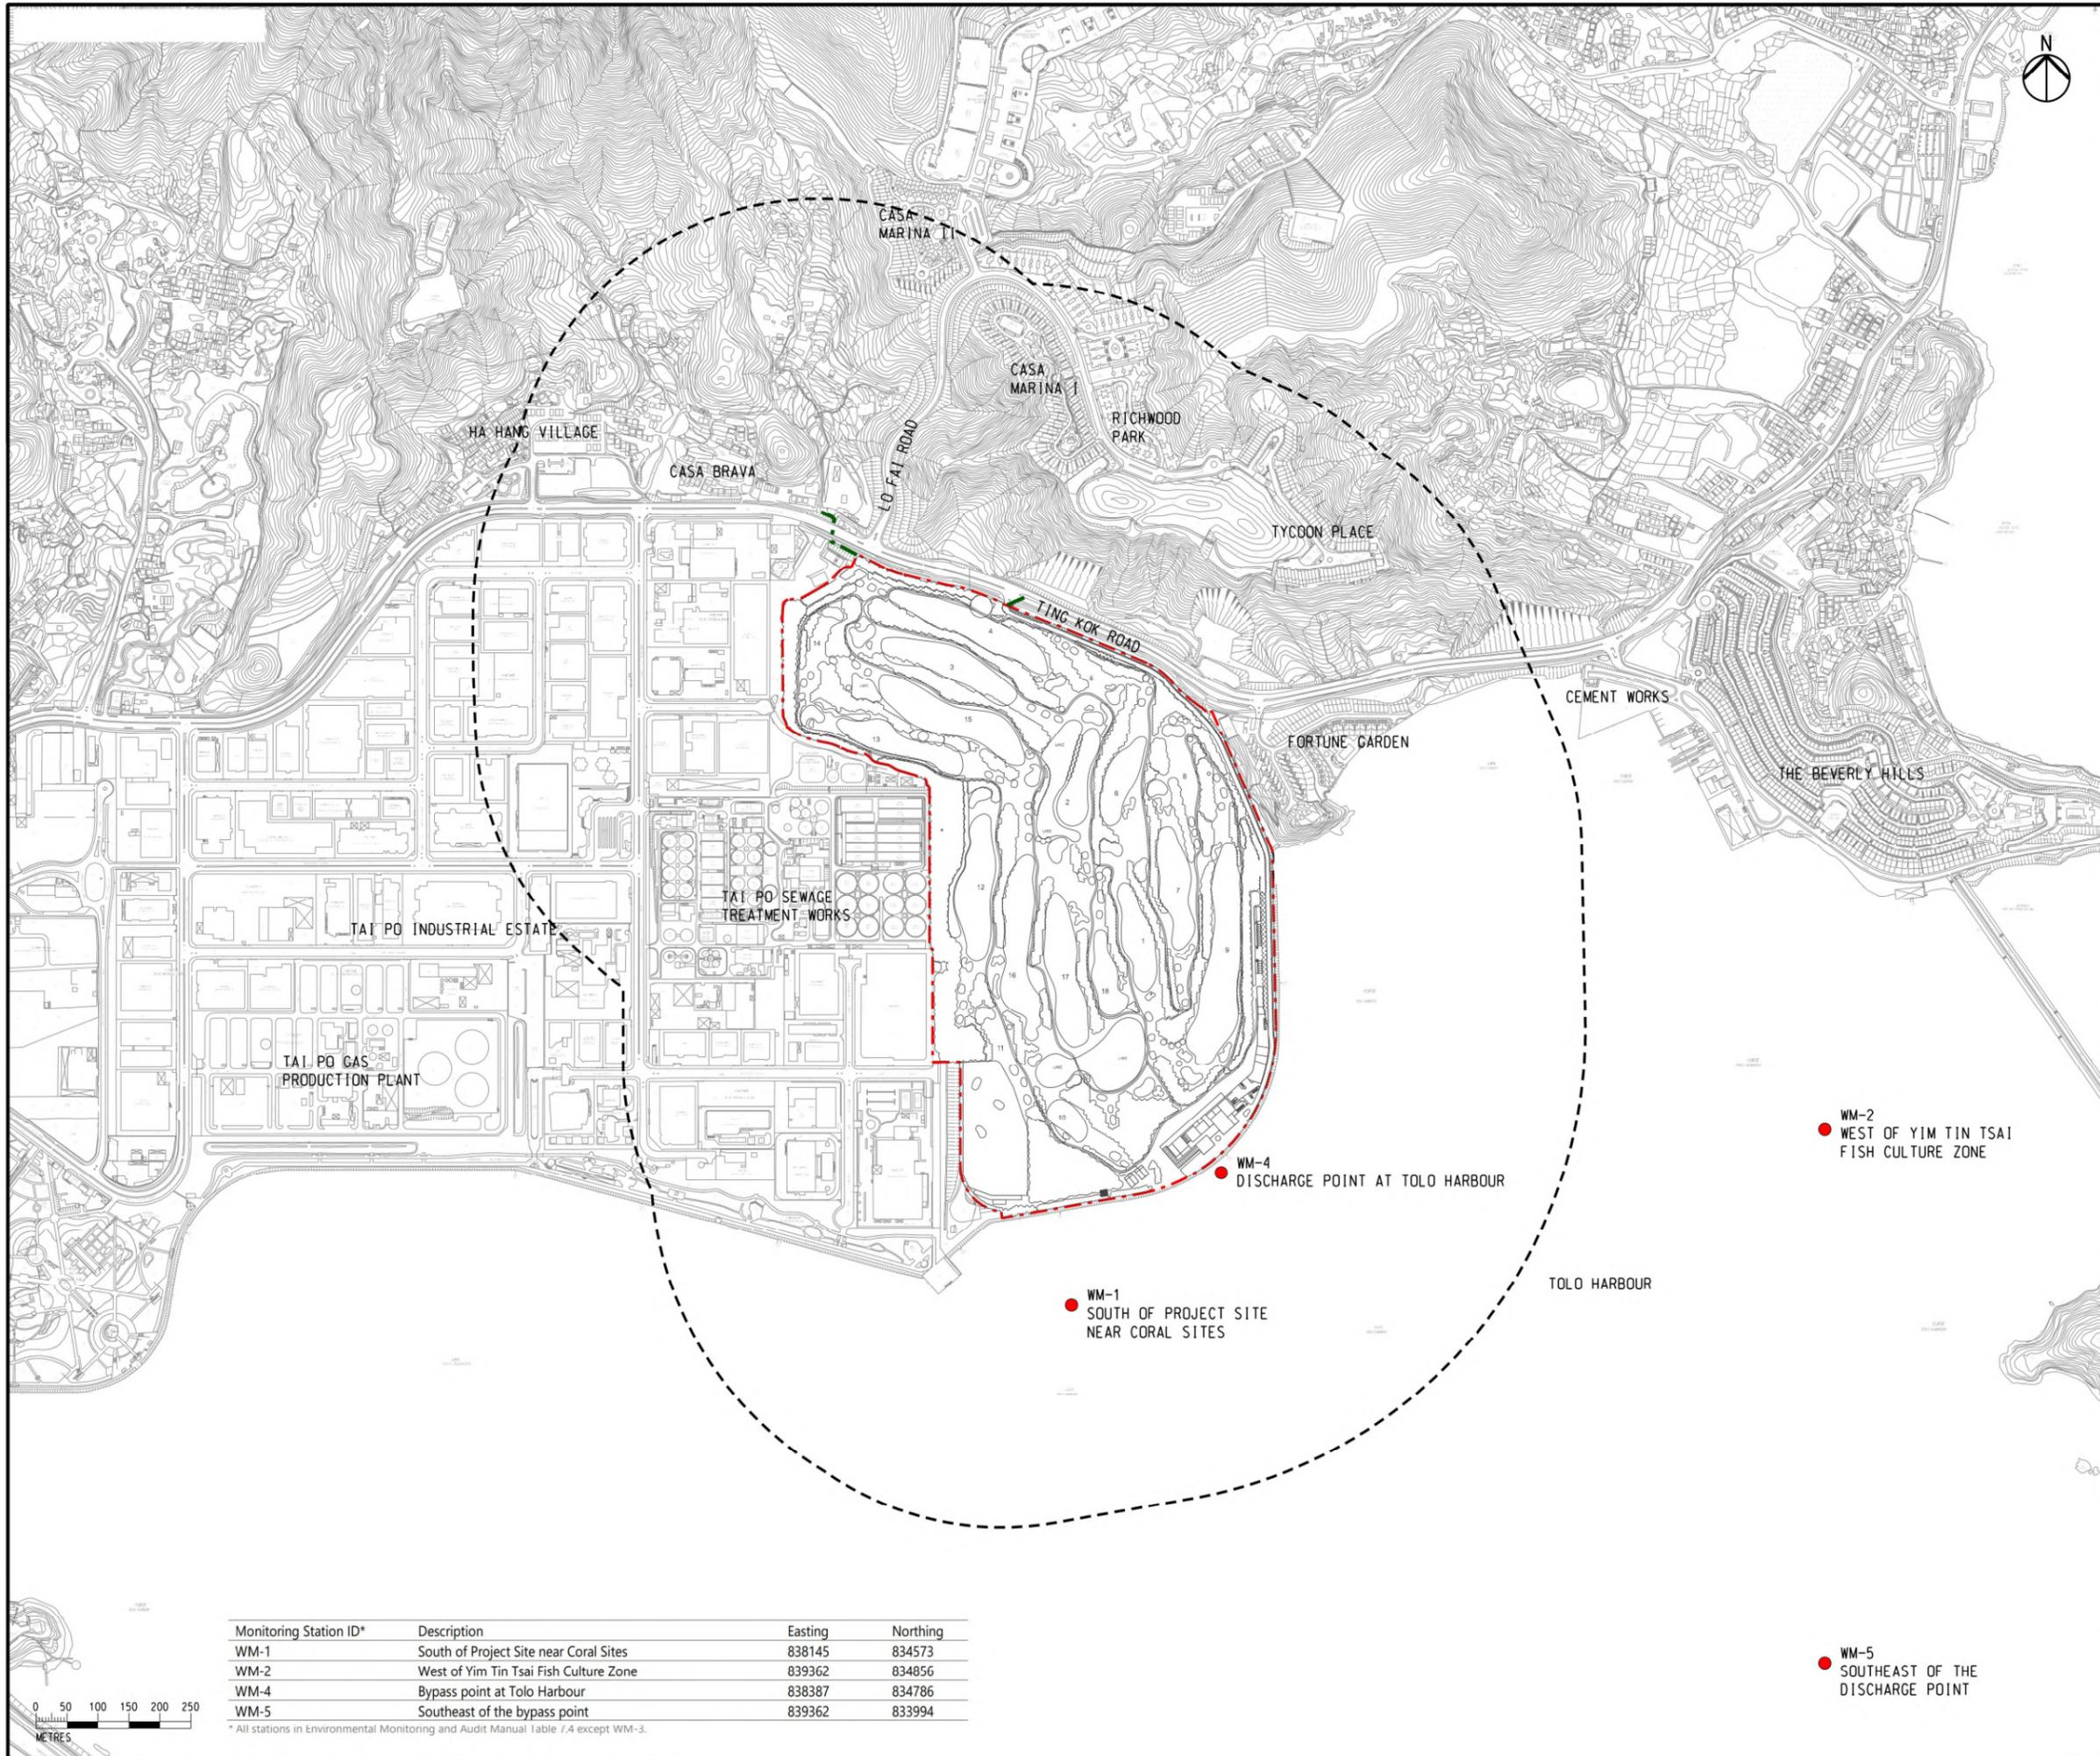
- LEGEND**
- PROJECT BOUNDARY
 - 500m ASSESSMENT AREA
 - PROPOSED DRAINAGE / SEWERAGE / WATERWORKS OUTSIDE SITE BOUNDARY
 - WATER QUALITY MONITORING STATION

- 3.7.1.1 Site inspections during construction phase shall be carried out to monitor any malpractice leading to deterioration of water quality of the surrounding which may in turn affect the fisheries resources. Site inspection shall be undertaken by the Environmental Team at least once per week during the routine environmental audit as detailed in **Section 6** of this report. During construction phase, the proposed water quality monitoring programme stated in Section 6 of the EIA report will include the closest FCZ (i.e. Yim Tin Tsai FCZ, near Water Quality Monitoring Station WM-2). The locations of water quality monitoring station are presented in **Appendix 3.1**.
