Proposed Golf Course Development at Tai Po Lot No. 246 Shuen Wan

Document to be Certified: Monthly EM&A Report (April 2026) [Version 2]

Reference: 289499-Monthly EM&A Report-019-01

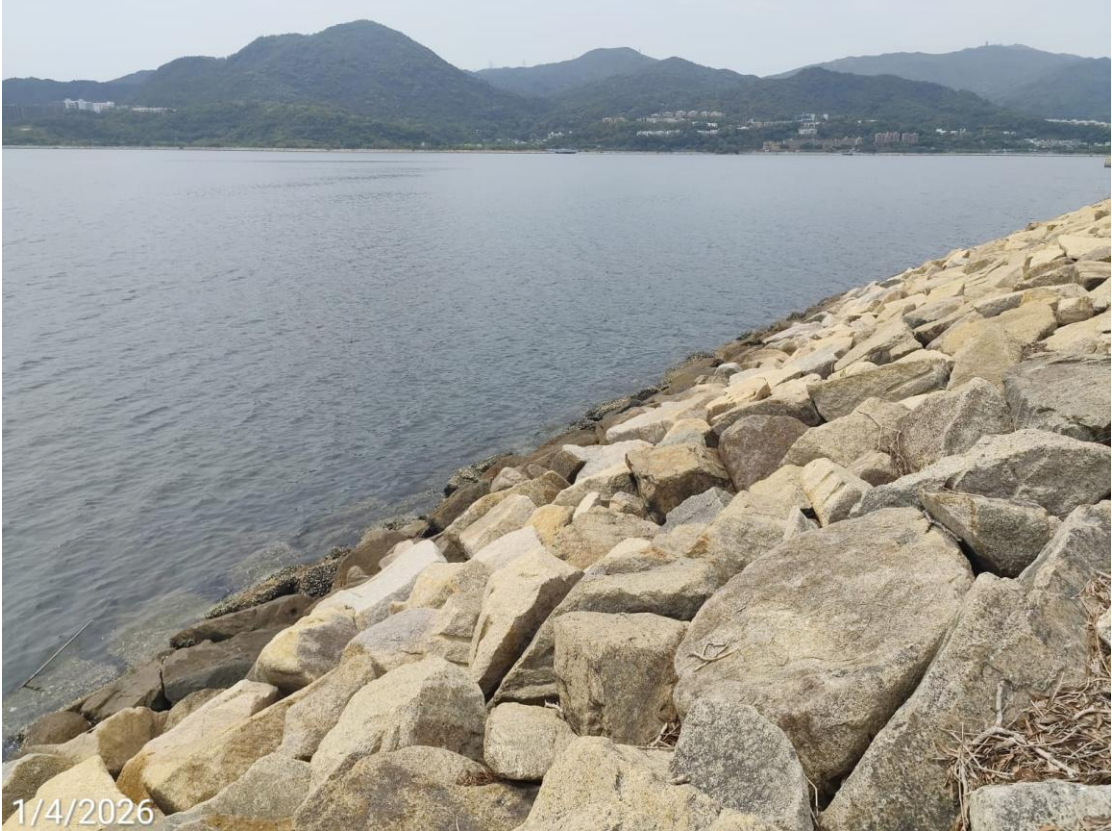
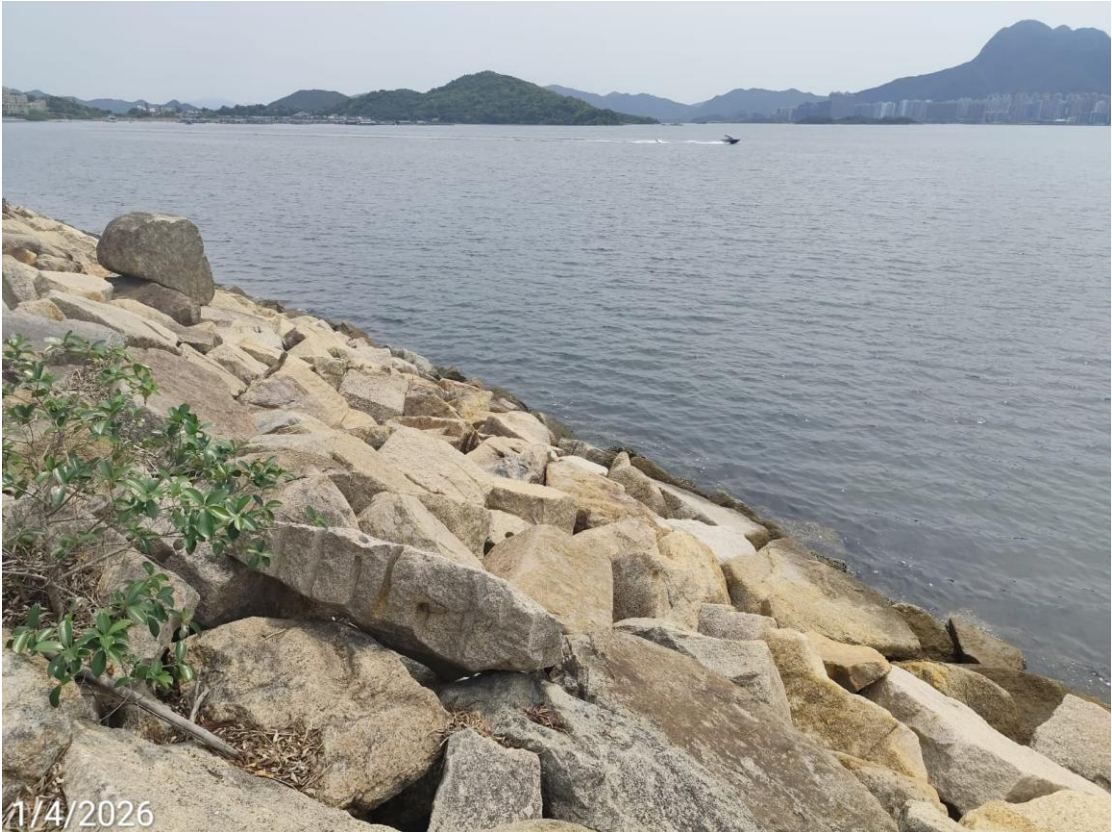
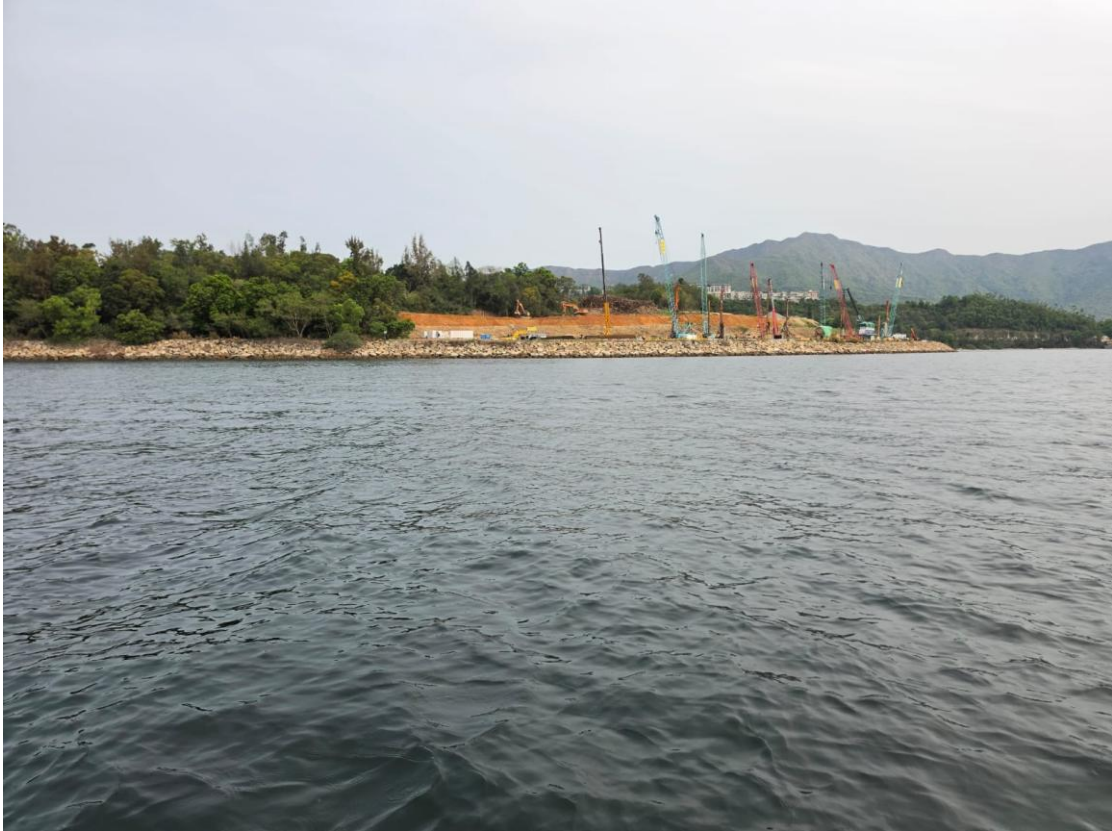
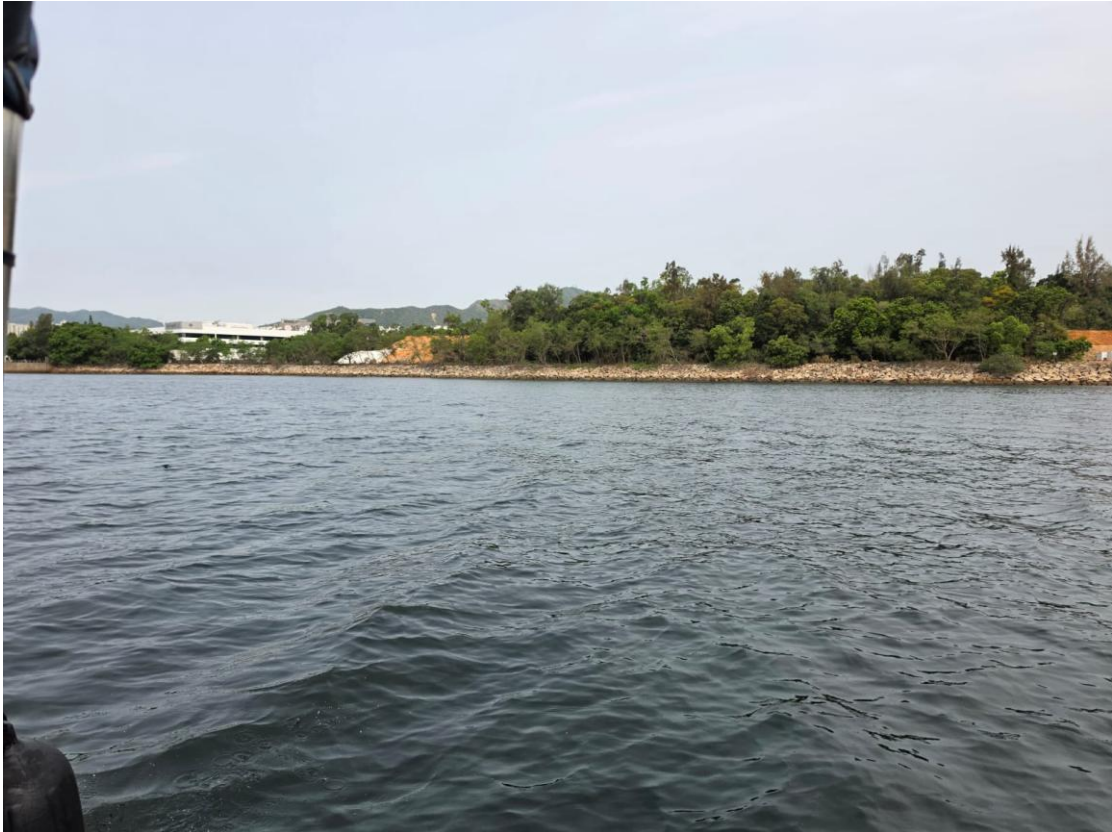
Photos taken by the Contractor on 01/04/2026

5.3.1.3 The number of DO (Dissolved Oxygen) monitoring results triggering the corresponding Action Level and Limit Level during this reporting period were 15 and 0 respectively. Seasonal fluctuation and increase of biosolid in the water caused by algal growth may be the cause of non-compliance on 1, 10, 24 and 29 April 2026. **Table 5.4** presents the summary of the DO compliance status at WM-1 and WM-2 stations during mid-ebb and mid-flood for the reporting period. Photo records during water sampling days are presented in **Appendix 5.3**.

5.3.1.4 The number of turbidity monitoring results triggering the corresponding Action Level and Limit Level during this reporting period were 1 and 0 respectively. In accordance with Event and Action Plan stipulated in the Manual, IEC and the Contractor(s) were informed when the corresponding Action or Limit Levels were triggered. **Table 5.5** presents the summary of the turbidity compliance status at WM-1 and WM-2 stations during mid-ebb and mid-flood for the reporting period. Seasonal fluctuation and algal blooming may be the cause of non-compliance on 29 April 2026. Photo records during water sampling days are presented in **Appendix 5.3**.
