**Agreement No. CE 32/2021 (CE)**  
**Improvement Works at Lai Chi Wo Pier and Tung Ping Chau Public Pier**  
**– Design and Construction**

**Environmental Permit No. EP-586/2021**  
**Submission of Updated Pre-construction Dive Survey Report & Translocation Plan**  
**(Rev. 02)**

# Updated Pre-construction Dive Survey Report & Translocation Plan

Pre-construction Dive Survey Report &  
Translocation Proposal  
at Lai Chi Wo Pier (Rev 2)  
(5207869-OR017A-02a)

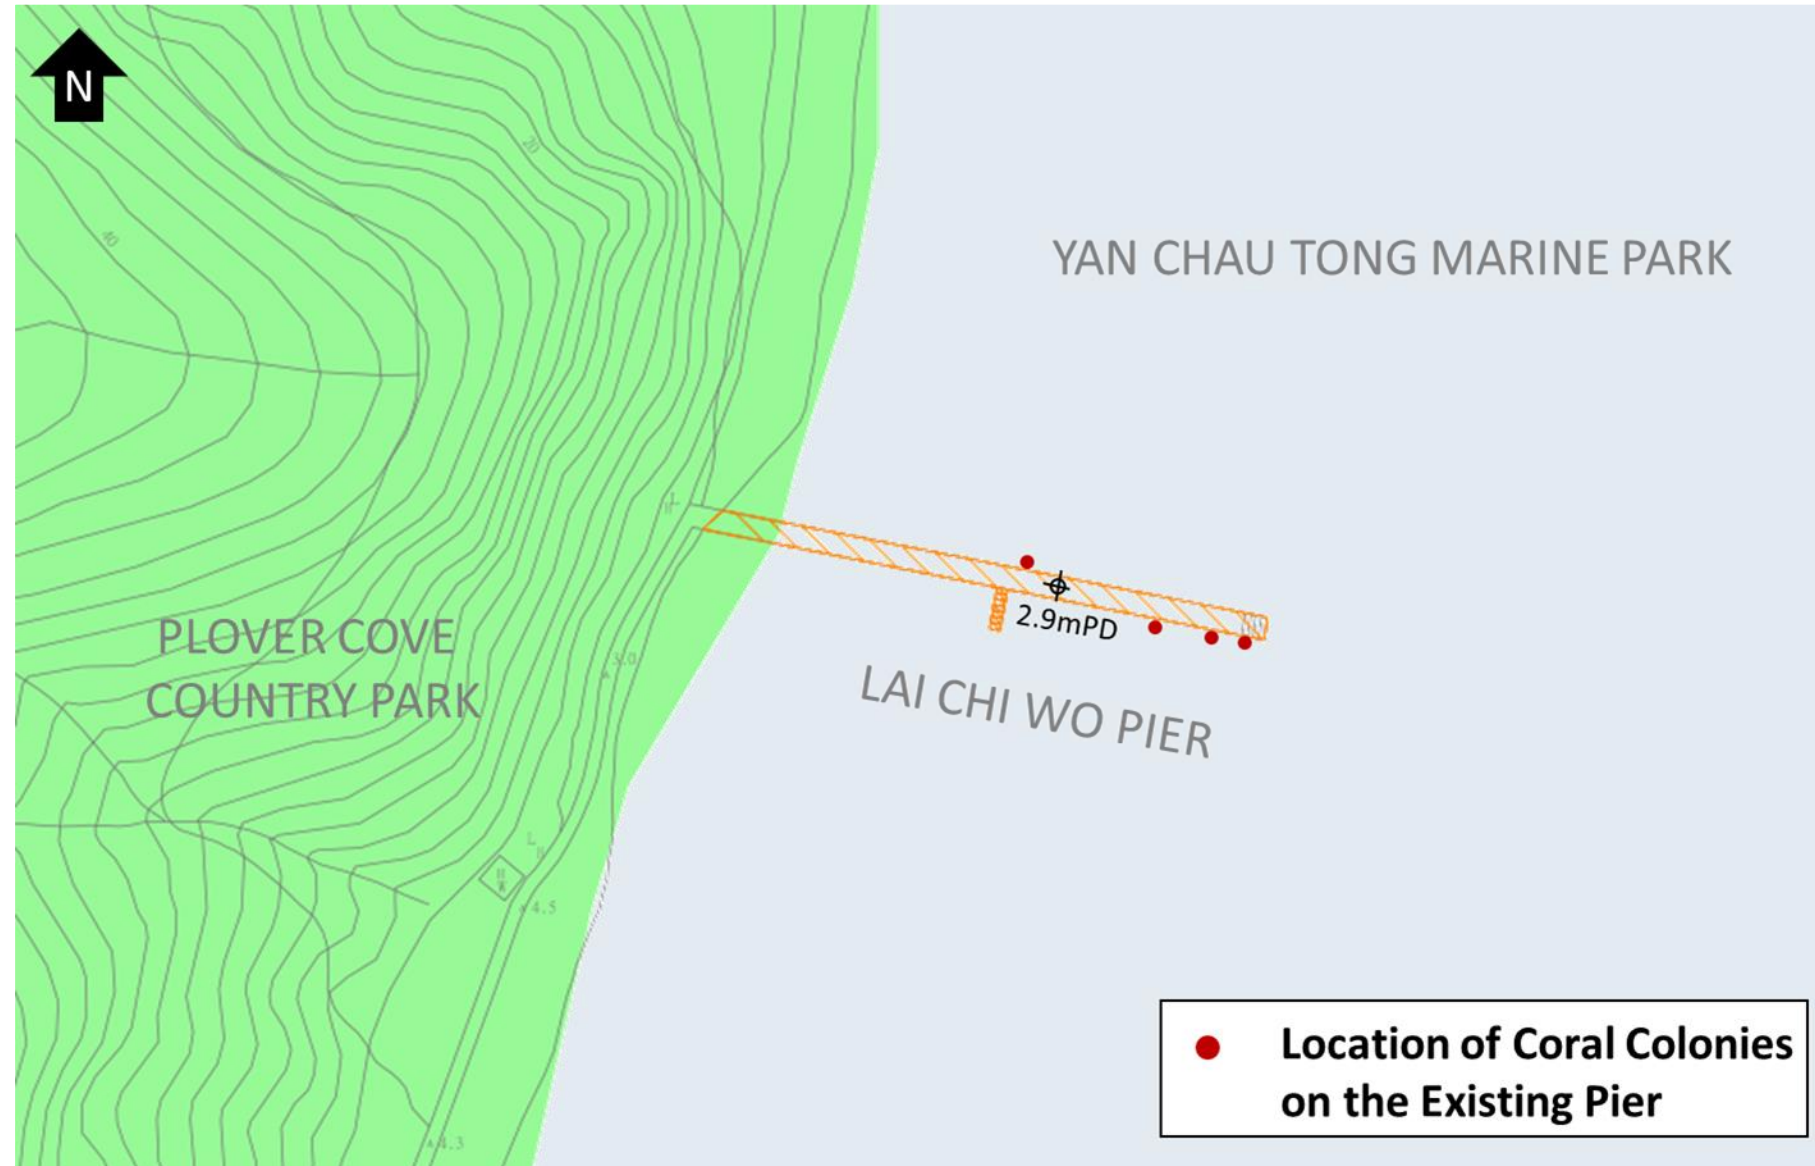
Figure 2 Locations of Coral Colonies Recorded on the Existing Pier

2.2.2 During the mapping survey, a total of four coral colonies (Figure 2 and Photo Plate A) were found to have suitable size for translocation and their species name, size and health condition were shown in Table 2.5.

Coral #	Coral species	Health Condition	Size (Diameter)	Abundance in Hong Kong
01	Porites lutea	Good	35 cm	Dominant
02	Porites lutea	Good	25 cm	Dominant
03	Cyphastrea serailia	Good	20 cm	Dominant
04	Porites lutea	Good	25 cm	Dominant

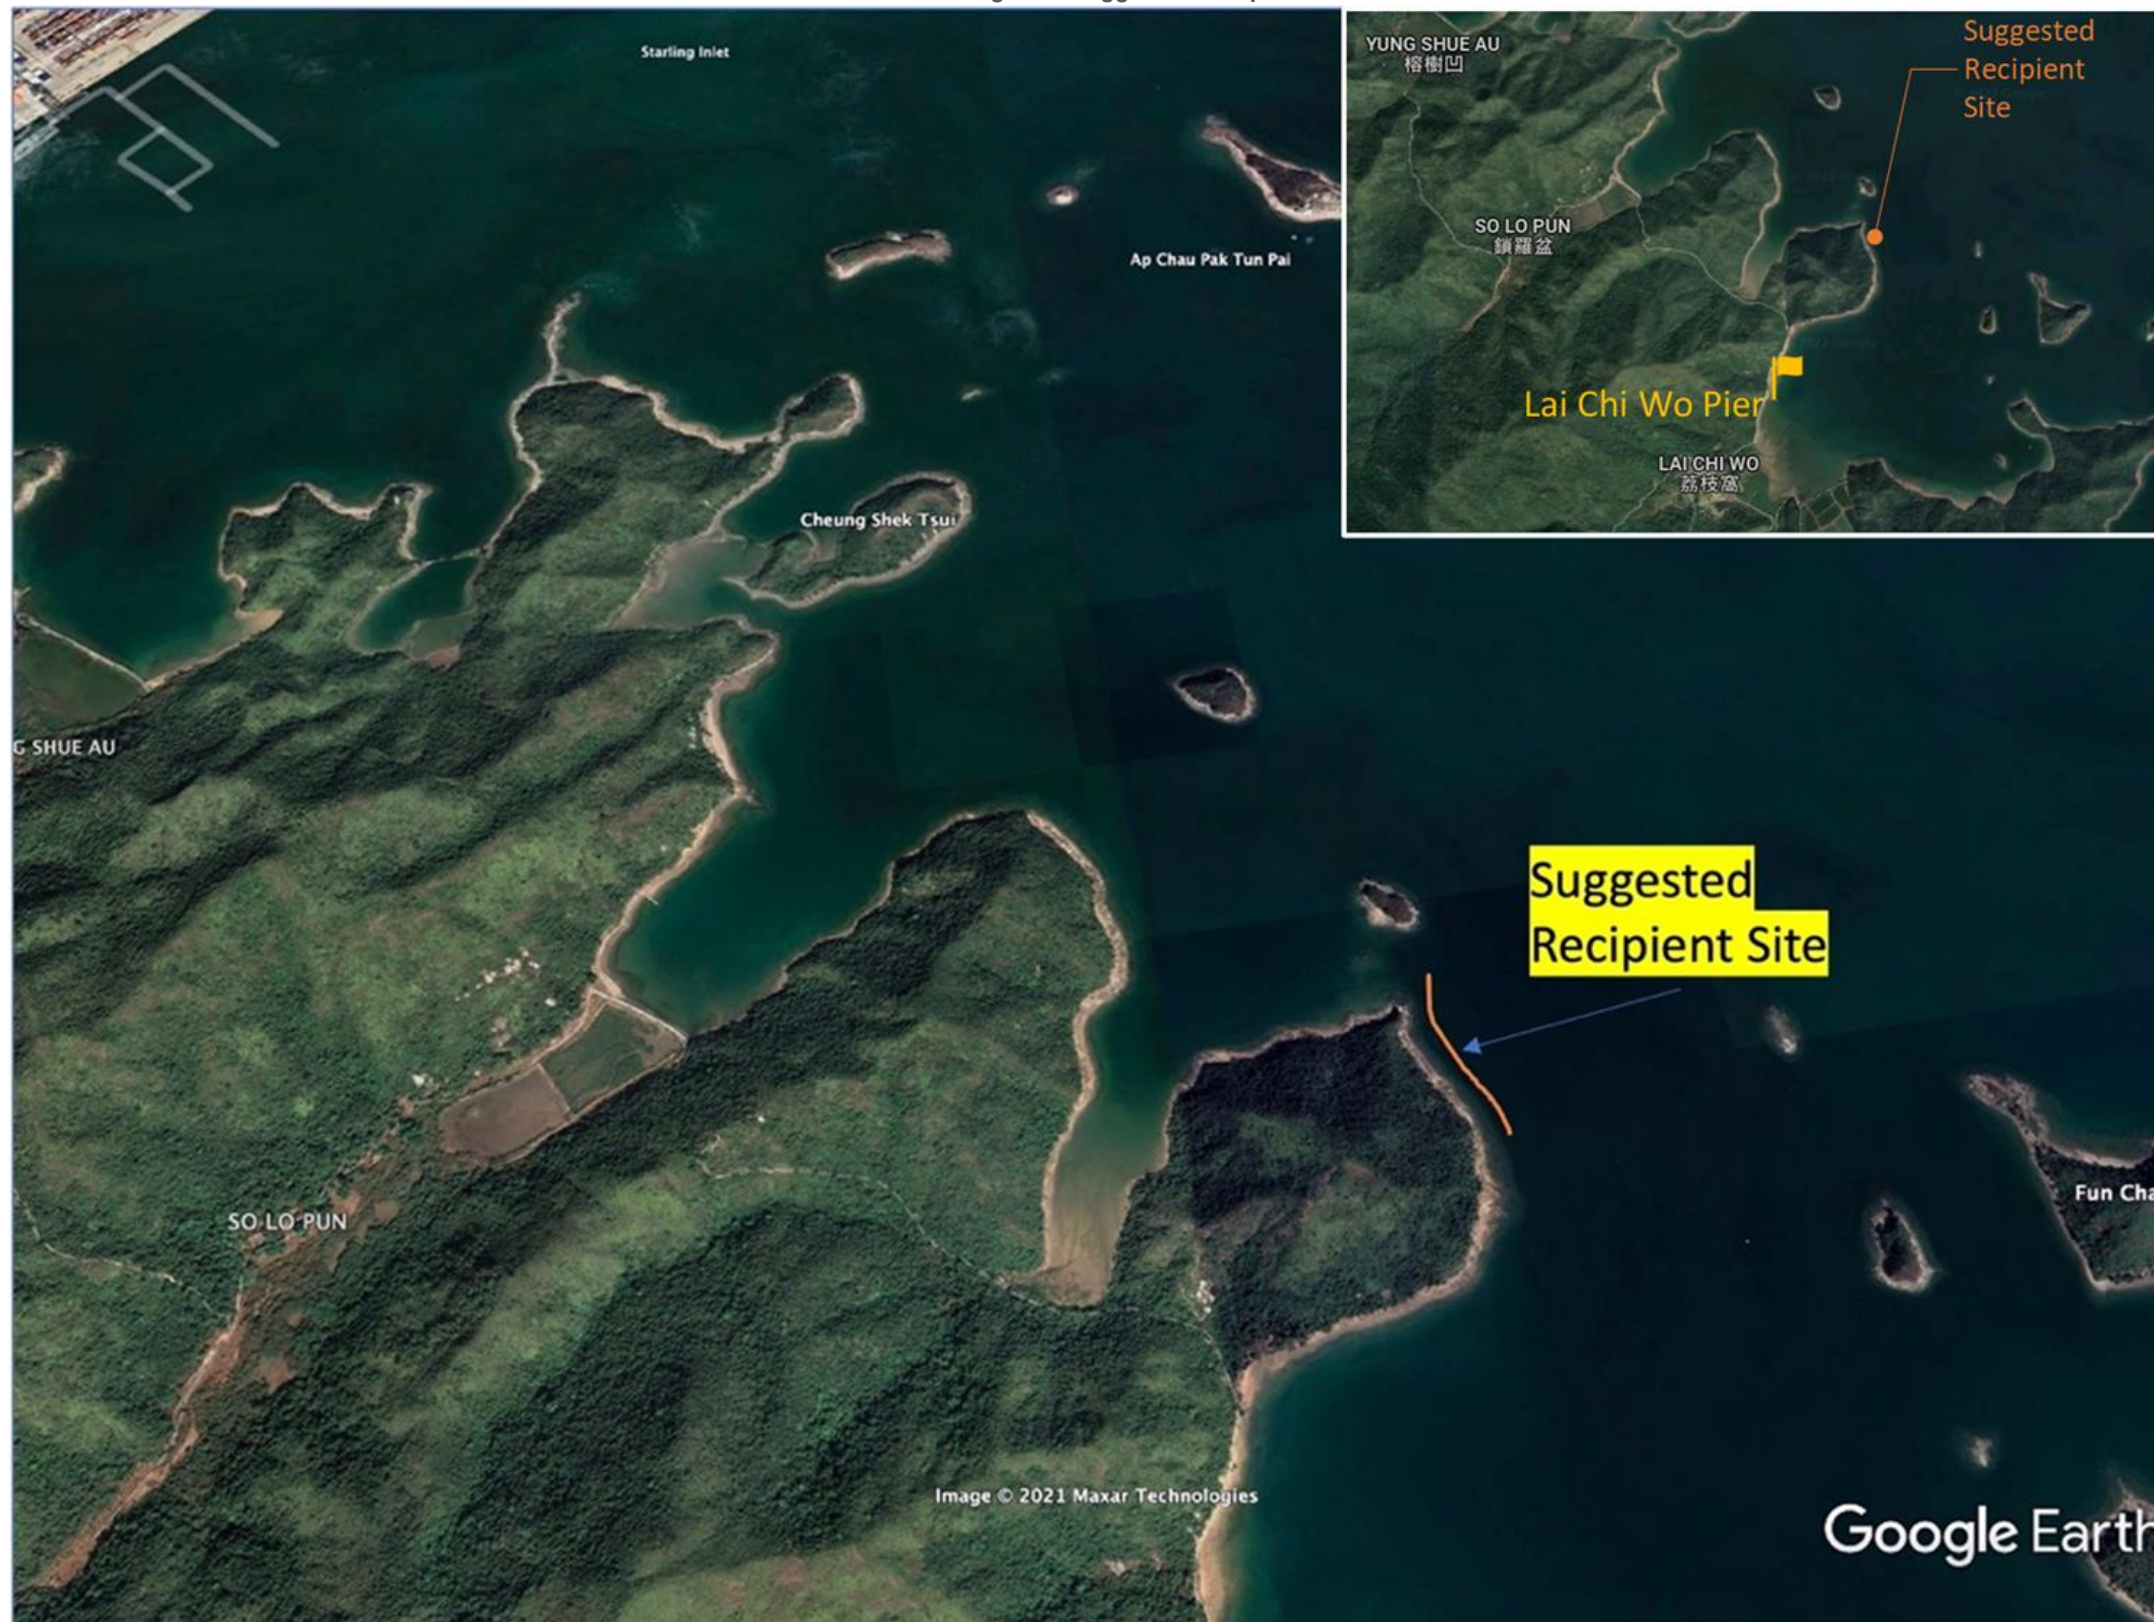
Figure 3 Suggested Recipient Site

2.2.5 Spot check dive was carried out at the suggested recipient site (Figure 3). The GPS coordinates, route distance, maximum depth, bottom substrate and bottom visibility each surveyed sites were summarized in **Table 2.7**.

2.2.6 The spot check site was mainly composed of natural bedrock. Substrates beyond the maximum depth are all sandy with scattered boulders and rocks with visibility around 1m to 1.5 m. Sponges, bryozoans, *Diadema* sea urchin and tubeworms *Sabelastarte japonica* were the dominant animal species in the surveyed site in which they are commonly found in Hong Kong waters.

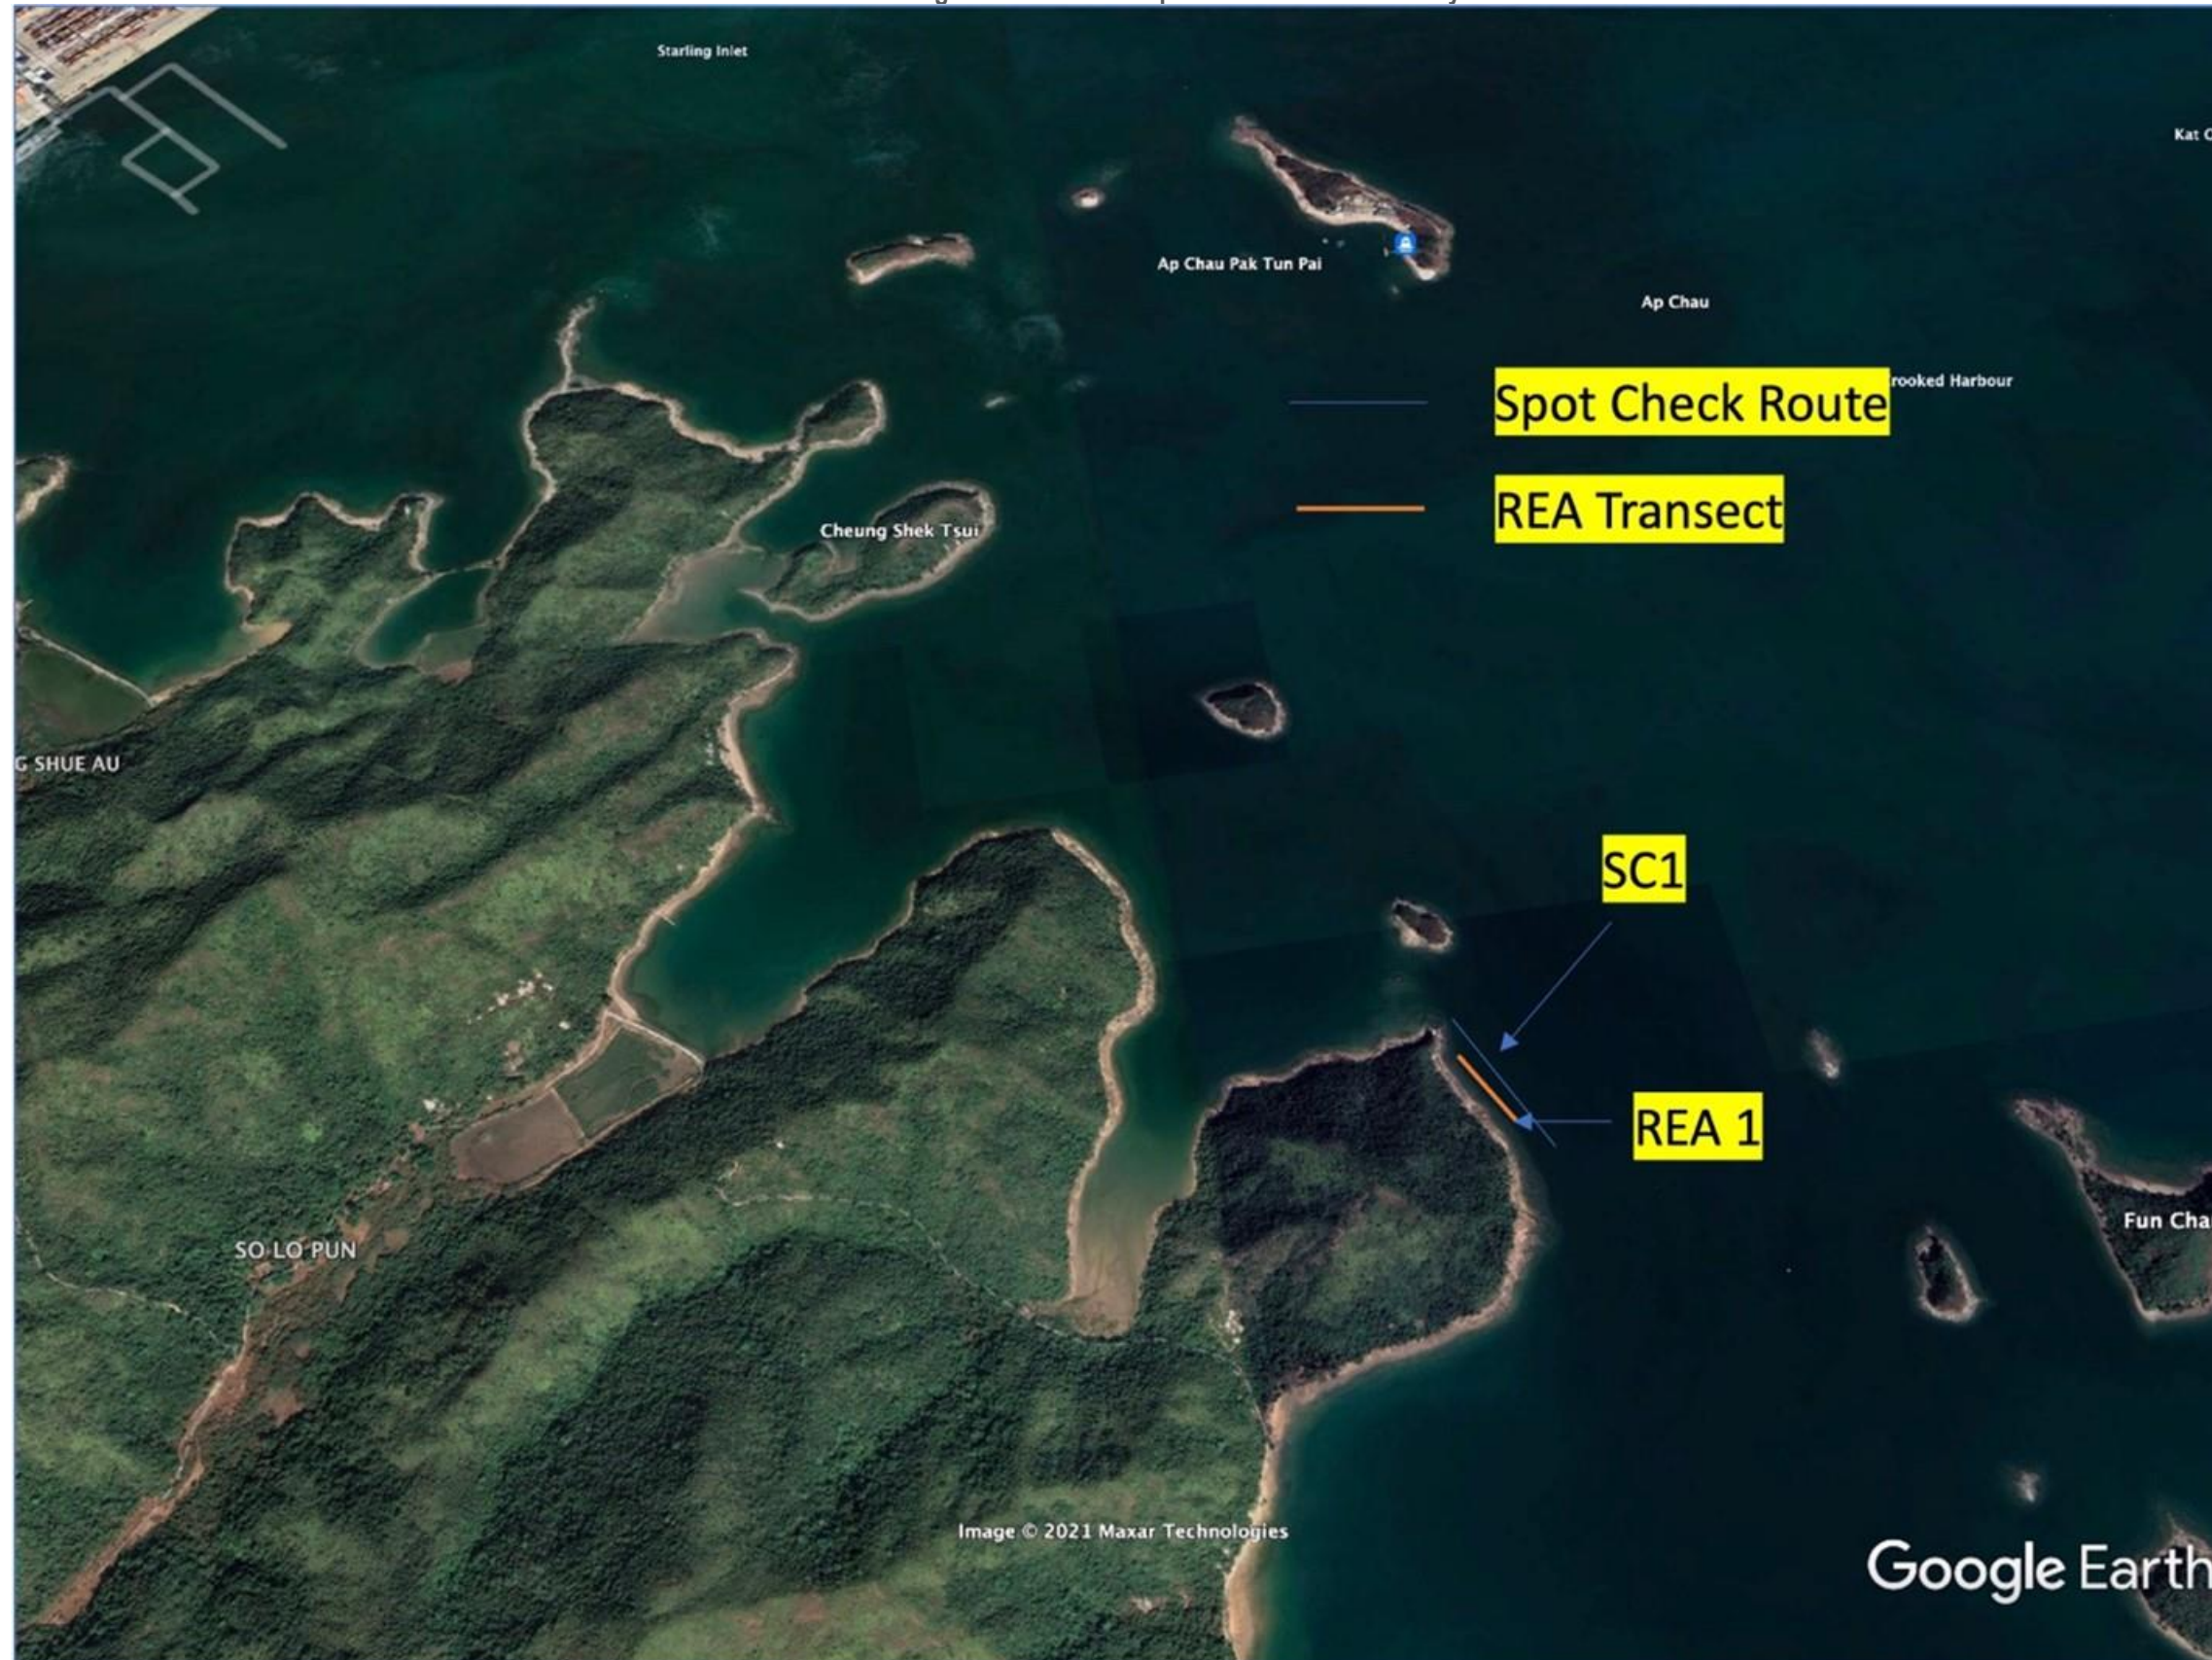
Figure 4 Location of Spot Check and REA Survey

2.2.9 A 100 m transect was laid down along the coastline which covered part of spot check site SC1 (**Figure 3**). The average depth for the transect was about 3.5 m and visibility around 1.5 m

2.2.10 The substrate along the transect line is mainly composed of natural bedrocks (**Table 6**). Common marine life such as common sponges, bryozoans, rock oyster *Saccostrea cucullata*, common green mussel *Perna viridis*, *Diadema* sea urchin and tubeworm *Sabelastarte japonica* were found on survey area.

- 2.2.11 This site supported high percentage (>50%) of hard coral. A total of 18 coral species (**Table 2.12**) were recorded during the REA survey. They were of large to medium size (about 15 to 120 cm in diameter) and in high coverage. All the coral colonies were in good condition.

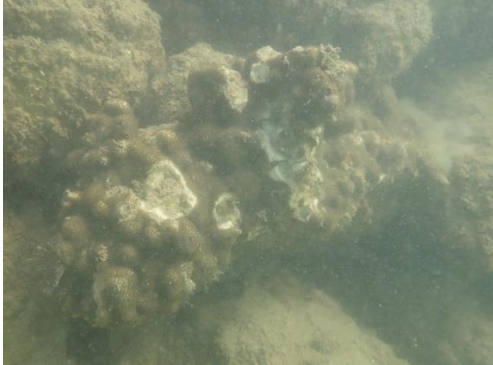
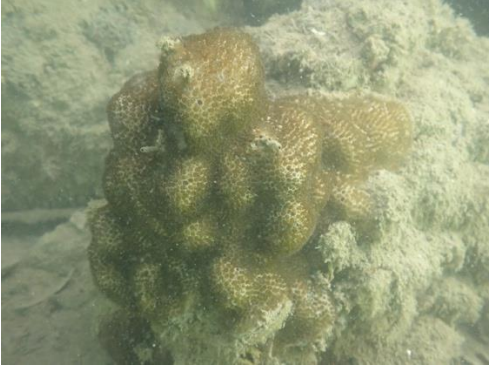
2.2.3 All recorded translocatable coral colonies showed good in health condition

<p>Coral #1 <i>Porites lutea</i></p>	<p>Coral #2 <i>Porites lutea</i></p>

- 3.1.1 Translocation of all identified translocatable coral colonies in the direct impact site will be needed in order to minimize the impact to existing coral communities. All coral colonies with diameter over 9 cm (smallest size of translocated coral colonies in Shek Kwu Chau Coral Translocation 2017, EP/SP/66/12) on the seawall of the existing pier will be translocated.

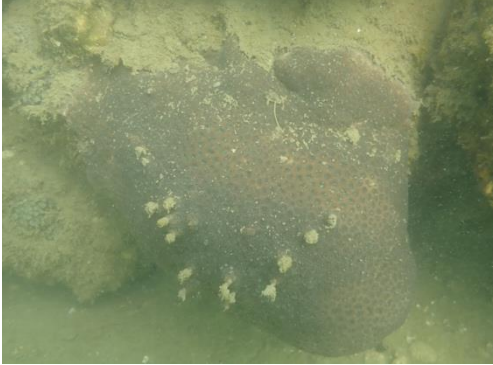
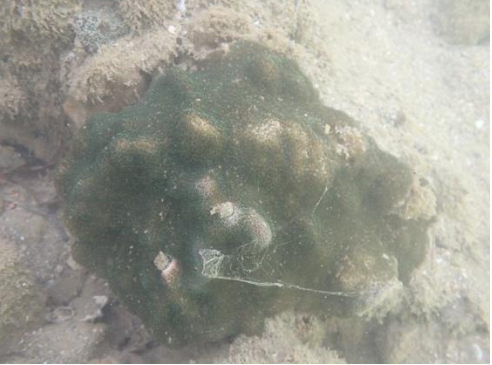
<p>Coral #3 <i>Cyphastrea serailia</i></p>	<p>Coral #4 <i>Porites lutea</i></p>

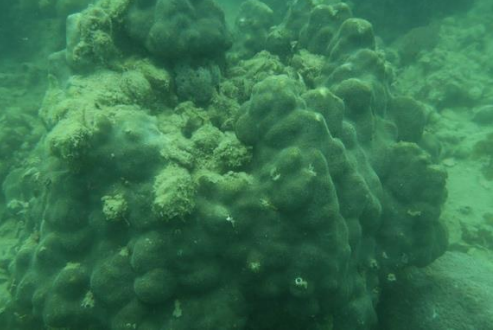
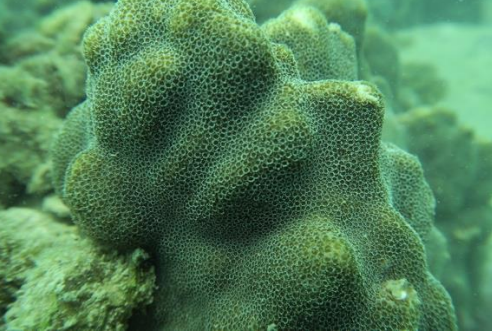
<p><i>Porites lutea</i> recorded at suggested recipient site</p>

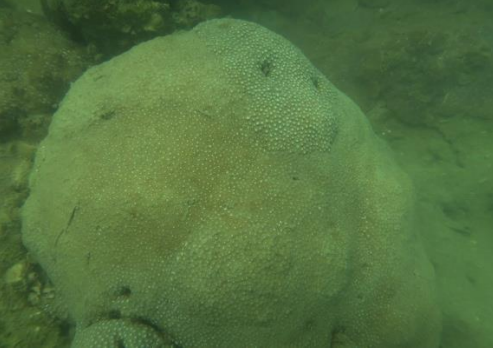
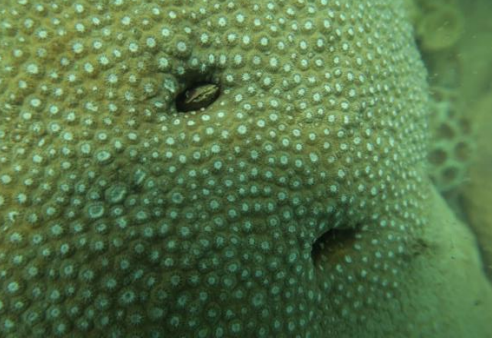
<p><i>Cyphastrea serailia</i> recorded at suggested recipient site</p>
