Agreement No. CE40/2023 (CE)

Development of Tseung Kwan O Area 137 and Associated Reclamation Sites - Investigation, Design and Construction

Coral Translocation and Enhancement Plan for EP-668/2025 (Final)

January 2026

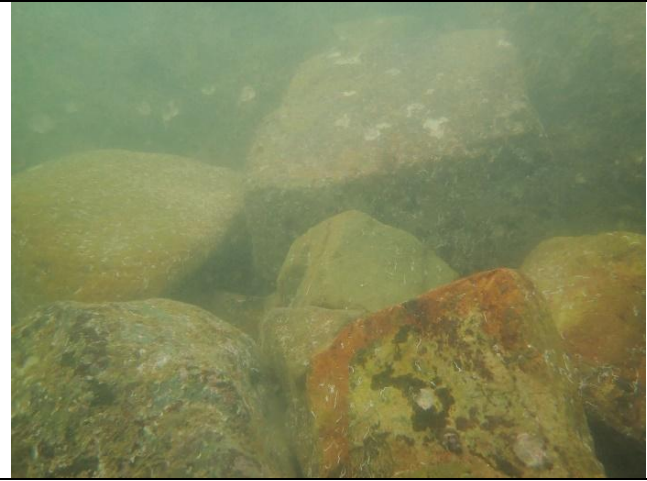
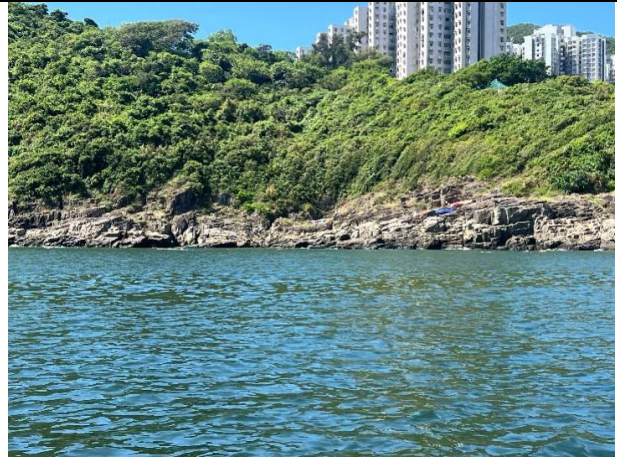
Cape Collinson (Recipient Site)

2.1 Substrate Photos at Coral Survey Locations

- 2.2.10 In Cape Collinson, the substrates also mainly composed of bedrocks and boulders. A total of four hard coral species, two gorgonian species and one black coral species were observed along the REA transect (**Table 2.8** refers). The size of the hard corals ranged from 8 cm to 35 cm. The coral species recorded along the REA transect were also evenly distributed. The coverage of hard coral, gorgonian and black coral along CC1 was about 1-5%. All coral colonies were in good condition with no or low level sedimentation, bleaching or partial mortality.

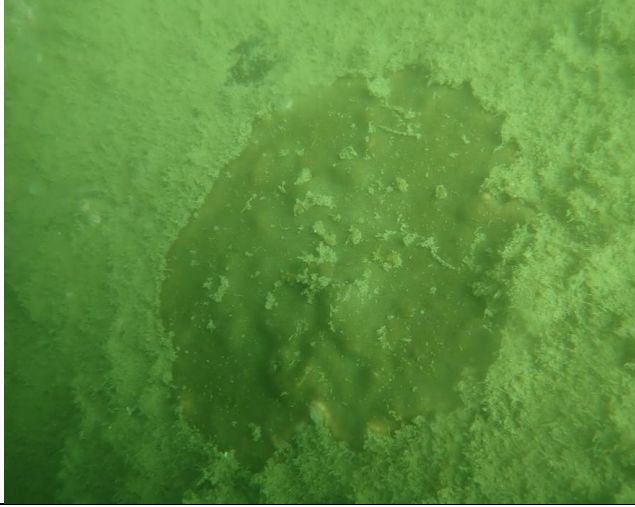
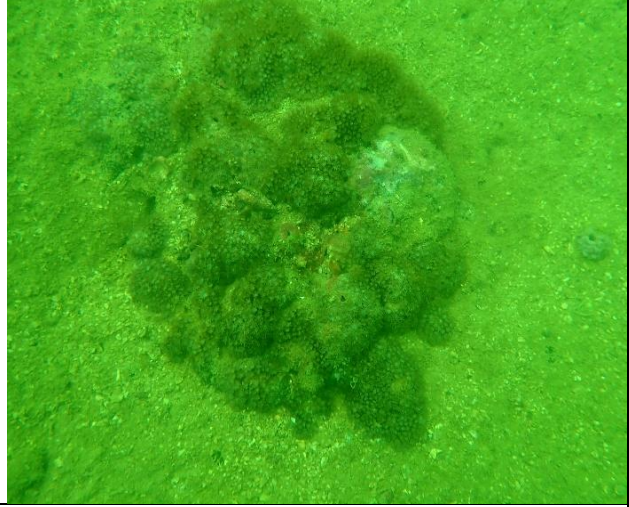
2.2 Representation Coral Photos at Donor Site

<i>Psammocora profundacella</i>	<i>Bernardpora stutchburyi</i>

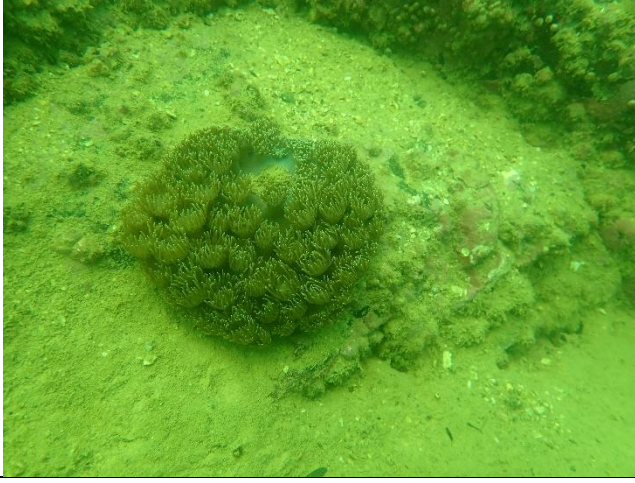
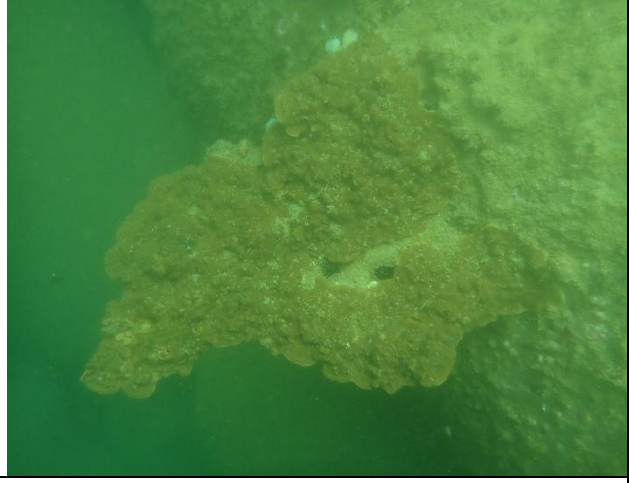
<i>Duncanopsammia peltata</i>	<i>Montipora peltiformis</i>

- 2.3.3 Coral colonies of *Montipora peltiformis* having good health condition and with diameters over 9 cm, are suitable for translocation with the implementation of enhancement measures. Those identified coral colonies that are suitable for translocation will be translocate before the commencement of marine works of the corresponding parts of the Project.
