JOB NO.: TCS00491/09

DSD CONTRACT No.: DC/2009/08

CONSTRUCTION OF YUEN LONG SOUTH BRANCH SEWERS AND EXPANSION OF HA TSUEN SEWAGE PUMPING STATION

2<sup>ND</sup> ENVIRONMENTAL MONITORING & AUDIT MONTHLY REPORT – MARCH 2010

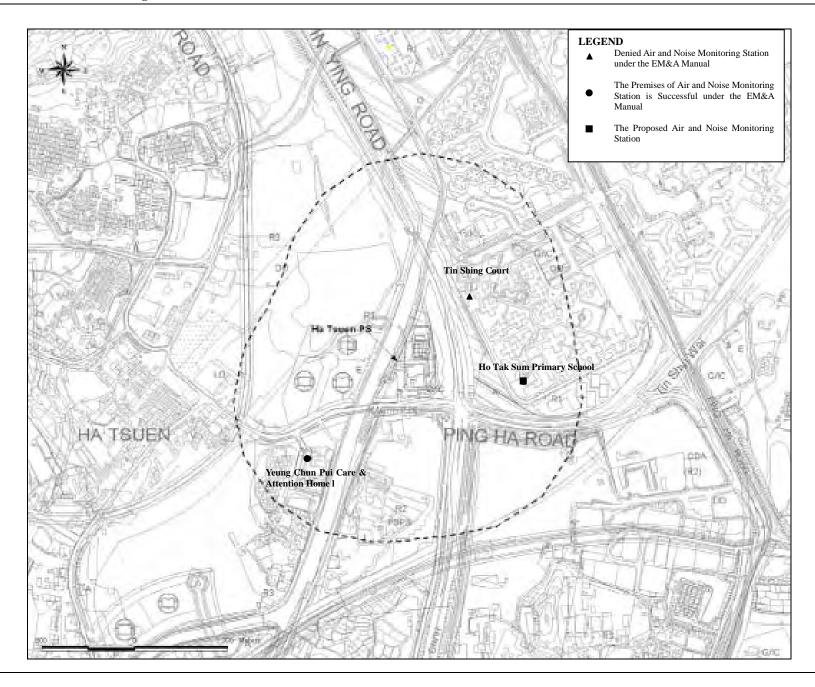
**Monitoring Location of EM&A Programme**

3.05 In this case, the alternative location Ho Tak Sum Primary School as one sensitive receiver mentioned in the EIA Report (Register No. AEIAR-072/2003) is proposed to be the replacement to undertake air quality monitoring during the expansion works of Ha Tsuen Sewage Pumping Station in accordance with the EM&A Manual Clauses 2.2.1.20. Simultaneously, air monitoring at the designated location Yeung Chun Pui Care & Attention Home is proposed to perform. The proposal and recommendation is agreed by IEC and as endorsed by EPD. The monitoring stations are detailed to list in *Table 3-2* and illustrated in *Appendix D*

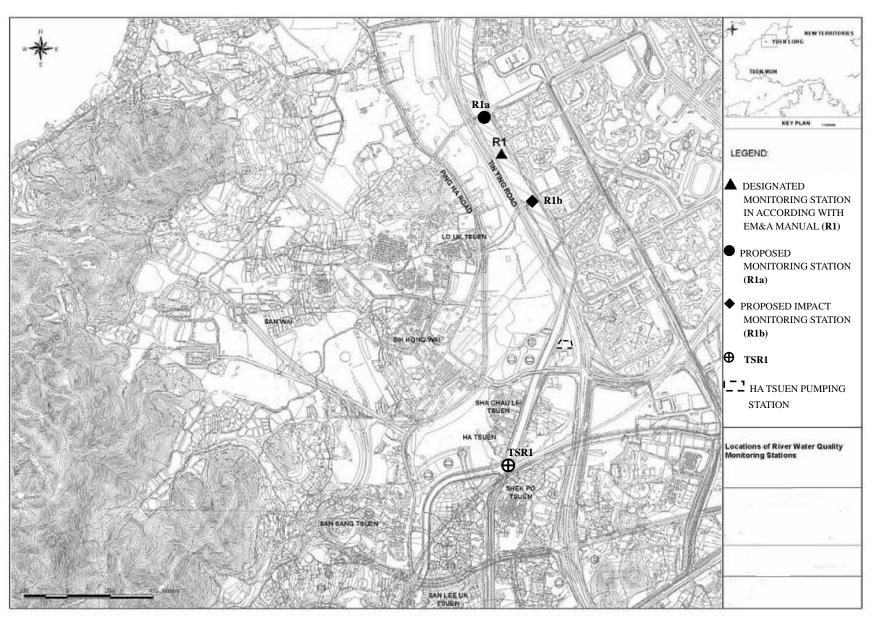
### **Proposed Water Quality Monitoring Location**

3.08 One designated location of a local stream course, Tin Shui Wai Nullah, is recommended to carry out water quality monitoring in accordance with the EM&A Manual. The designated sampling location R1 is located at the midpoint between two pedestrian flyovers athwart Tin Shui Wai Nullah, which are 320 meters apart, there is technical difficulty and safety concern when conducting the sampling. So, a new sampling point located at approximately 160m upstream of the R1 (hereinafter as R1b) was therefore proposed for the local stream impact monitoring. A proposal (submission ref.: TCS00491/09/300/L0080) has been verified by IEC and no further comments by EPD.

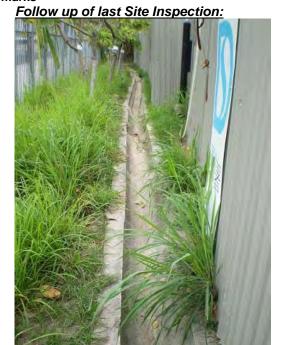
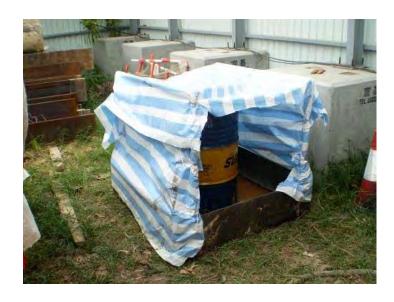
Remarks

1. House keeping on site was found to be improved.
