JOB NO.: TCS00491/09

DSD CONTRACT No.: DC/2009/08

CONSTRUCTION OF YUEN LONG SOUTH BRANCH SEWERS AND EXPANSION OF HA TSUEN SEWAGE PUMPING STATION

4TH ENVIRONMENTAL MONITORING & AUDIT MONTHLY REPORT – MAY 2010

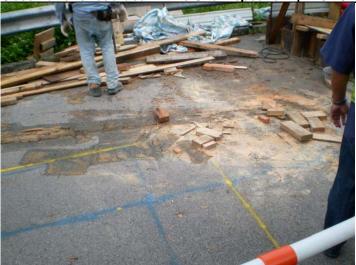
Remark 1: C&D material scattered was observed, housekeeping should be improved to maintain the site clean and tidy.

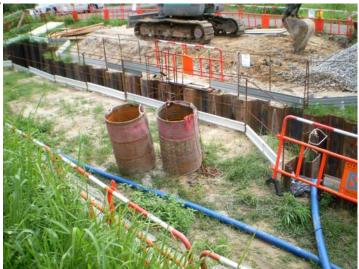
Remark 2: The empty container without any covering was observed, the contractor was reminded to cover with tarpaulin sheet especially in the rainy season.

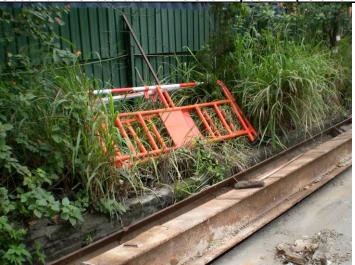
Remark 1: The contractor was reminded to remove the abandoned fencing near the tree and improve the site tidiness.

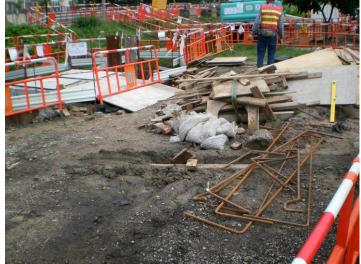
Remark 2: The contractor was reminded to improve the house-keeping measures to keep the site clean.

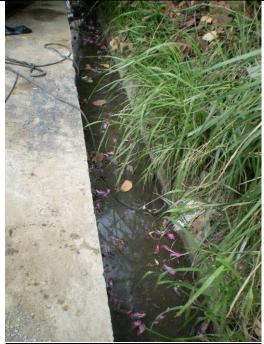
Remark 1: The stagnant water accumulated should be drained away or applied larvidical oil to prevent mosquitoes breeding.

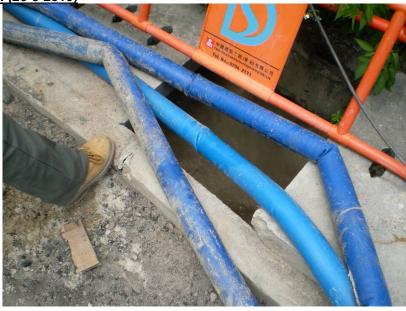
Remark 2: Mud was accumulated within the channel. The contractor was reminded to clean the channel and remove the mud to prevent muddy water discharge.
