CONTRACT NO. DC/2013/10 - DESIGN,
BUILD AND OPERATE SAN WAI
SEWAGE TREATMENT WORKS –
PHASE 1

**MONTHLY EM&A REPORT
NO. 16**

(01 AUGUST – 31 AUGUST 2018)

Report No.: ENA86333

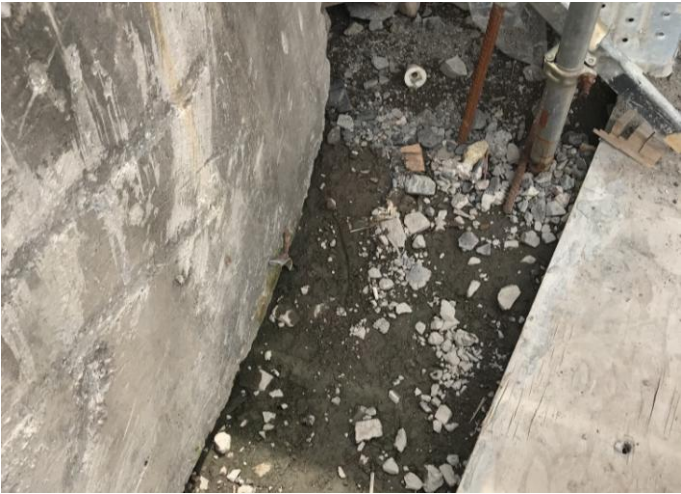
| Item | Details of observations | Follow Up Action | Photo Ref. | Further Action Required (Yes/No) | Proposed Follow up Date |
|---|--|---|---|---|---|
| -- | <p>Follow up action to Item 1 on 27/07/2018, general refuse was collected at Portion AB.</p> | -- | 180803_001 | No | -- |

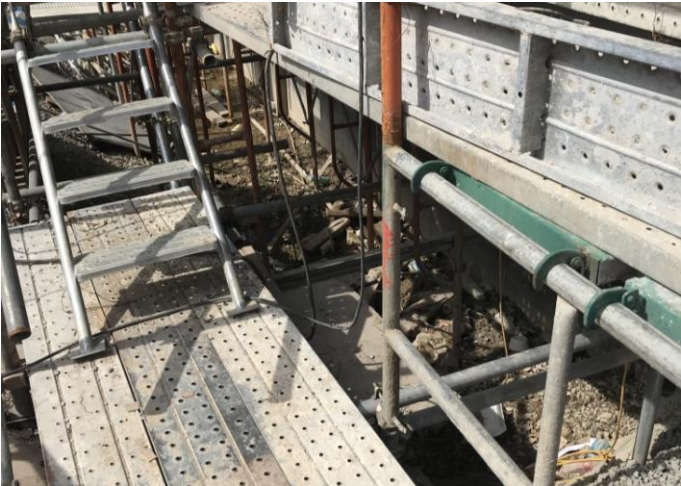
| -- | <p>Follow up action to Item 1 on 27/07/2018, stagnant water was cleared near Portion SDB.</p> | -- | 180803_003 | No | -- |

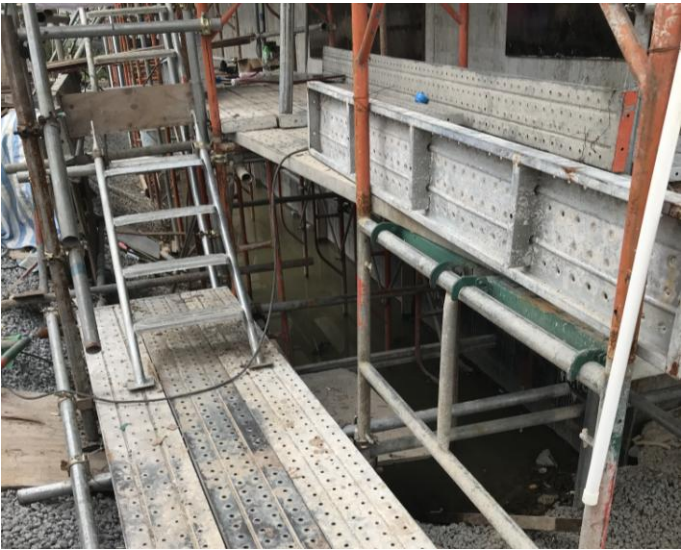
Observations Ith2: Stagnant water was observed near Portion SDB.

| 1 | <p>Stagnant water was observed near Portion SDB.</p> | To clear the stagnant pool | 180803_004 | Yes | 10/08/2018 |

| Date | Observations/ Reminders | Follow-up Action | Closed Date |
|---|--|---|---|
| 03 August 2018 | 1. Stagnant water was observed near Portion SDB. | 1. Stagnant water was cleared at Portion SDB. | 10 August 2018 |

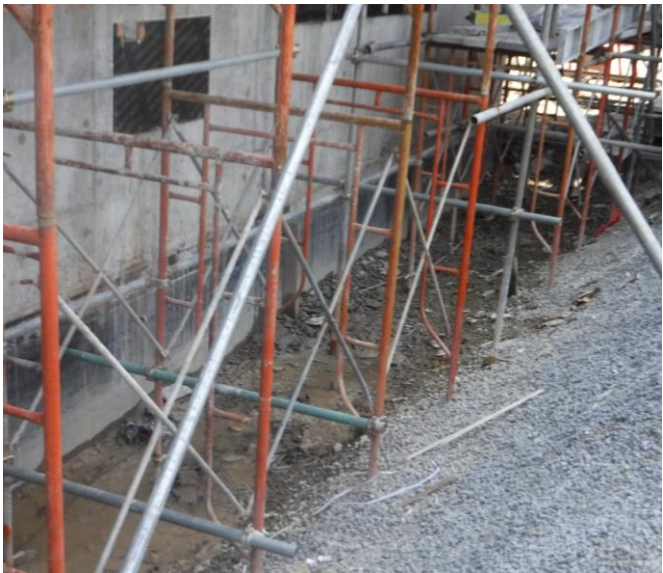
| Item | Details of observations | Follow Up Action | Photo Ref. | Further Action Required (Yes/No) | Proposed Follow up Date |
|---|---|---|---|---|---|
| -- | <p>Follow up action to Item 1 on 03/08/2018, stagnant water was cleared at Portion SDB.</p> | -- | 180810_001 | No | -- |

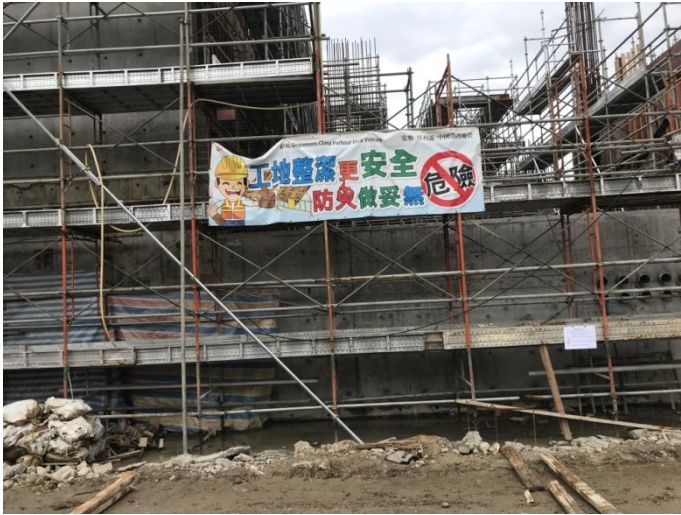
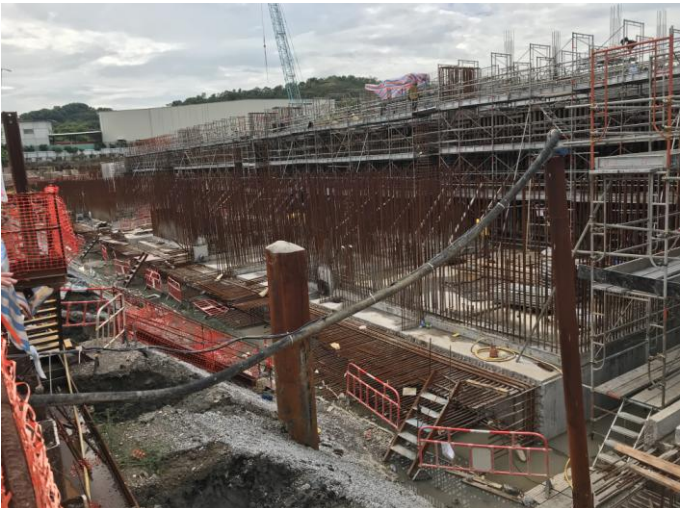
| Item | Details of observations | Follow Up Action | Photo Ref. | Further Action Required (Yes/No) | Proposed Follow up Date |
|---|--|---|---|---|---|
| 1 | | To clear the stagnant pool | 180817_001 | Yes | 23/08/2018 |

| | <p>Stagnant water was observed at Portion SDB, CEPT & UV.</p> | | | | |

| Date | Observations/ Reminders | Follow-up Action | Closed Date |
|---|--|---|---|
| 17 August 2018 | 1. Stagnant water was observed at Portion SDB, CEPT & UV. | 1. Stagnant water was cleared at Portion SDB, CEPT & UV. | 23 August 2018 |

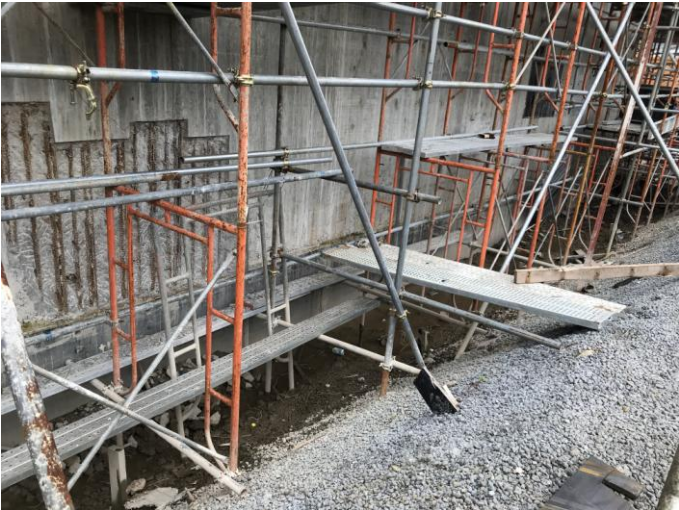
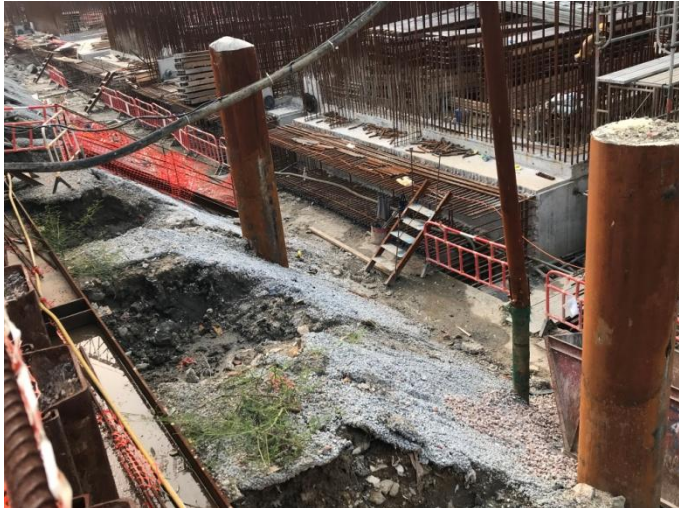
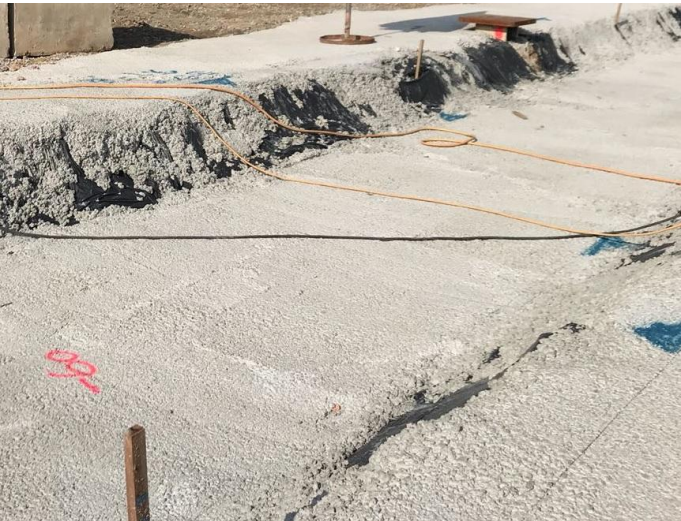
| | <p>Follow up action to Item 1 on 17/08/2018, stagnant water was cleared at Portion SDB, CEPT & UV.</p> | | | | |

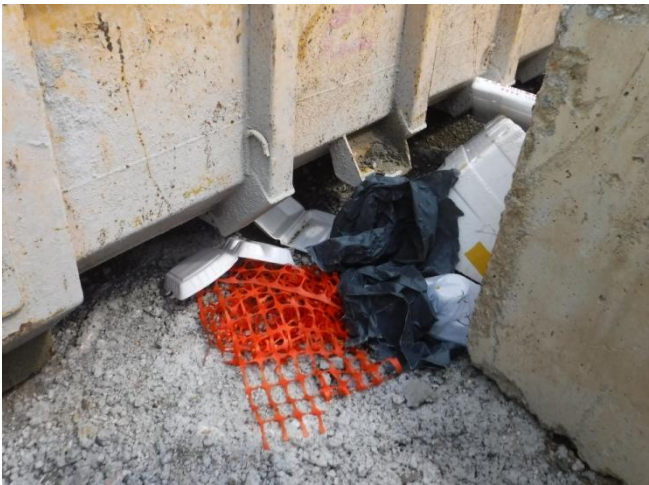
| 1 | <p>Improper disposal of general refuse was observed.</p> | To collect the general refuse properly | 180823_002 | Yes | 31/08/2018 |

| Date | Observations/ Reminders | Follow-up Action | Closed Date |
|---|--|---|---|
| 23 August 2018 | 1. Improper disposal of general refuse was observed. | 1. General refuse was collected. | 31 August 2018 |

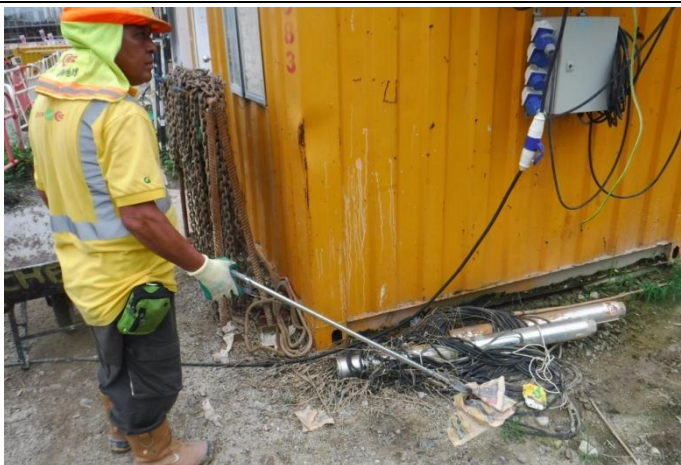
| Item | Details of observations | Follow Up Action | Photo Ref. | Further Action Required (Yes/No) | Proposed Follow up Date |
|---|--|---|---|---|---|
| -- | <p>Follow up action to Item 1 on 23/08/2018, general refuse was collected.</p> | -- | 180831_001 | No | -- |

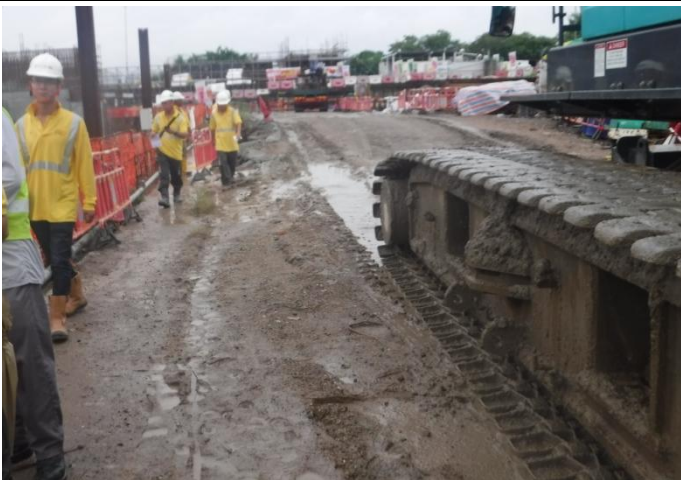
| Item | Details of observations | Follow Up Action | Photo Ref. | Further Action Required (Yes/No) | Proposed Follow up Date |
|---|--|---|---|---|---|
| 1 | <p>Stagnant water was observed at CEPT.</p> | To clear the stagnant pool | 180831_002 | Yes | 06/09/2018 |

| Date | Observations/ Reminders | Follow-up Action | Closed Date |
|---|--|---|---|
| 31 August 2018 | 1. Stagnant water was observed at CEPT. 2. General refuse was observed at CEPT. | Follow-up actions for outstanding observation will be inspected during the next site inspection. | -- |

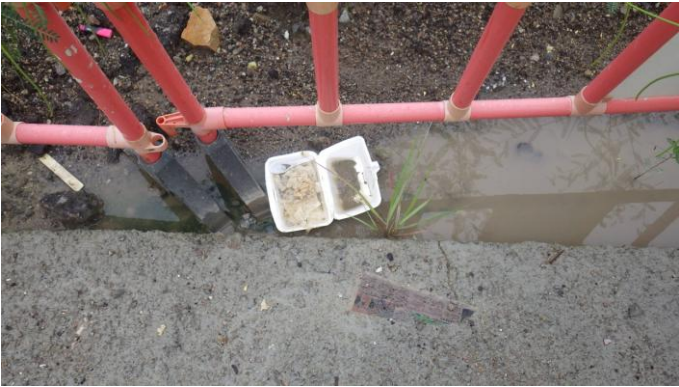
| 2 | <p>General refuse was observed at CEPT.</p> | To collect the general refuse properly | 180831_003 | Yes | 06/09/2018 |

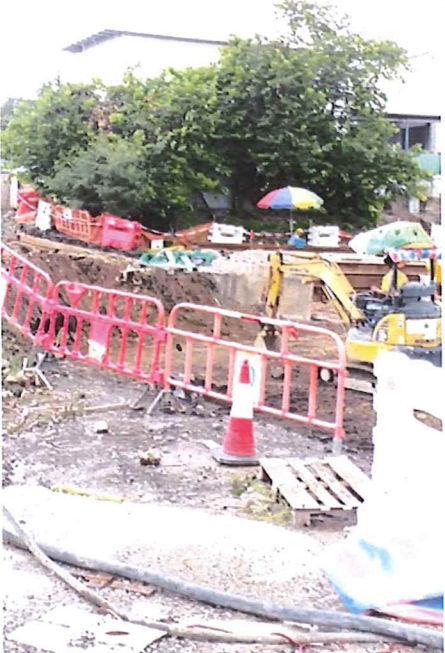
| Figure 1 | Figure 2 |

| Figure 1 | Figure 2 |
|---|--|
| General condition of the trees at south west corner of the site | Weeds climbers found on the trees at south west corner of the site |

1. Generally, contractor was reminded to keep on the tree protection and maintenance.
2. Some of the protective fence at the existing fence of the treatment plant required to fix.
3. Weeds climbers was found clinging on the trees at south west corner. Contractor is required to remove it immediately.
4. Weeding within the site

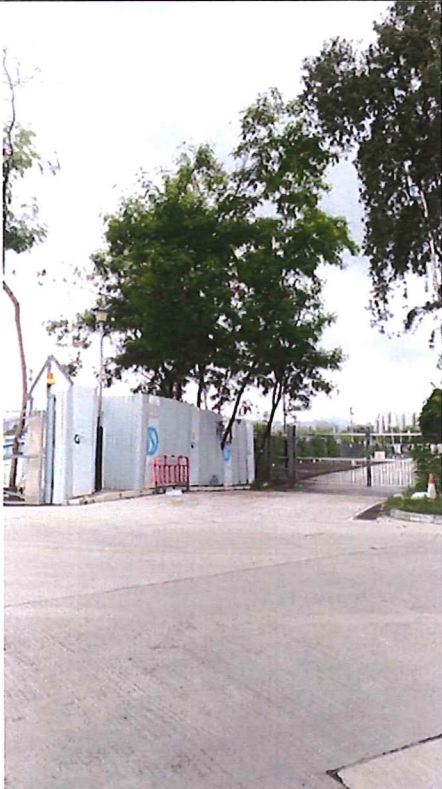
| <p>Figure 3</p> | <p>Figure 4</p> |

| <p>Trees inside robust TPZ</p> | <p>Condition of trees at the entrance of the existing treatment plant</p> |

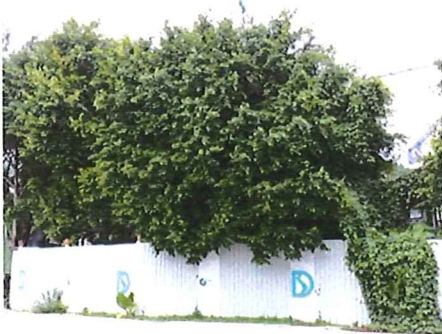
| <p>Figure 5</p> | <p>Figure 6</p> |

| <p>General condition of the existing trees at eastern boundary</p> | <p>Proper protective fence (outside works extent) is noted</p> |

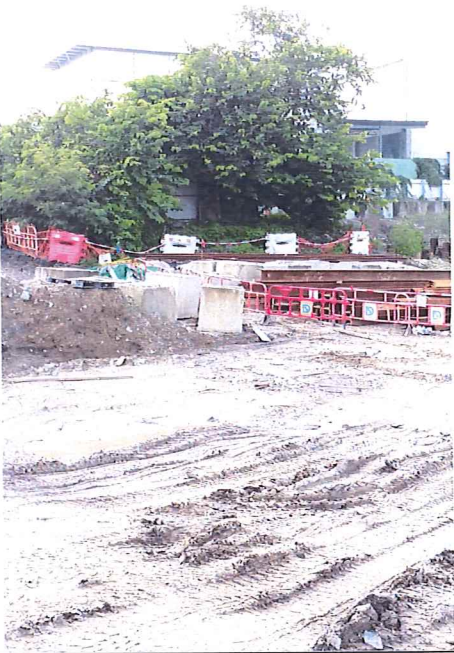
| Figure 1 | Figure 2 |

| Figure 1 | Figure 2 |
|---|--|
| General condition of the trees at south west corner of the site | Weeds climbers found on the trees at south west corner of the site |

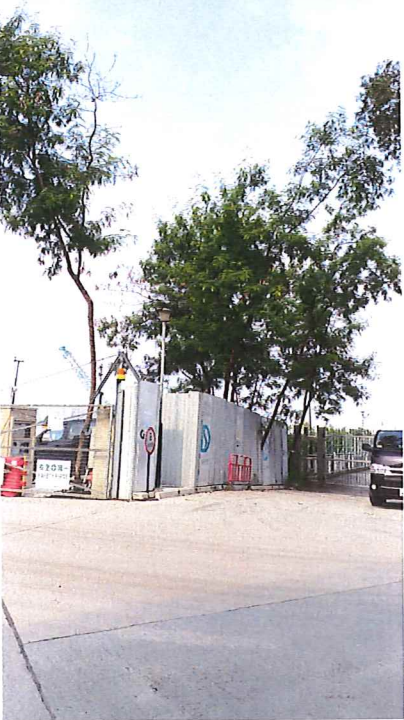
| <p>Figure 3</p> | <p>Figure 4</p> |

| <p>Trees inside robust TPZ</p> | <p>Condition of trees at the entrance of the existing treatment plant</p> |

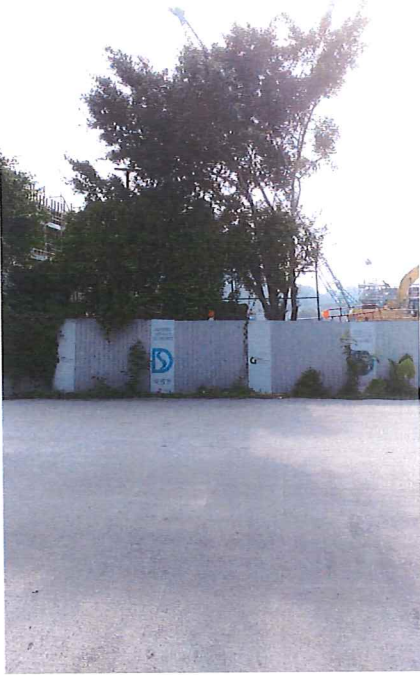
| <p>Figure 5</p> | <p>Figure 6</p> |

| <p>General condition of the existing trees at eastern boundary</p> | <p>Proper protective fence (outside works extent) is required to fix</p> |
