## **ATAL-DEGREMONT-CHINA HARBOUR JOINT VENTURE**

CONTRACT NO. DC/2013/10 - DESIGN,  
BUILD AND OPERATE SAN WAI  
SEWAGE TREATMENT WORKS –  
PHASE 1

**MONTHLY EM&A REPORT  
NO. 27**

**(01 JULY – 31 JULY 2019)**

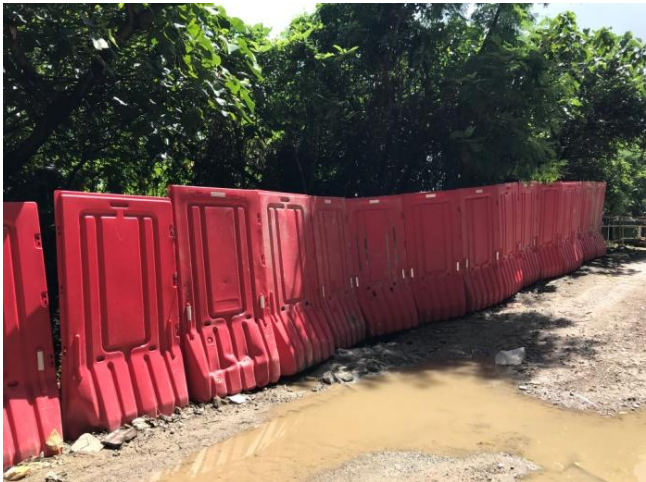
| Item | Details of observations | Follow Up Action | Photo Ref. | Further Action Required (Yes/No) | Proposed Follow up Date |
|---|---|---|---|---|---|
| -- | <p>Follow up action to Item 1 on 28/06/2019, the temporary hoarding were erected.</p> | -- | 190705_001 | No | -- |

| Date | Observations/ Reminders | Follow-up Action | Closed Date |
|---|---|---|---|
| 28 June 2019 | 1. Stagnant water was observed near SDB. | 1. The temporary hoardings were erected. | 05 July 2019 |

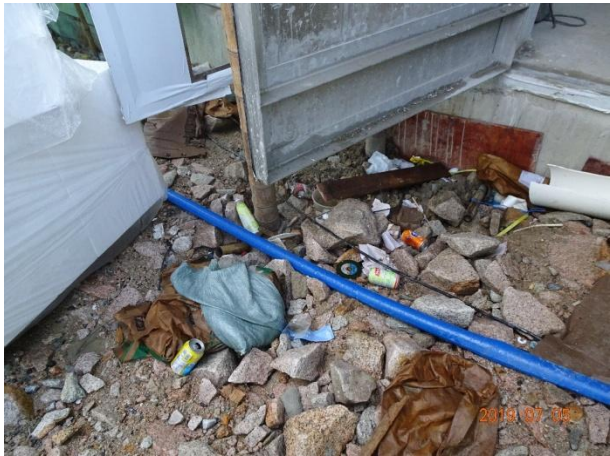
| Item | Details of observations | Follow Up Action | Photo Ref. | Further Action Required (Yes/No) | Proposed Follow up Date |
|---|---|---|---|---|---|
| 1 | <p>General refuse was observed near EB3 area.</p> | To collect the general refuse properly | 190705_002 | Yes | 12/07/2019 |

| Date | Observations/ Reminders | Follow-up Action | Closed Date |
|---|---|---|---|
| 05 July 2019 | 1. General refuse was observed near EB3 area. | 1. General refuse was collected near EB3 area. | 12 July 2019 |

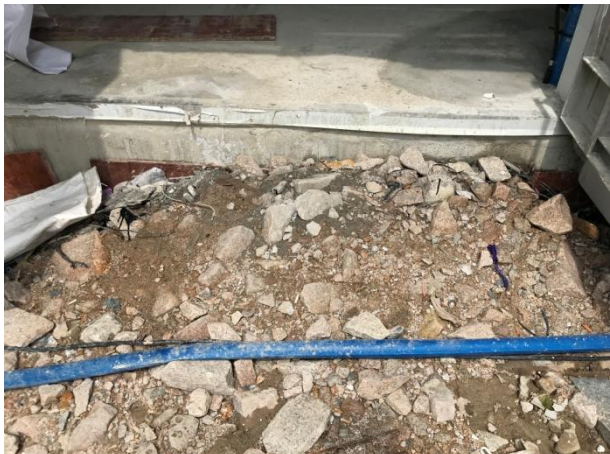
| Item | Details of observations | Follow Up Action | Photo Ref. | Further Action Required (Yes/No) | Proposed Follow up Date |
|---|---|---|---|---|---|
| -- | <p>Follow up action to Item 1 on 05/07/2019, general refuse was collected near EB3 area.</p> | -- | 190712_001 | No | -- |

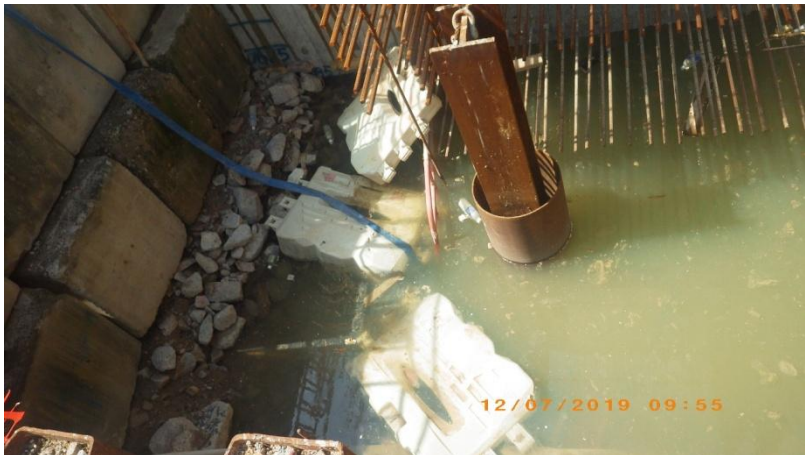
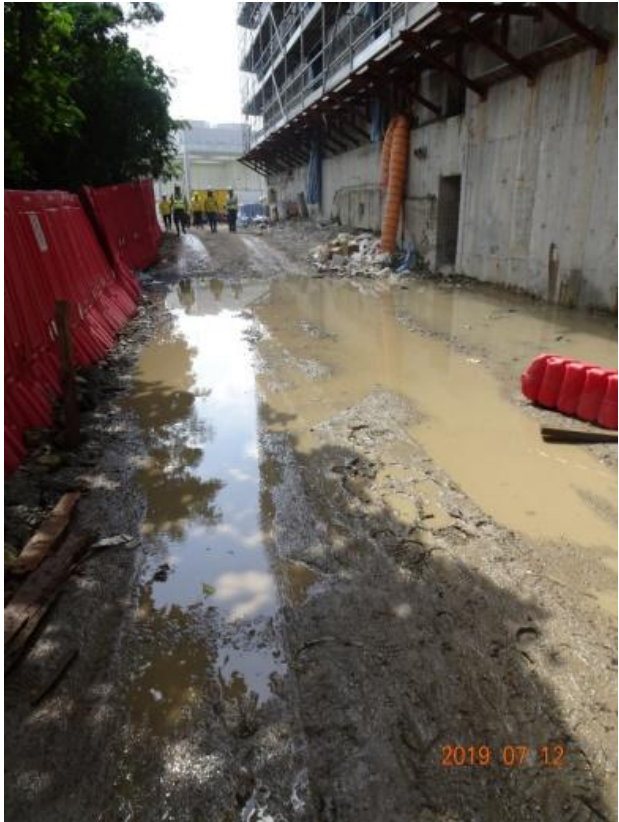
| | <p>2019 07 12</p> <p>Stagnant water was observed near SDB area.</p> | | | | |

| Date | Observations/ Reminders | Follow-up Action | Closed Date |
|---|---|---|---|
| 12 July 2019 | 1. Stagnant water was observed near SDB area. | 1. Stagnant water was cleared and larvicidal oil was applied. | 19 July 2019 |

| Item | Details of observations | Follow Up Action | Photo Ref. | Further Action Required (Yes/No) | Proposed Follow up Date |
|---|---|---|---|---|---|
| 1 | | To clear the stagnant water properly | 190712_002 | Yes | 19/07/2019 |

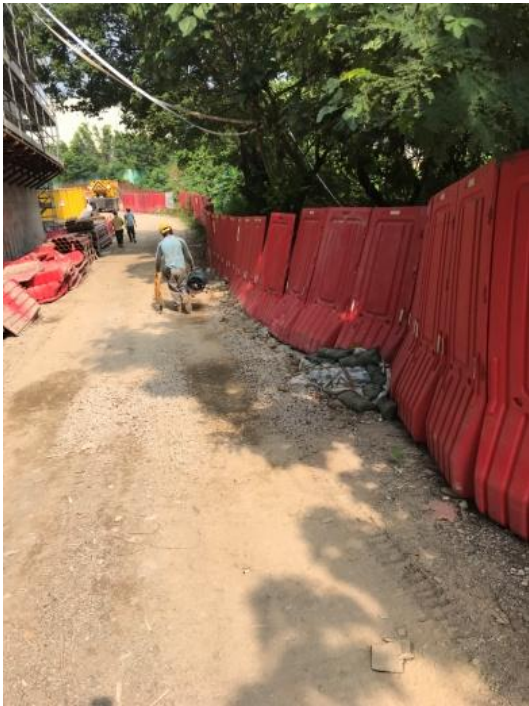
| | <div data-bbox="369 210 907 932"></div> <p data-bbox="188 938 1081 1008">Follow up action to Item 1 on 12/07/2019, stagnant water was cleared and larvicidal oil was applied.</p> | | | | |

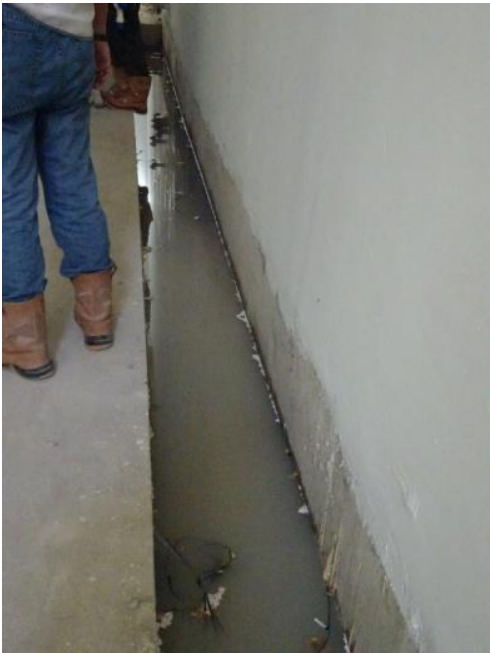
| Item | Details of observations | Follow Up Action | Photo Ref. | Further Action Required (Yes/No) | Proposed Follow up Date |
|---|---|---|---|---|---|
| 1 | <p>Stagnant water was observed.</p> | -- | 190725_001 | Yes | 02/08/2019 |

| Date | Observations/ Reminders | Follow-up Action | Closed Date |
|---|---|---|---|
| 25 July 2019 | 1. Stagnant water was observed. | Follow-up actions for outstanding observation will be inspected during the next site inspection. | -- |

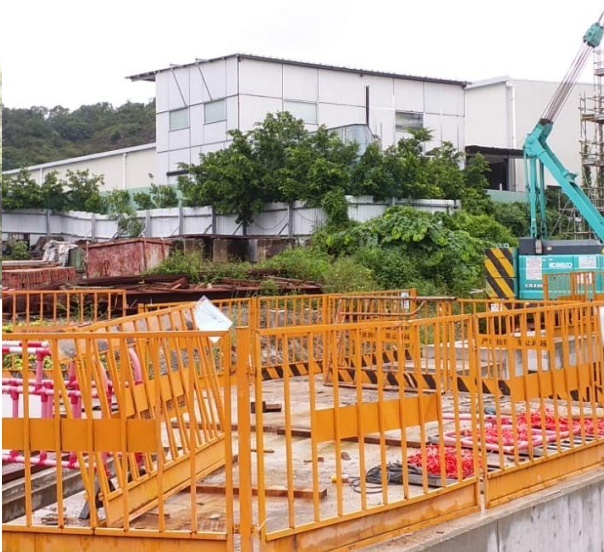
| Figure 1 | Figure 2 |
|---|---|
| General condition of the existing trees at eastern boundary | General condition of the south-west corner of the site. Former trees are removed. |

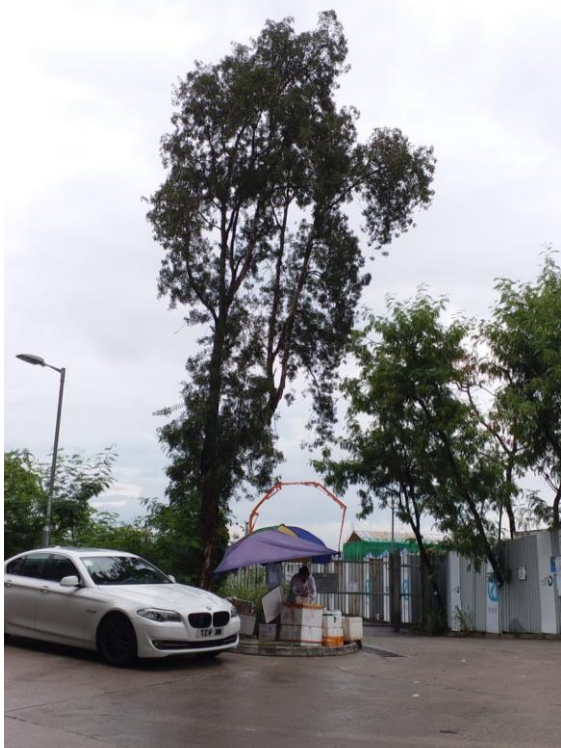
| Figure 3 | Figure 4 |

| Figure 3 | Figure 4 |
|---|---|
| <p>Condition of trees at the entrance of the existing treatment plant</p> | <p>All the existing trees near the eastern entrance are removed</p> |

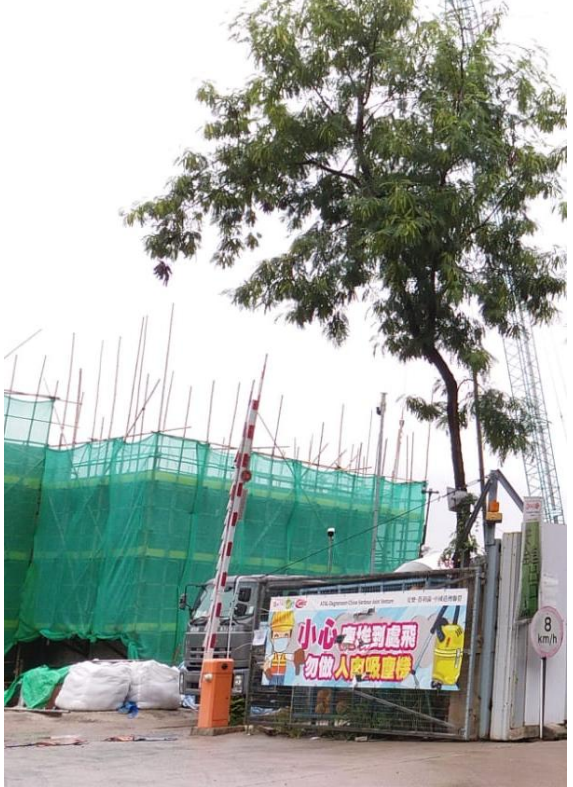
| Figure 3 | Figure 4 |
|---|---|
| Figure 5 | Figure 6 |

| Figure 3 | Figure 4 |
|---|---|
| <p>Existing trees at the site entrance protected by the hoarding fence</p> | <p>Existing trees at the site entrance protected by the hoarding fence</p> |

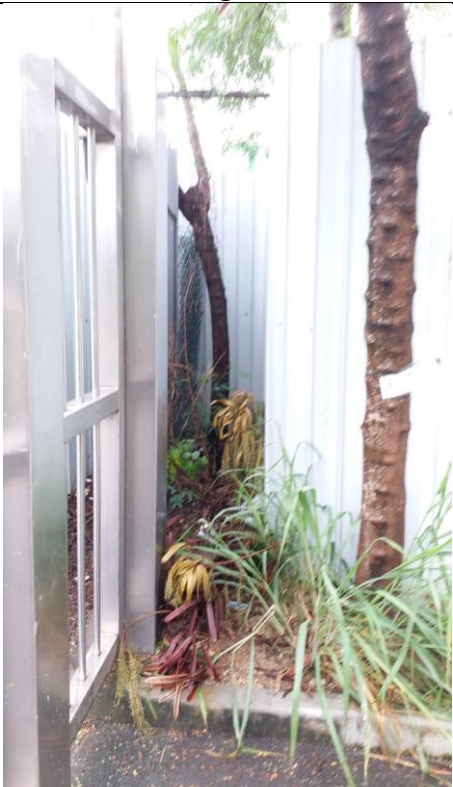
| Figure 7 | Figure 8 |
|---|---|
| <p>Protective fence is removed.</p> | <p>Death branch is found on T11. Contractor is required to have follow-up and keep on monitoring. Replacement may be needed.</p> |

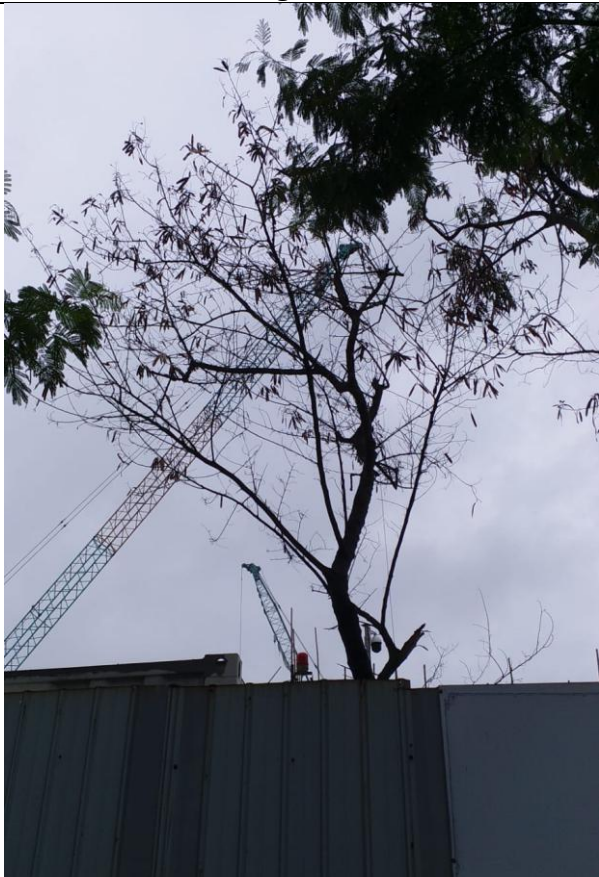
| Figure 7 | Figure 8 |
|---|---|
| <p>Poor vigour condition of tree T11</p> | |

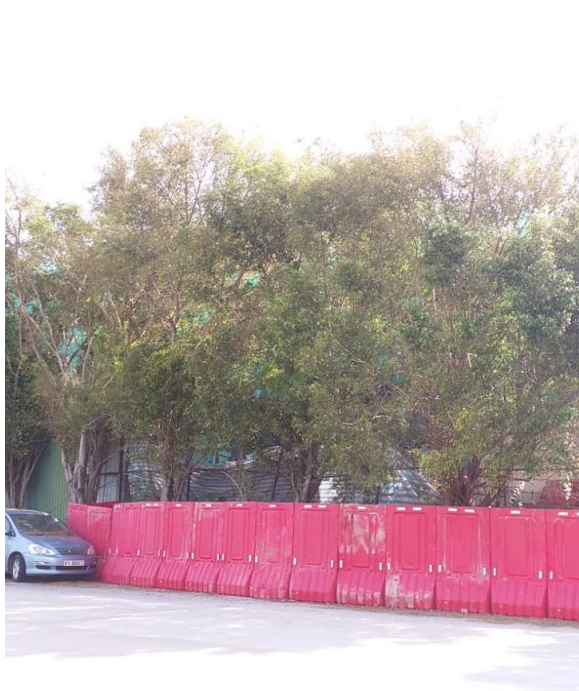
| Figure 1 | Figure 2 |

| Figure 1 | Figure 2 |
|---|---|
| General condition of the existing trees at eastern boundary | General condition of the south-west corner of the site. Former trees are removed. |

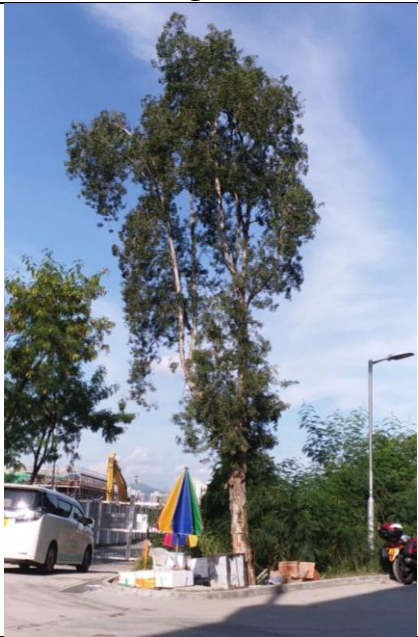
| Figure 3 | Figure 4 |

| Condition of trees at the entrance of the existing treatment plant | Existing tree- T11 is removed |

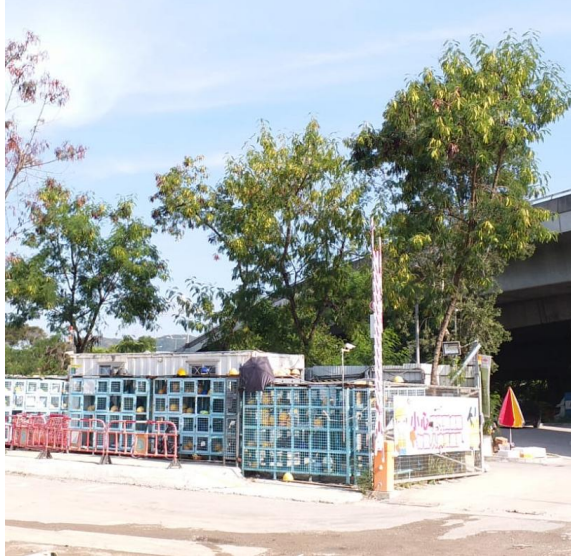
| Figure 5 | Figure 6 |

| Existing trees at the site entrance- looking from the site | Existing trees at the site entrance near the hoarding fence |

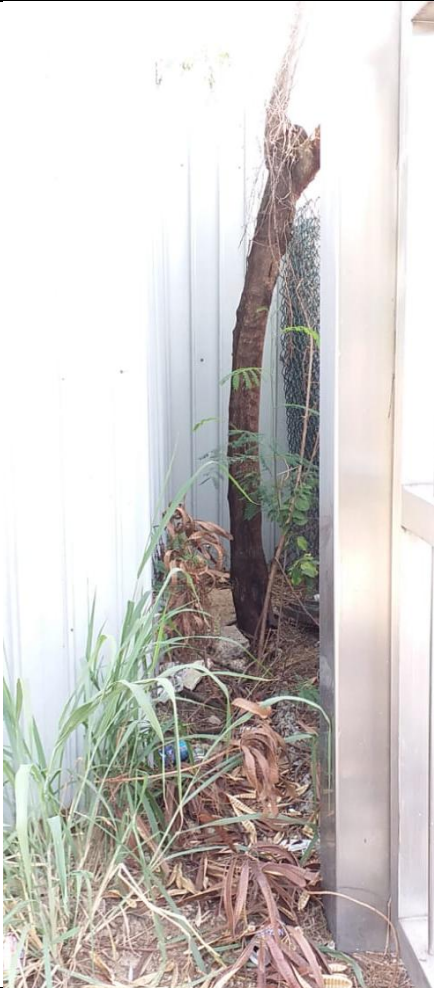
| Figure 7 | |
|---|--|
| Tree protection area should be kept tidy. | |
