CONTRACT NO. DC/2013/10 - DESIGN, BUILD AND OPERATE SAN WAI SEWAGE TREATMENT WORKS – PHASE 1

> MONTHLY EM&A REPORT NO. 28

(01 AUGUST - 31 AUGUST 2019)

Report No.: ENA96838

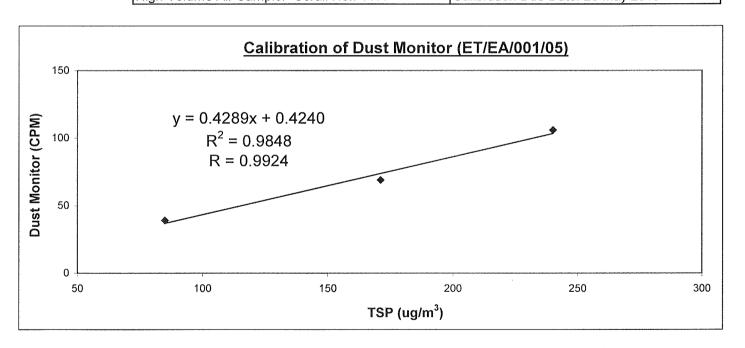
and High Volume Air Samper together under the same environmental condition

Dust Monitor (CPM)	39	69	106
TSP (ug/m³)	85	171	240
High Volume Air Sampler Serail No.: 1177	Calibration D	ue Date: 28 Ma	v 2019

Correlation coefficient (r) of the calibration curve greater than 0.990

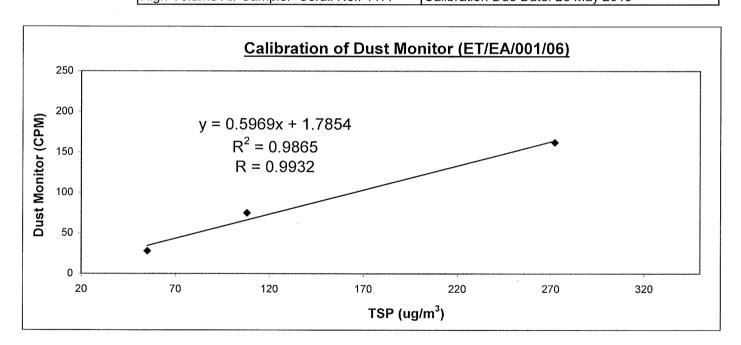
and High Volume Air Samper together under the same environmental condition

Dust Monitor (CPM)	28	75	162
TSP (ug/m ³)	55	108	272
High Volume Air Sampler, Serail No.: 1177	Calibratio	n Due Date: 28 May	2019

Correlation coefficient (r) of the calibration curve greater than 0.990 after

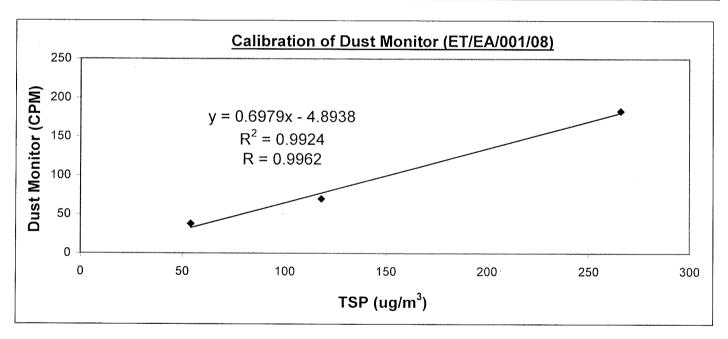
and High Volume Air Samper together under the same environmental condition

Dust Monitor (CPM)	38	70	183
High Volume Air Sampler (ug/m³)	54	118	266
High Volume Air Sampler Serail No.:1177	7 Calibrati	on Due Date: 29 Mar	ch 2019

Correlation coefficient (r) of the calibration curve greater than 0.990

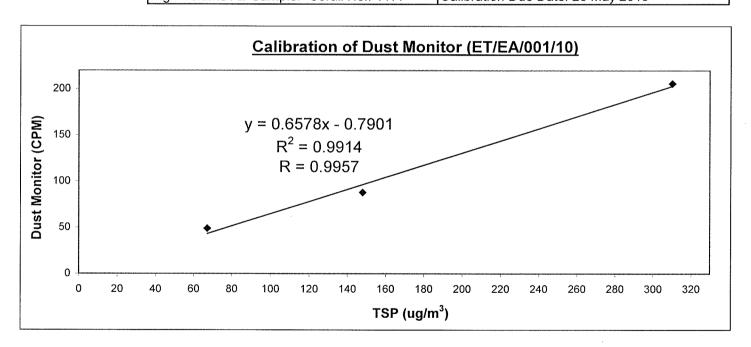
and High Volume Air Samper together under the same environmental condition

Dust Monitor (CPM)	49	88	206
TSP (ug/m³)	67	148	310
High Volume Air Sampler Serail No : 1177	Calibration	n Due Date: 28 May	v 2019

Correlation coefficient (r) of the calibration curve greater than 0.990 after a three-point

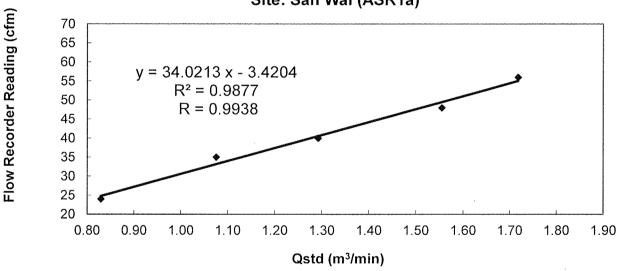
Sampler 1934 Calibration Curve Site: San Wai (ASR1a)

Flow recorder readin	56	48	40	35	24		
Qstd (Actual flow rate	e, m³/min)		1.72	1.55	1.29	1.08	0.83
Pressure :	767.31	mm	нg	Temp.:		301	K

Acceptance Criteria: Correlation coefficient (r) of the calibration curve greater than 0.990 after a 5-point calibration.

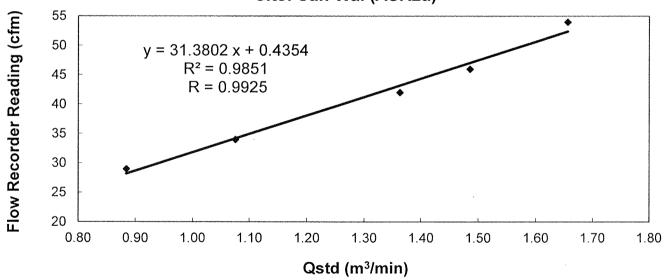
Sampler 9998 Calibration Curve Site: San Wai (ASR2a)

Flow recorder	reading (cfm)	54	46	42	34	29
Qstd (Actual fl	ow rate, m³/min)	1.66	1.49	1.36	1.08	0.88
Pressure :		Temp.:	301	K

Acceptance Criteria: Correlation coefficient (r) of the calibration curve greater than 0.990 after a 5-point calibration.

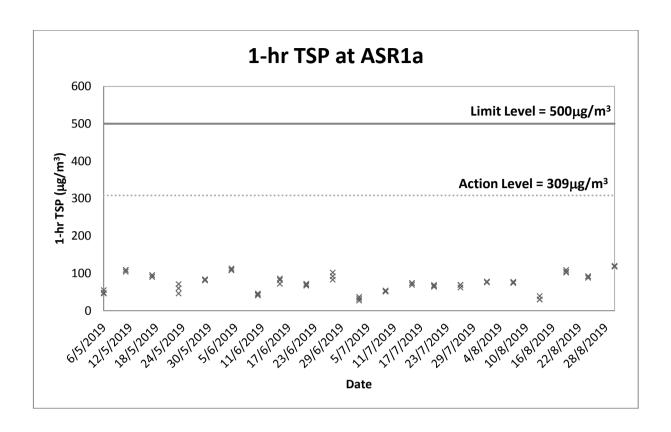
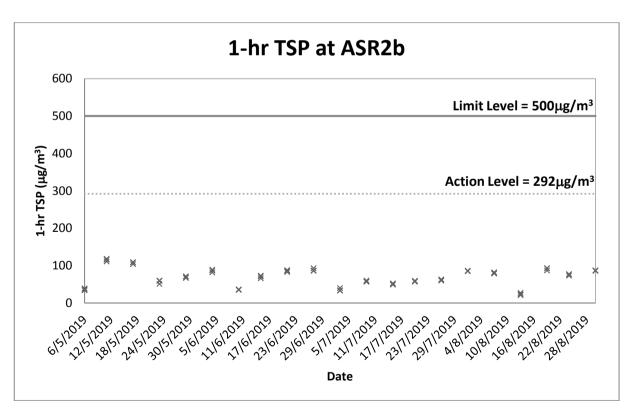
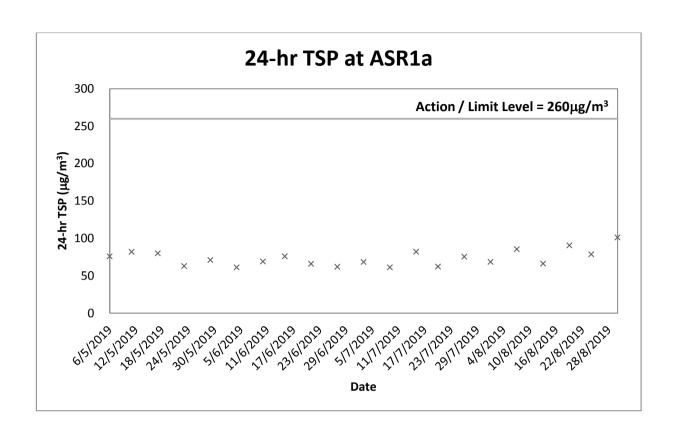
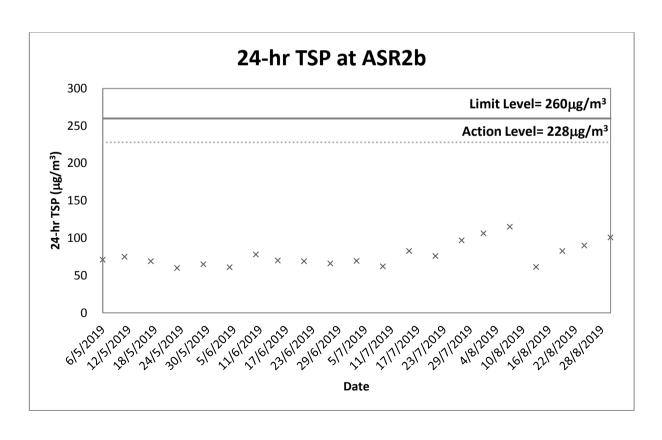
Graphical Plots of Impact Air Quality Monitoring Results

Generally, 1-hour TSP and 24-hour TSP monitoring results fluctuated well below the Action Level in this reporting period. The major dust source observed near the monitoring stations was mainly from vehicles passing by the container yards and general earth works. It can be concluded that the contractor implemented sufficient dust mitigation measures during this reporting month.

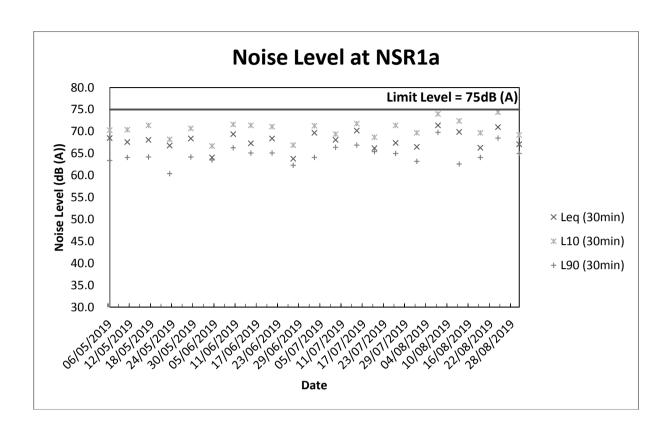
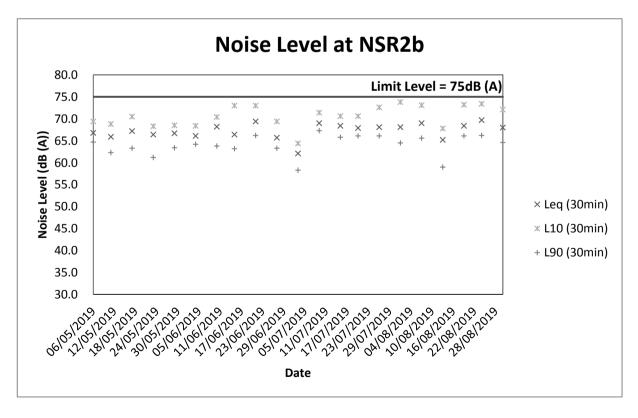
Graphical Plots of Impact Noise Monitoring Data

The noise monitoring data were found to be lower than the limit level. The major noise source during the monitoring event was the vehicles passing through the container yard entrance and the general earth works inside the construction site.

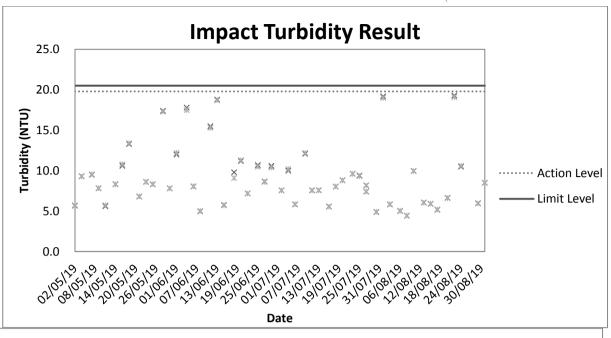
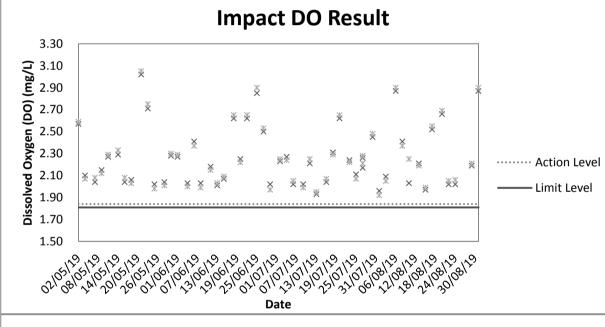
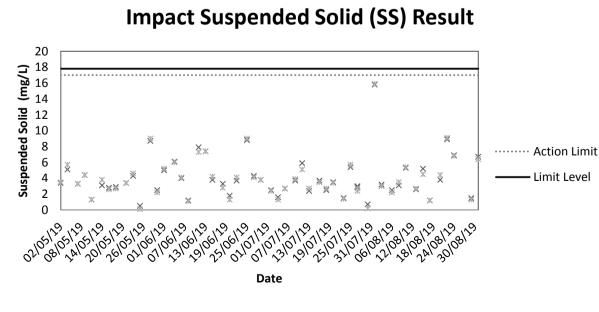
Graphical Plots of Impact Water Quality Monitoring Data

Generally, the turbidity and suspended solids were found to be lower than the action level. Besides, all results of dissolved oxygen measured in this reporting month were higher than the action level.

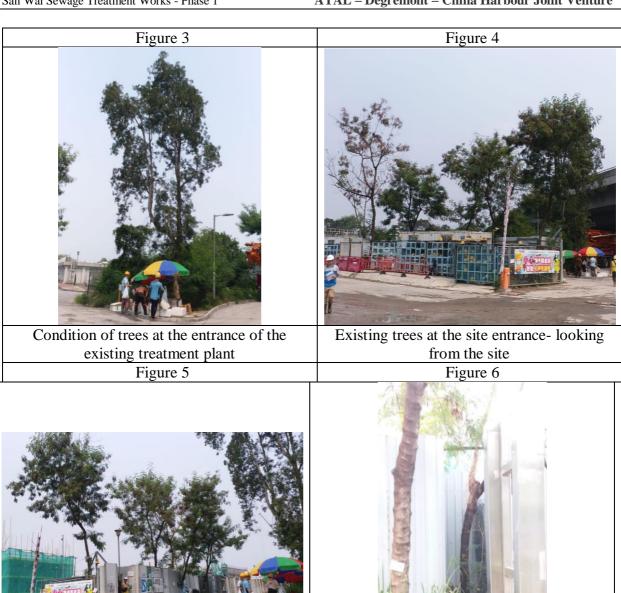
hoarding fence

Tree protection area should be kept tidy.
