CONTRACT NO. DC/2013/10 - DESIGN, BUILD AND OPERATE SAN WAI SEWAGE TREATMENT WORKS – PHASE 1

> MONTHLY EM&A REPORT NO. 29

(01 SEPTEMBER - 30 SEPTEMBER 2019)

Report No.: ENA97546

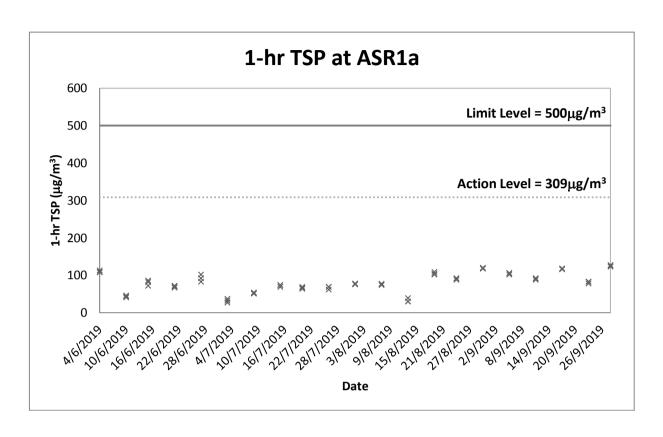
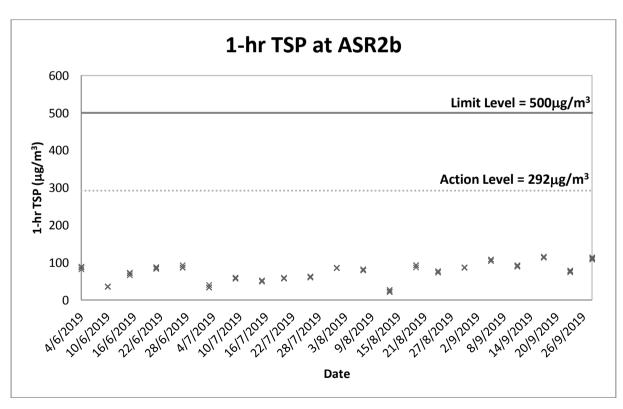
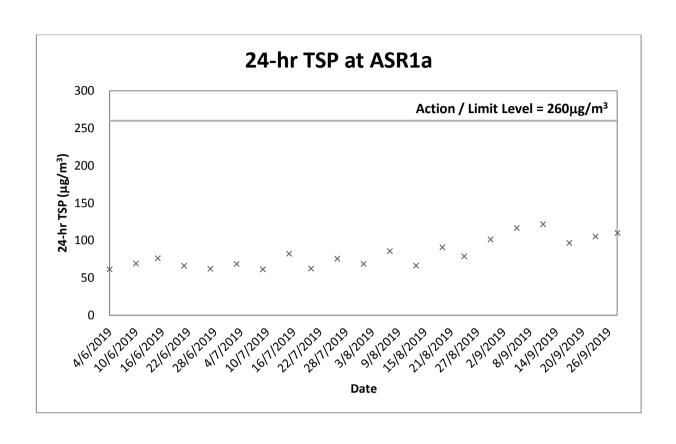
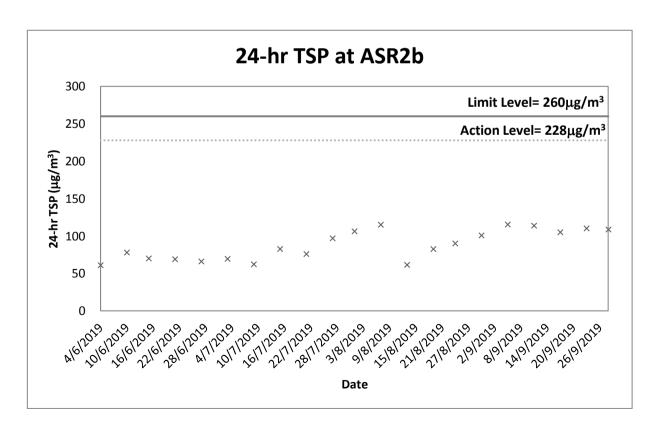
Graphical Plots of Impact Air Quality Monitoring Results

Generally, 1-hour TSP and 24-hour TSP monitoring results fluctuated well below the Action Level in this reporting period. The major dust source observed near the monitoring stations was mainly from vehicles passing by the container yards and general earth works. It can be concluded that the contractor implemented sufficient dust mitigation measures during this reporting month.

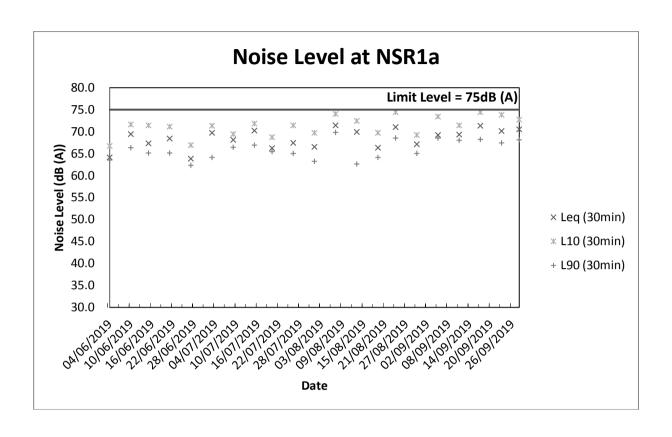
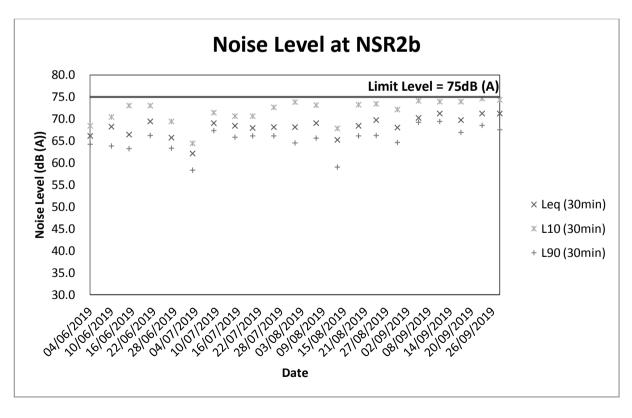
Graphical Plots of Impact Noise Monitoring Data

The noise monitoring data were found to be lower than the limit level. The major noise source during the monitoring event was the vehicles passing through the container yard entrance and the general earth works inside the construction site.

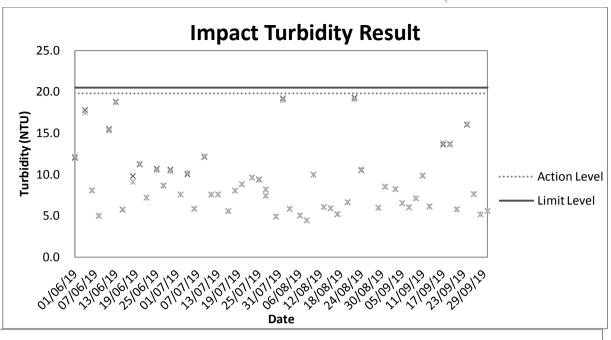
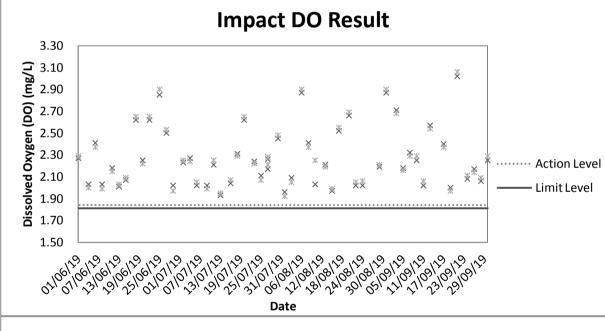
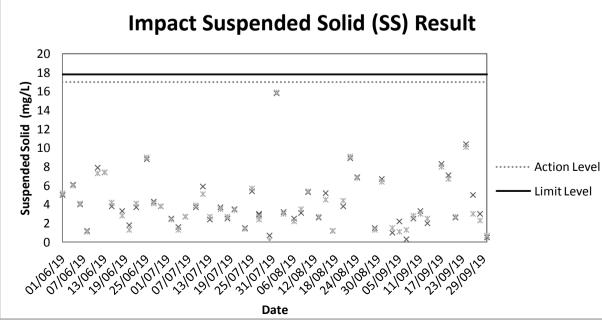
Graphical Plots of Impact Water Quality Monitoring Data

Generally, the turbidity and suspended solids were found to be lower than the action level. Besides, all results of dissolved oxygen measured in this reporting month were higher than the action level.

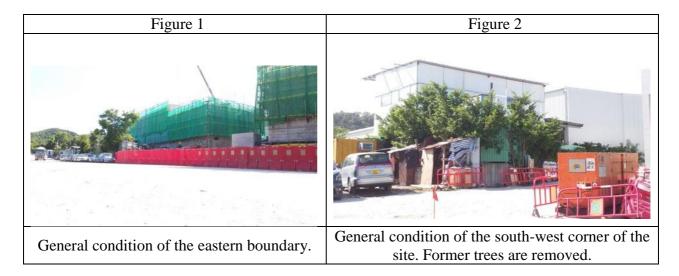
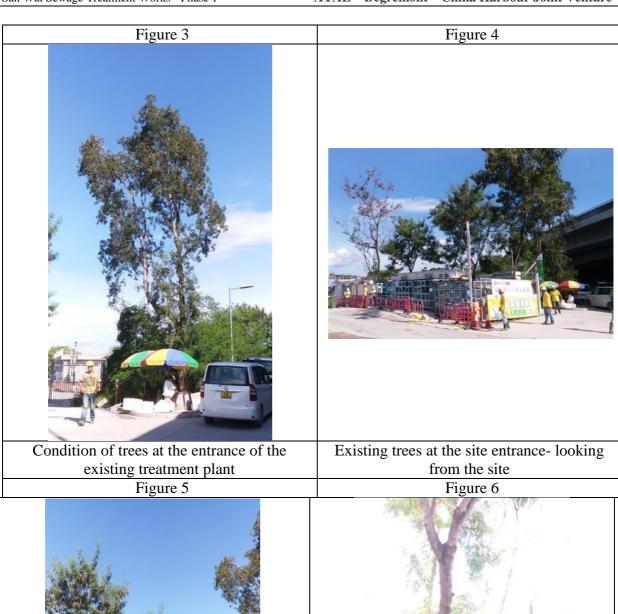
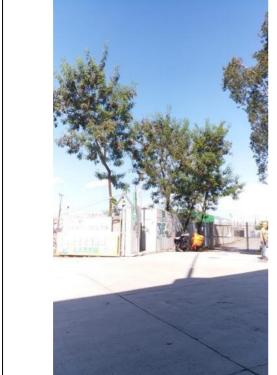
- 1. Contractor was reminded to provide TPZ with robust fence, whenever possible, at the drip line of all retained trees unless the trees are well beyond the extend of construction activities.
- 2. Contractor was reminded not to disturb trees outside site along the boundary.
- 3. It is noted that T11 (Leucaena leucocephala) was removed from the site.

Existing trees at the site entrance near the hoarding fence

Clearance of stored piles is noted in tree protection area.
