# ATAL-DEGREMONT-CHINA HARBOUR JOINT VENTURE

CONTRACT NO. DC/2013/10 - DESIGN, BUILD AND OPERATE SAN WAI SEWAGE TREATMENT WORKS – PHASE 1

> MONTHLY EM&A REPORT NO. 31

(01 OCTOBER - 31 OCTOBER 2019)

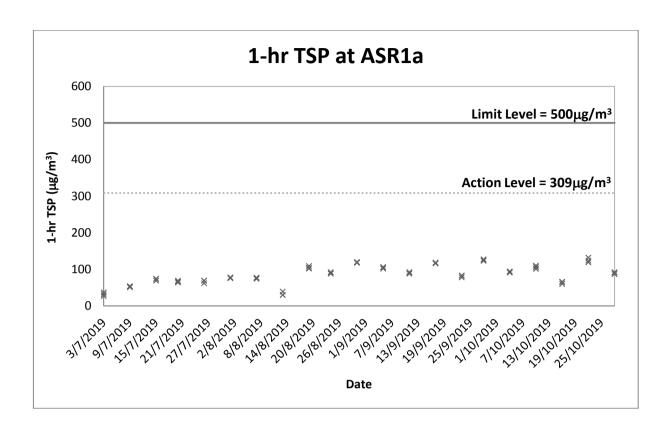
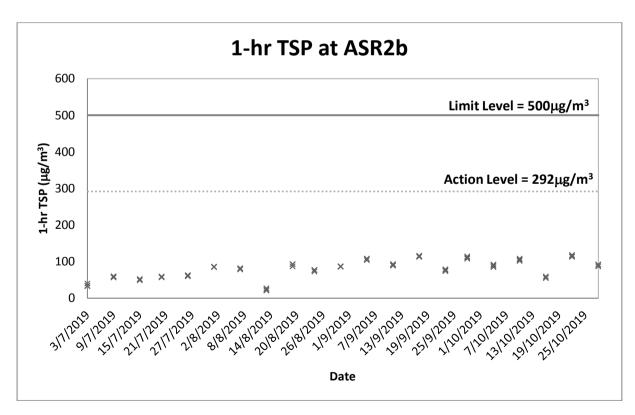
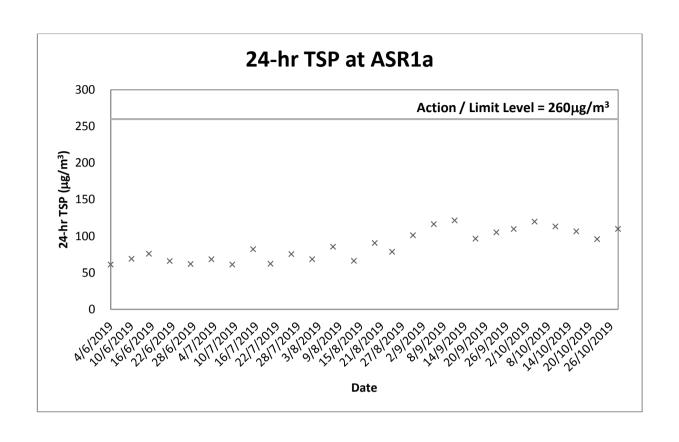
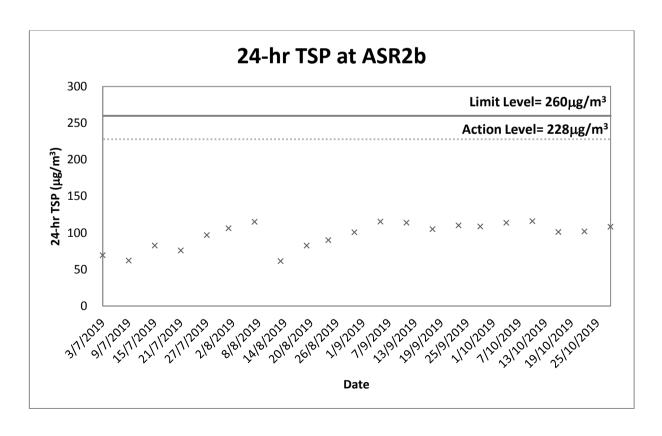
**Graphical Plots of Impact Air Quality Monitoring Results**

Generally, 1-hour TSP and 24-hour TSP monitoring results fluctuated well below the Action Level in this reporting period. The major dust source observed near the monitoring stations was mainly from vehicles passing by the container yards and general earth works. It can be concluded that the contractor implemented sufficient dust mitigation measures during this reporting month.

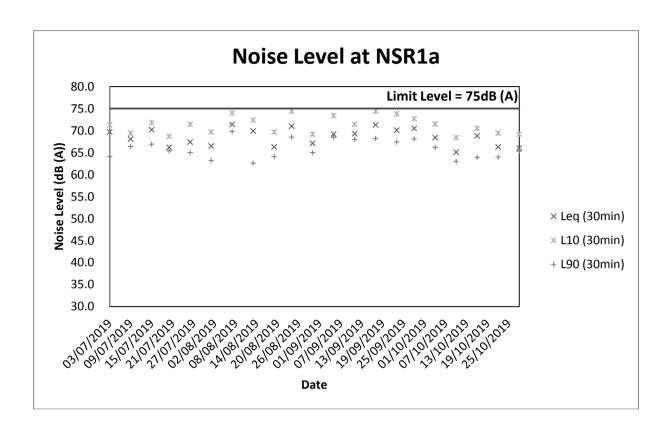
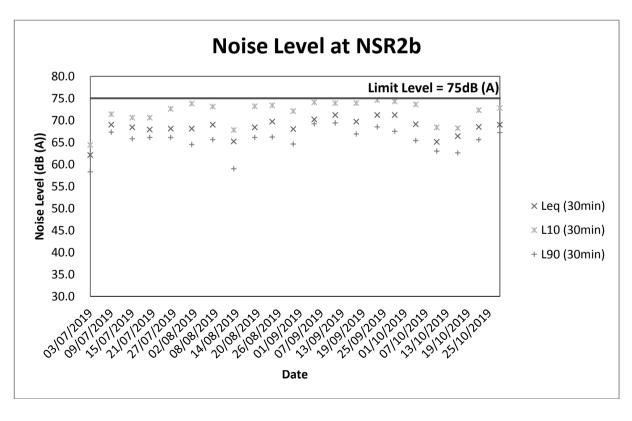
**Graphical Plots of Impact Noise Monitoring Data**

The noise monitoring data were found to be lower than the limit level. The major noise source during the monitoring event was the vehicles passing through the container yard entrance and the general earth works inside the construction site.

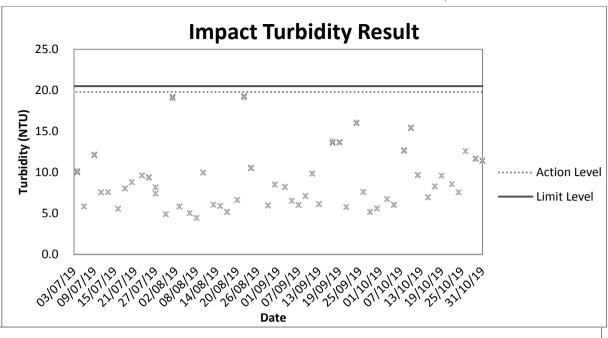
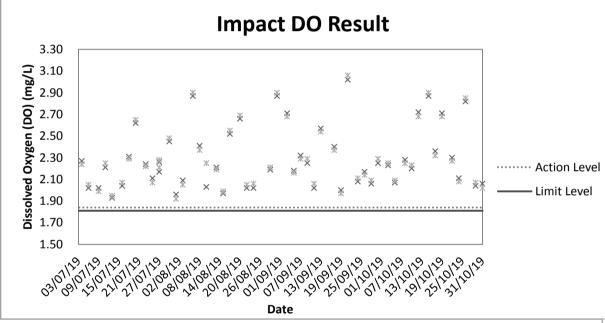
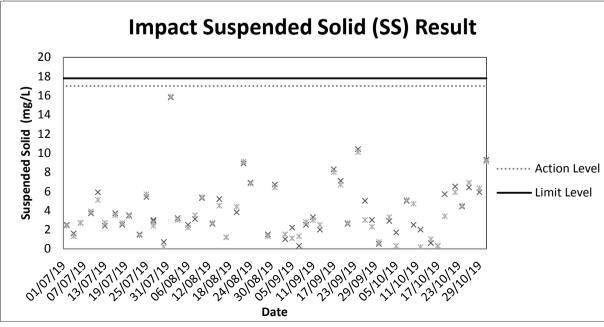
**Graphical Plots of Impact Water Quality Monitoring Data**

Generally, the turbidity and suspended solids were found to be lower than the action level. Besides, all results of dissolved oxygen measured in this reporting month were higher than the action level.

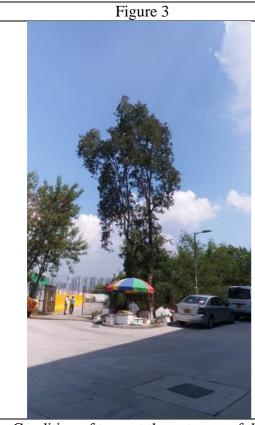
Condition of trees at the entrance of the existing treatment plant

- 1. Contractor was reminded to provide TPZ with robust fence, whenever possible, at the drip line of all retained trees unless the trees are well beyond the extend of construction activities.
- 2. Contractor was reminded not to disturb trees outside site along the boundary.

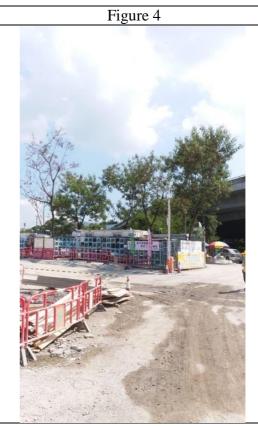
Existing trees at the site entrance- looking from the site

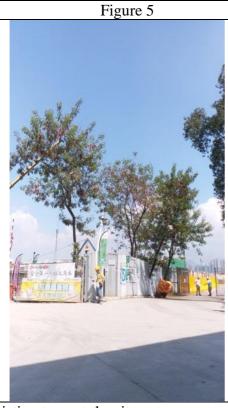
Existing trees at the site entrance near the hoarding fence

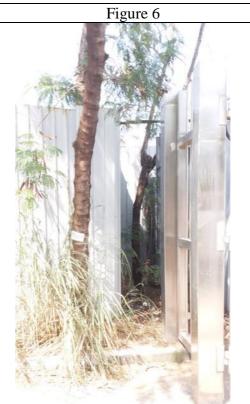
Clearance of stored piles is noted in tree protection area
