CONTRACT NO. DC/2013/10 - DESIGN, BUILD AND OPERATE SAN WAI SEWAGE TREATMENT WORKS – PHASE 1

> MONTHLY EM&A REPORT NO. 31

(01 NOVEMBER - 30 NOVEMBER 2019)

Report No.: ENA99774

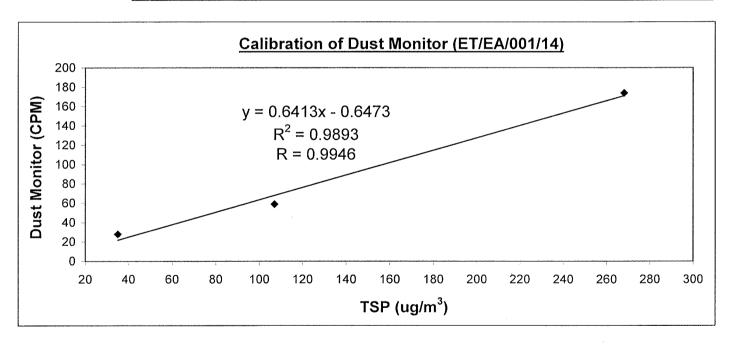
Dust Monitor (CPM)	28	59	174
TSP (ug/m³)	35	107	268
High Volume Air Sampler Serail No.: 1177	Calibratio	n Due Date: 28 Sep	tember 2019

Correlation coefficient (r) of the calibration curve greater than 0.990 after a three-point calibration

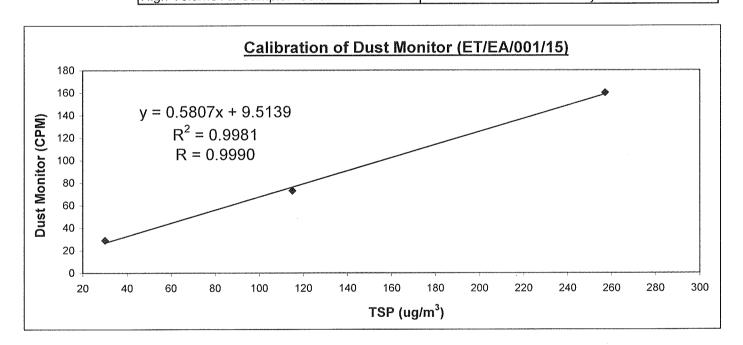
Dust Monitor (CPM)	29	73	160		
TSP (ug/m³)	30	115	257		
High Volume Air Sampler, Serail No. 1	L177 Calibrat	Calibration Due Date: 28 July 2019

Correlation coefficient (r) of the calibration curve greater than 0.990 after a three-point calibration

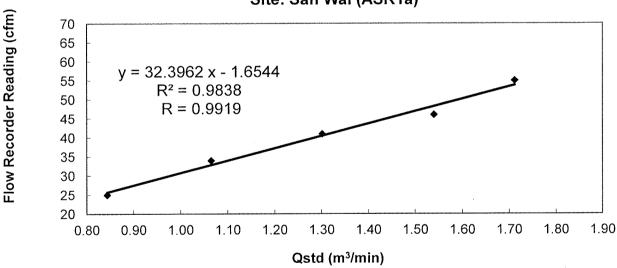
Sampler 1934 Calibration Curve Site: San Wai (ASR1a)

Flow recorder reading (cfm)			55	46	41	34	25
Qstd (Actual flow rate, m³/min)			1.71	1.54	1.30	1.06	0.84
Pressure: 767.31 mm		Hg	Temp. :		301	K

Acceptance Criteria: Correlation coefficient (r) of the calibration curve greater than 0.990 after a 5-point calibration.

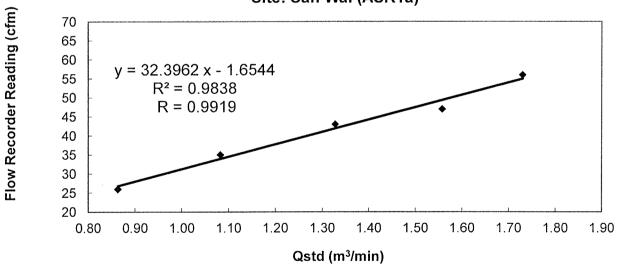
Sampler 1934 Calibration Curve Site: San Wai (ASR1a)

Flow recorder reading (cfm)			56	47	43	35	26
Qstd (Actual flow rate, m³/min)			1.73	1.56	1.33	1.08	0.86
Pressure :	767.31 n	767.31 mm Hg		Temp. :		297	K

Acceptance Criteria: Correlation coefficient (r) of the calibration curve greater than 0.990 after a 5-point calibration.

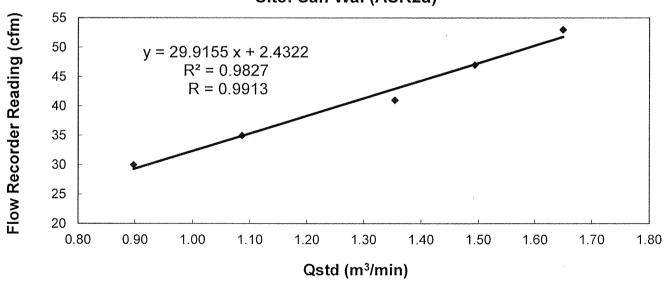
Sampler 9998 Calibration Curve Site: San Wai (ASR2a)

Flow recorder	53	47	41	35	30	
Qstd (Actual fl	1.65	1.49	1.35	1.09	0.90	
Pressure :	767.31 mm Hg		Temp. :	301	K

Acceptance Criteria: Correlation coefficient (r) of the calibration curve greater than 0.990 after a 5-point calibration.

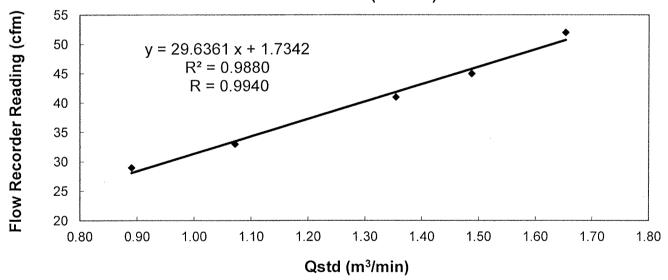
Sampler 9998 Calibration Curve Site: San Wai (ASR2a)

Flow recorder	52	45	41	33	29	
Qstd (Actual flow rate, m³/min)		1.65	1.49	1.35	1.07	0.89
Pressure :	767.31 mm Hg		Temp. :	297	K

Acceptance Criteria: Correlation coefficient (r) of the calibration curve greater than 0.990 after a 5-point calibration.

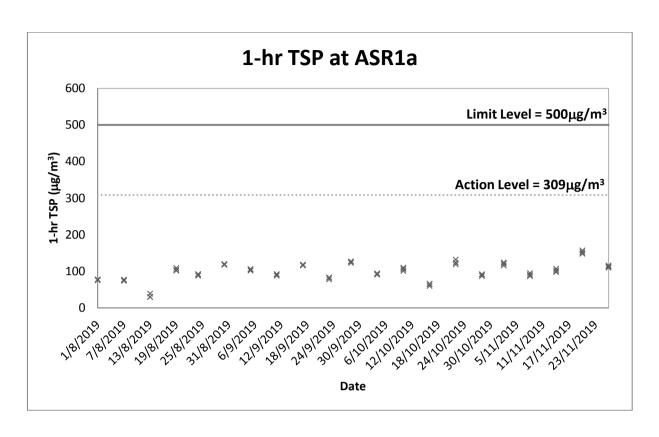
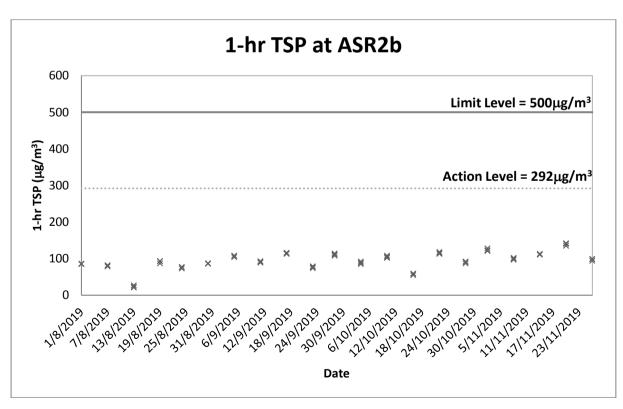
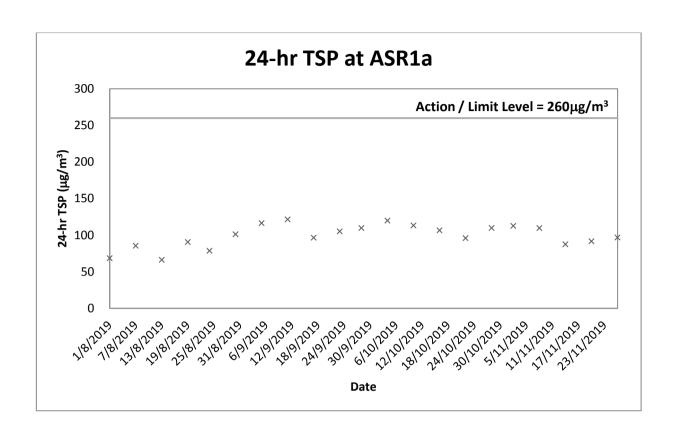
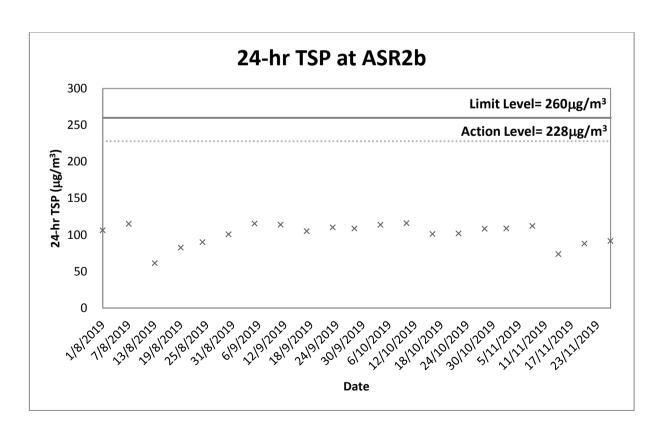
Graphical Plots of Impact Air Quality Monitoring Results

Generally, 1-hour TSP and 24-hour TSP monitoring results fluctuated well below the Action Level in this reporting period. The major dust source observed near the monitoring stations was mainly from vehicles passing by the container yards and general earth works. It can be concluded that the contractor implemented sufficient dust mitigation measures during this reporting month.

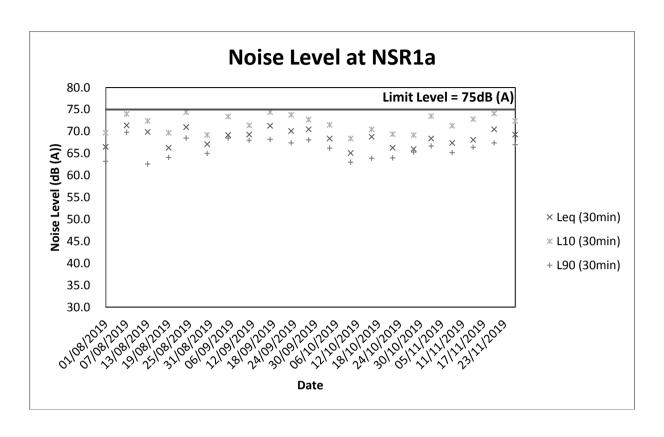
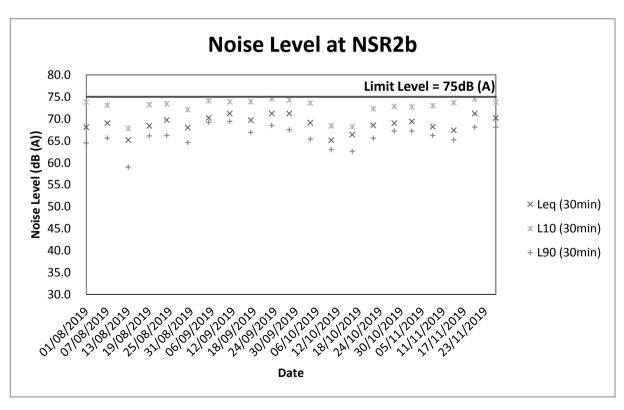
Graphical Plots of Impact Noise Monitoring Data

The noise monitoring data were found to be lower than the limit level. The major noise source during the monitoring event was the vehicles passing through the container yard entrance and the general earth works inside the construction site.

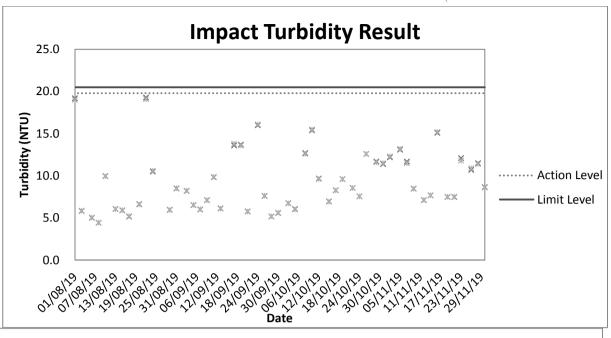
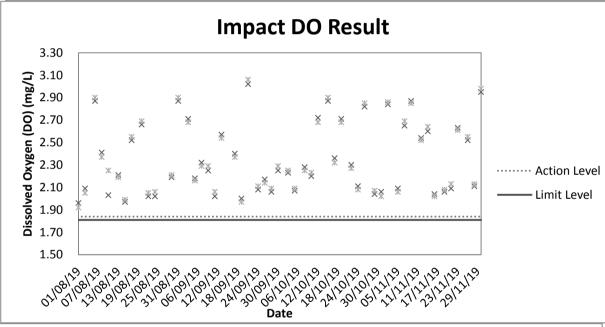
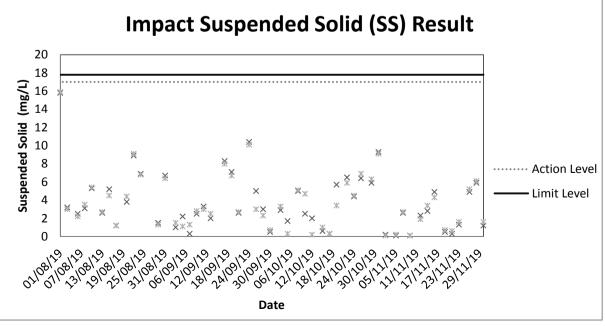
Graphical Plots of Impact Water Quality Monitoring Data

Generally, the turbidity and suspended solids were found to be lower than the action level. Besides, all results of dissolved oxygen measured in this reporting month were higher than the action level.

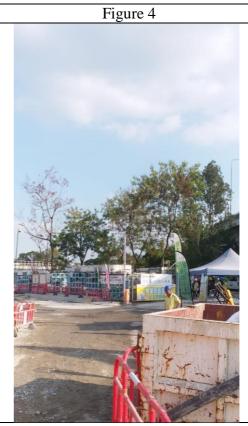
Condition of trees at the entrance of the existing treatment plant
Figure 5

Existing trees at the site entrance- looking from the site

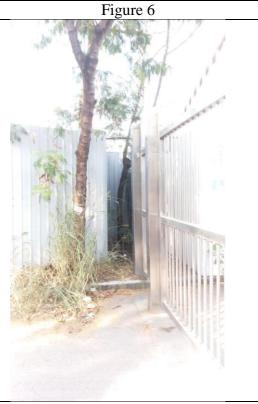
Clearance of stored piles is noted in tree protection area

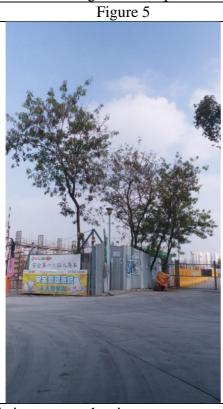
Existing trees at the site entrance near the hoarding fence

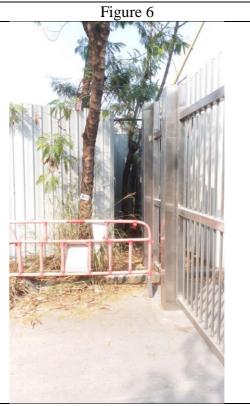
Clearance of stored piles is noted in tree protection area

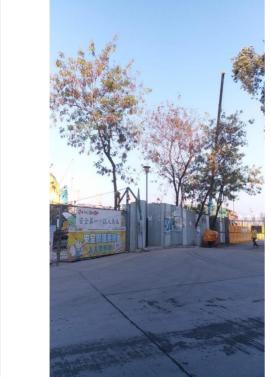
Existing trees at the site entrance near the hoarding fence

- 1. Contractor was reminded to provide TPZ with robust fence, whenever possible, at the drip line of all retained trees unless the trees are well beyond the extend of construction activities.
- 2. Contractor was reminded not to disturb trees outside site along the boundary.

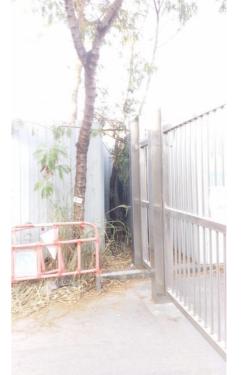
Clearance of stored piles is noted in tree protection area
