CONTRACT NO. DC/2013/10 - DESIGN, BUILD AND OPERATE SAN WAI SEWAGE TREATMENT WORKS – PHASE 1

> MONTHLY EM&A REPORT NO. 36

(01 APRIL - 30 APRIL 2020)

Report No.: ENA03764

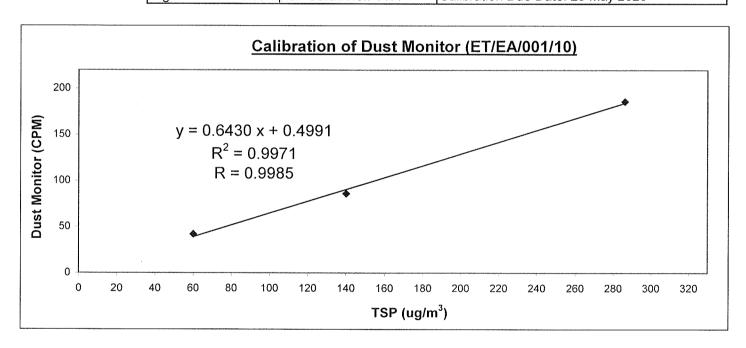
and High Volume Air Samper together under the same environmental condition

Dust Monitor (CPM)	42	86	186
TSP (ug/m³)	60	140	286
High Volume Air Sampler, Serail No	1177 Calibratio	on Due Date: 20 May	, 2020

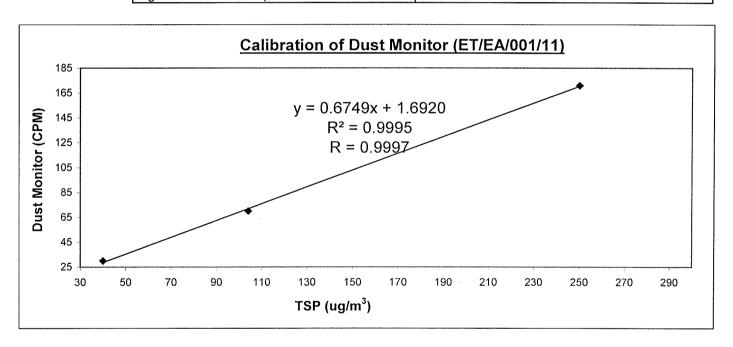
and High Volume Air Samper together under the same environmental condition

Dust Monitor (CPM)	30	70	171
TSP (ug/m³)	40	104	250
High Volume Air Sampler Serail No.:1177	Calibratio	n Due Date: 29 Nov	ember 2019

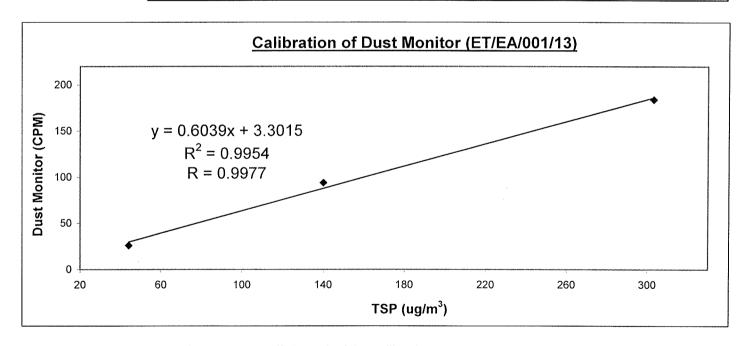
and High Volume Air Samper together under the same environmental condition

Dust Monitor (CPM)	26	94	184
TSP (ug/m³)	44	140	303
High Volume Air Sampler Serail No.: 1177	Calibration	Due Date: 29 Jan	nuary 2020

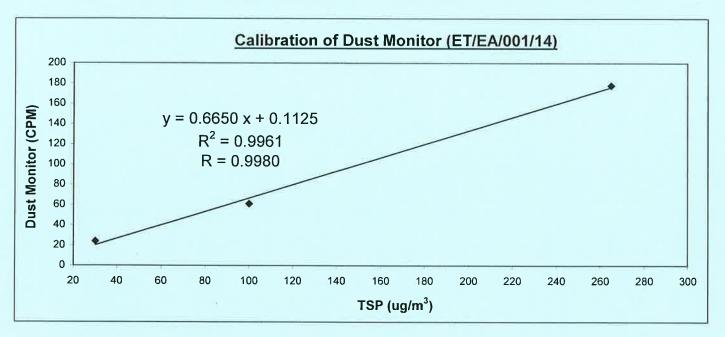
and High Volume Air Samper together under the same environmental condition

Dust Monitor (CPM)	24	61	178
TSP (ug/m³)	30	100	265
High Volume Air Sampler Serail No.: 1	177 Calibrati	on Due Date: 29 Mar	ch 2020

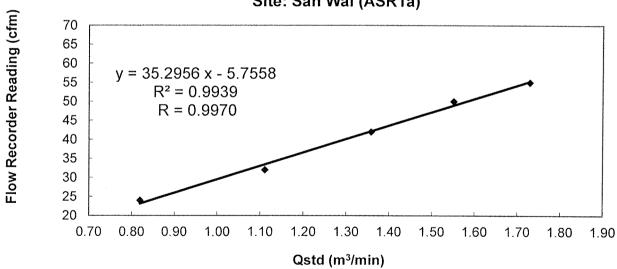
Sampler 1934 Calibration Curve Site: San Wai (ASR1a)

Flow recorder reading	g (cfm)	55	50	42	32	24
Qstd (Actual flow rate	e, m³/min)	1.73	1.55	1.36	1.11	0.82
Pressure :	767.31	mm Hg	Temp. :		292	K

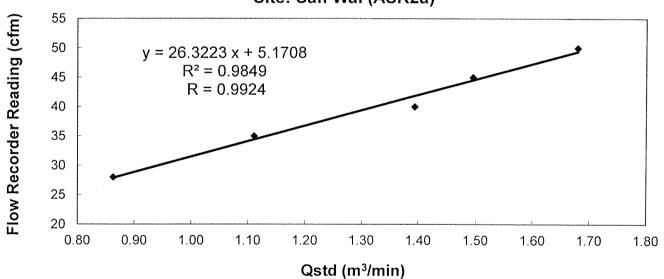
Sampler 9998 Calibration Curve Site: San Wai (ASR2a)

Flow recorder reading (cfm)		50	45	40	35	28
Qstd (Actual flow rate, m³/min)		1.68	1.49	1.39	1.11	0.86
Pressure:	767.31 mm Hg		Temp. :	292	K

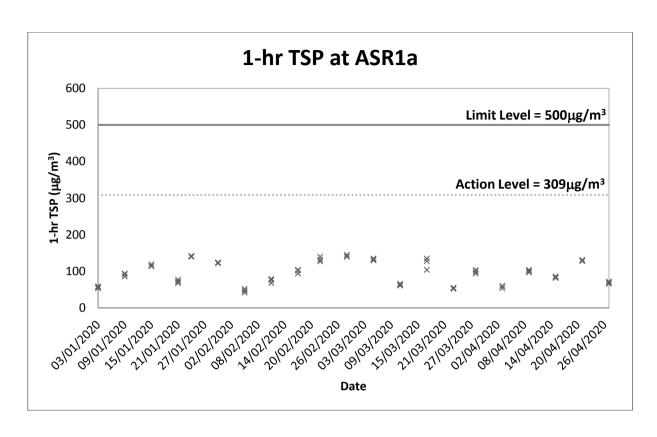
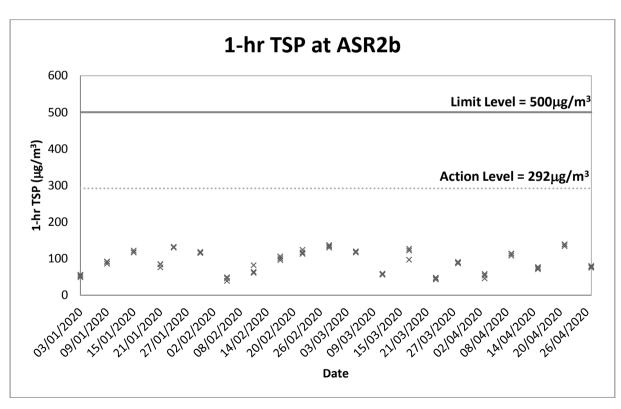
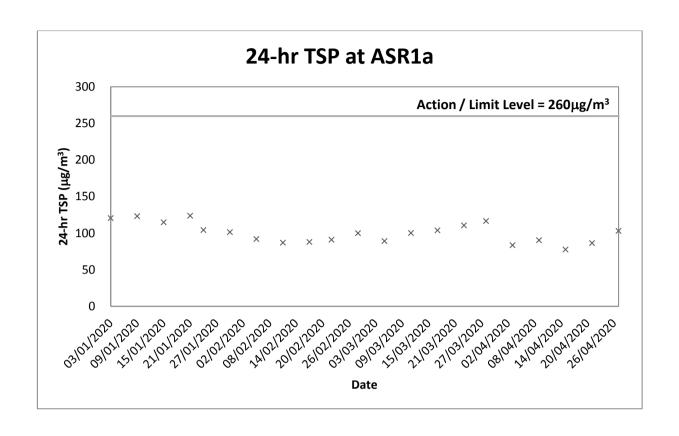
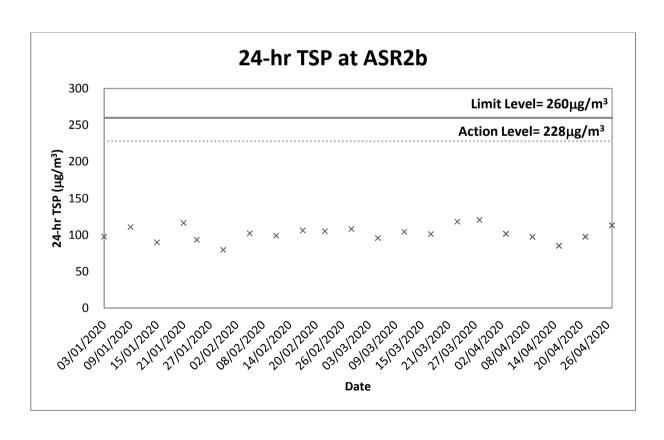
Graphical Plots of Impact Air Quality Monitoring Results

Generally, 1-hour TSP and 24-hour TSP monitoring results fluctuated well below the Action Level in this reporting period. The major dust source observed near the monitoring stations was mainly from vehicles passing by the container yards and general earth works. It can be concluded that the contractor implemented sufficient dust mitigation measures during this reporting month.

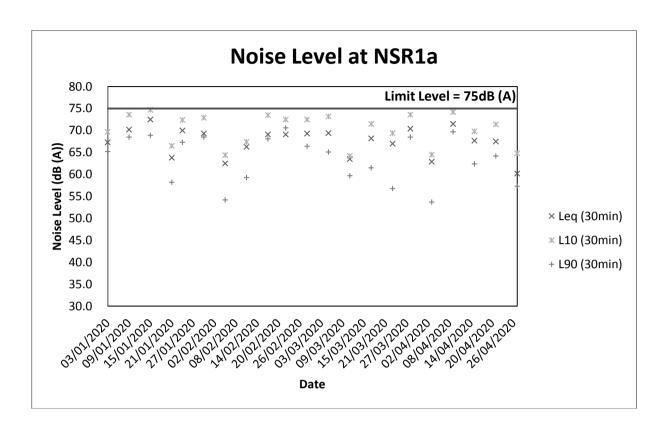
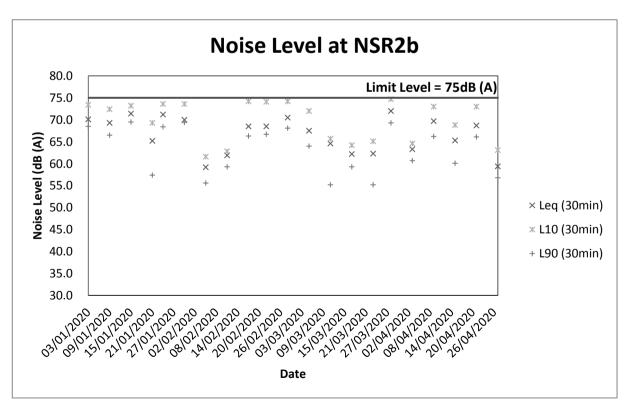
Graphical Plots of Impact Noise Monitoring Data

The noise monitoring data were found to be lower than the limit level. The major noise source during the monitoring event was the vehicles passing through the container yard entrance and the general earth works inside the construction site.

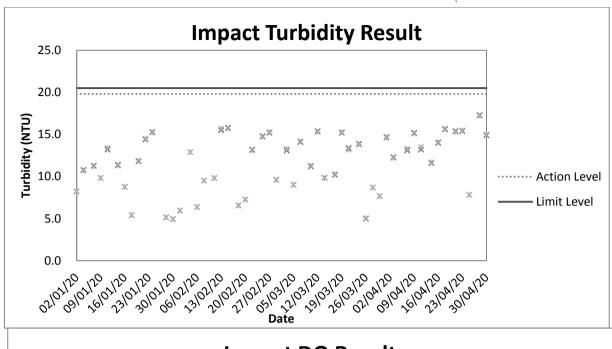
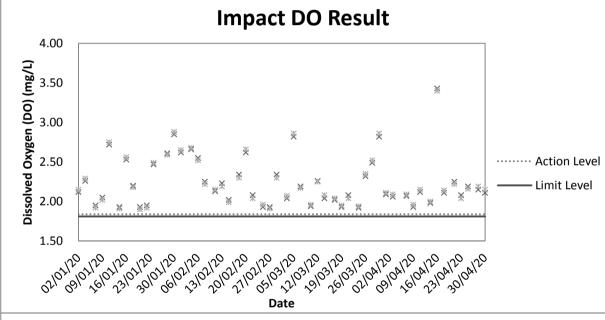
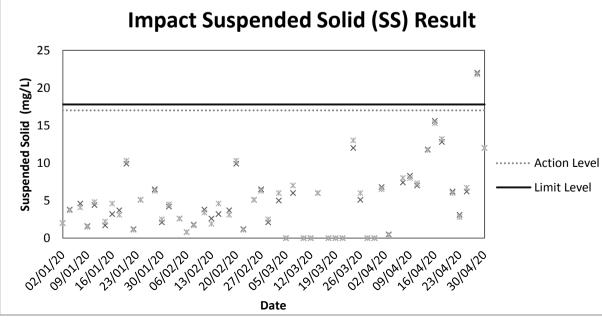
Graphical Plots of Impact Water Quality Monitoring Data

According to the summary of water monitoring results, there was one limit level exceedance of suspended solid at station R1b on 28 April 2020. After investigation, there was concluded that the exceedance was not relevant to this Contract since the results of effluent water sample sampled on 28 April 2020 at both P1 and P8 complied with the discharge license requirement and thus the effluent discharged from the construction site was unlikely to deteriorate the water quality of Tin Shui Wai nullah and resulted in suspended solids exceedance at R1b. Besides, the surface runoff and wastewater generated from the construction activities in different sections of the construction sites was collected and stored in the temporary storage pool and then transferred to the Wetsep for proper treatment prior to discharge. Therefore, the exceedance of water samples taken from 13:20 to 13:34pm on 28 April 2020 was considered as non-Project related. The Investigation Reports No. 004 (including the causes of exceedance, action taken and recommendation for mitigation) for Action or Limit Level Non-compliance were provided in **Appendix O**. Other than the above exceedance, no exceedance of Action and Limit level was recorded in the reporting month.

Generally, the turbidity and suspended solids were found to be lower than the action level. Besides, all results of dissolved oxygen measured in this reporting month were higher than the action level.

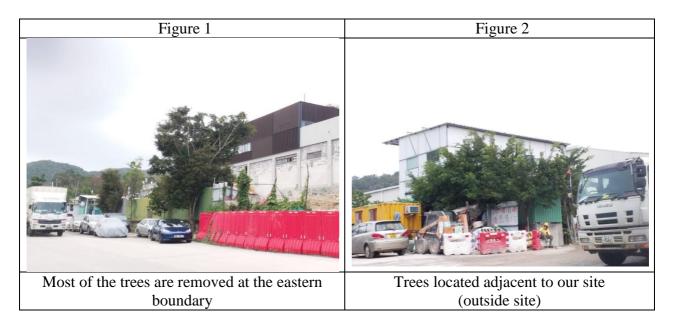
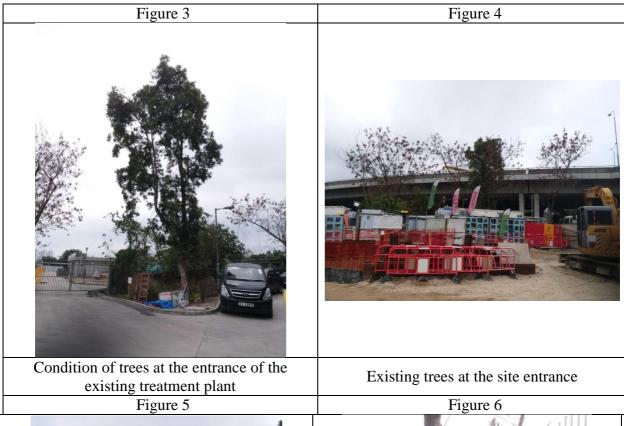
Existing trees at the site entrance near the hoarding fence

- 1. Contractor was reminded to provide TPZ with robust fence, whenever possible, at the drip line of all retained trees unless the trees are well beyond the extend of construction activities
- 2. Contractor was reminded not to disturb trees outside site along the boundary.

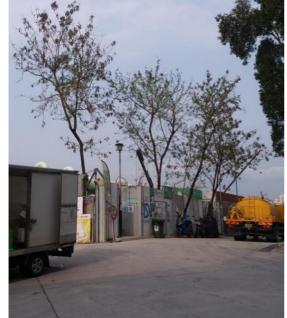
Figure 5

Existing trees at the site entrance near the hoarding fence

- 1. Contractor was reminded to provide TPZ with robust fence, whenever possible, at the drip line of all retained trees unless the trees are well beyond the extend of construction activities.
- 2. Contractor was reminded not to disturb trees outside site along the boundary.

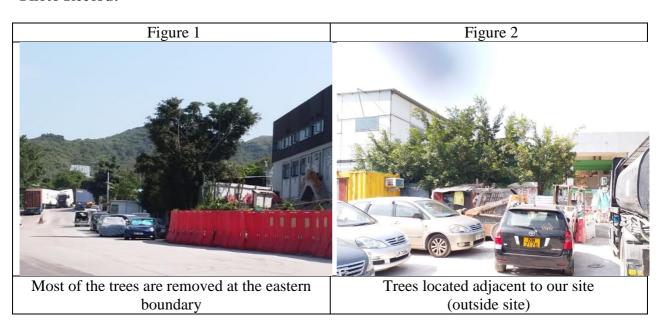
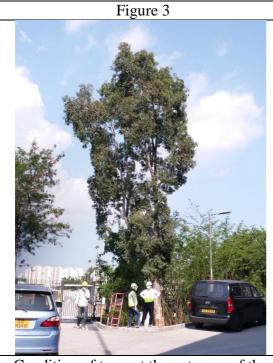
Condition of trees at the entrance of the existing treatment plant

- 1. Contractor was reminded to provide TPZ with robust fence, whenever possible, at the drip line of all retained trees unless the trees are well beyond the extend of construction activities.
- 2. Contractor was reminded not to disturb trees outside site along the boundary.
