CONTRACT NO. DC/2013/10 - DESIGN,
BUILD AND OPERATE SAN WAI
SEWAGE TREATMENT WORKS –
PHASE 1

**QUARTERLY EM&A REPORT
NO. 13**

(01 MAY 2020 – 31 JULY 2020)

Report No.: ENA06118

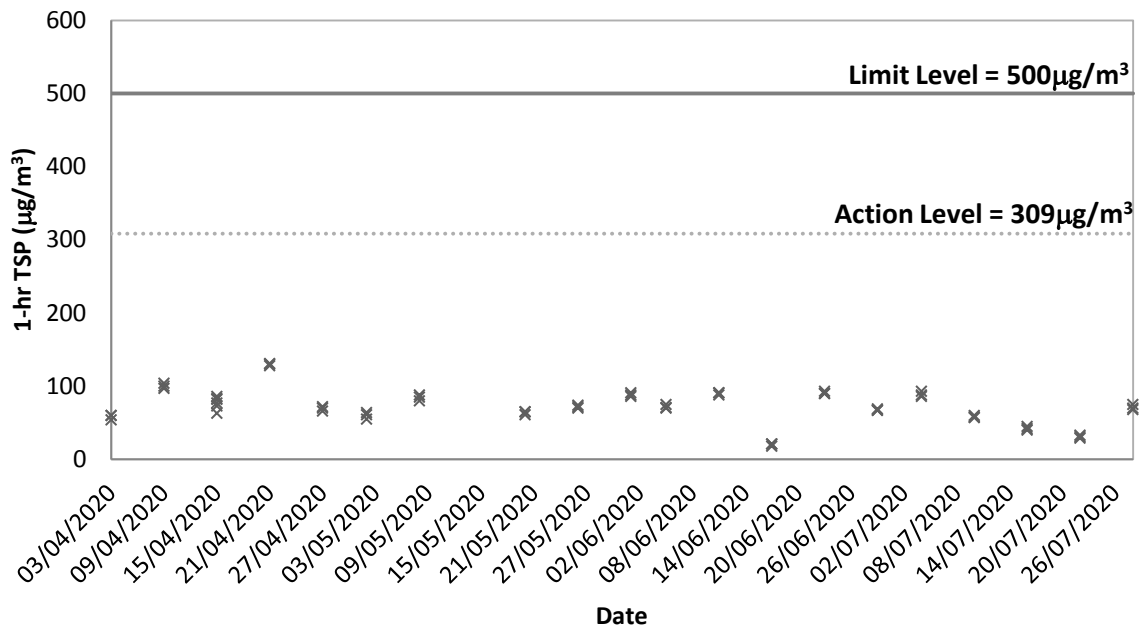
1-hr TSP at ASR1a

3.1.2. Generally, 1-hour TSP and 24-hour TSP monitoring results fluctuated well below the Action Level in this reporting period. The major dust source observed near the monitoring stations was mainly from vehicles passing by the container yards and general earth works. It can be concluded that the contractor implemented sufficient dust mitigation measures during this reporting quarter.

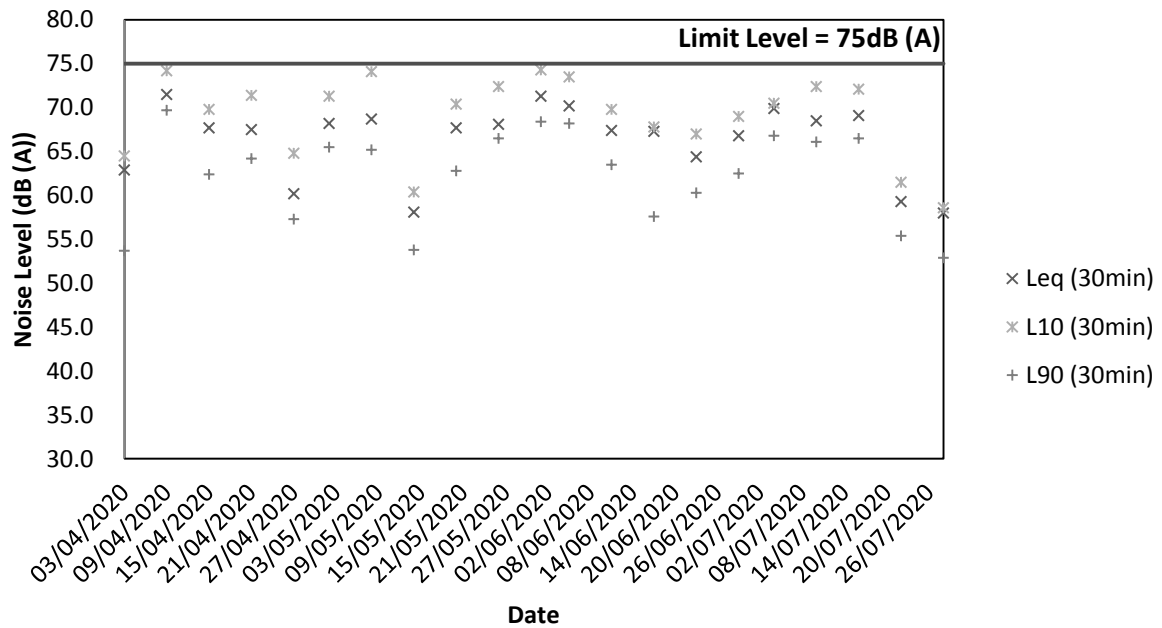
Noise Level at NSR1a

3.2.2. The noise monitoring data were found to be lower than the limit level. The major noise source during the monitoring event was the vehicles passing through the container yard entrance and the general earth works inside the construction site.

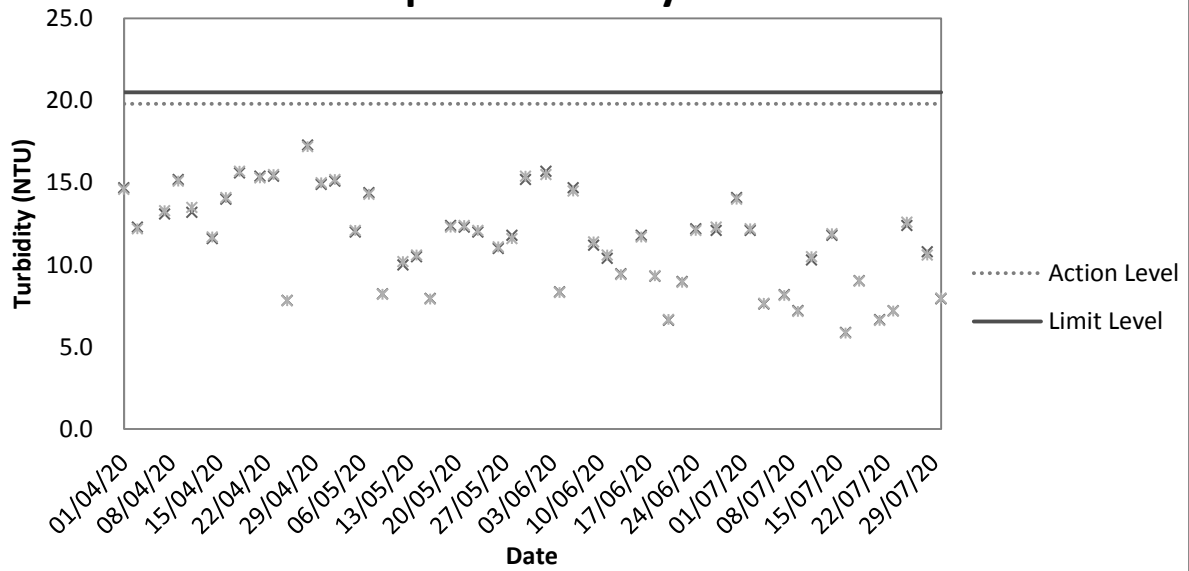
Impact Turbidity Result

- 3.3.2.** Generally, the turbidity and suspended solids were found to be lower than the action level. Besides, all results of dissolved oxygen measured in this reporting period were higher than the action level.
- 3.3.3.** Aside from the discharge, weather condition would be a major factor that affects the water quality in Tin Shui Wan Nallah. In rainy day, the soil and other suspended materials were flushed along the shore and entered the Tin Shui Wai Nallah. Besides, the nallah water would flow rapidly and the sand and stones in the nallah bed were upturned. Thus, the water quality would be deteriorated.

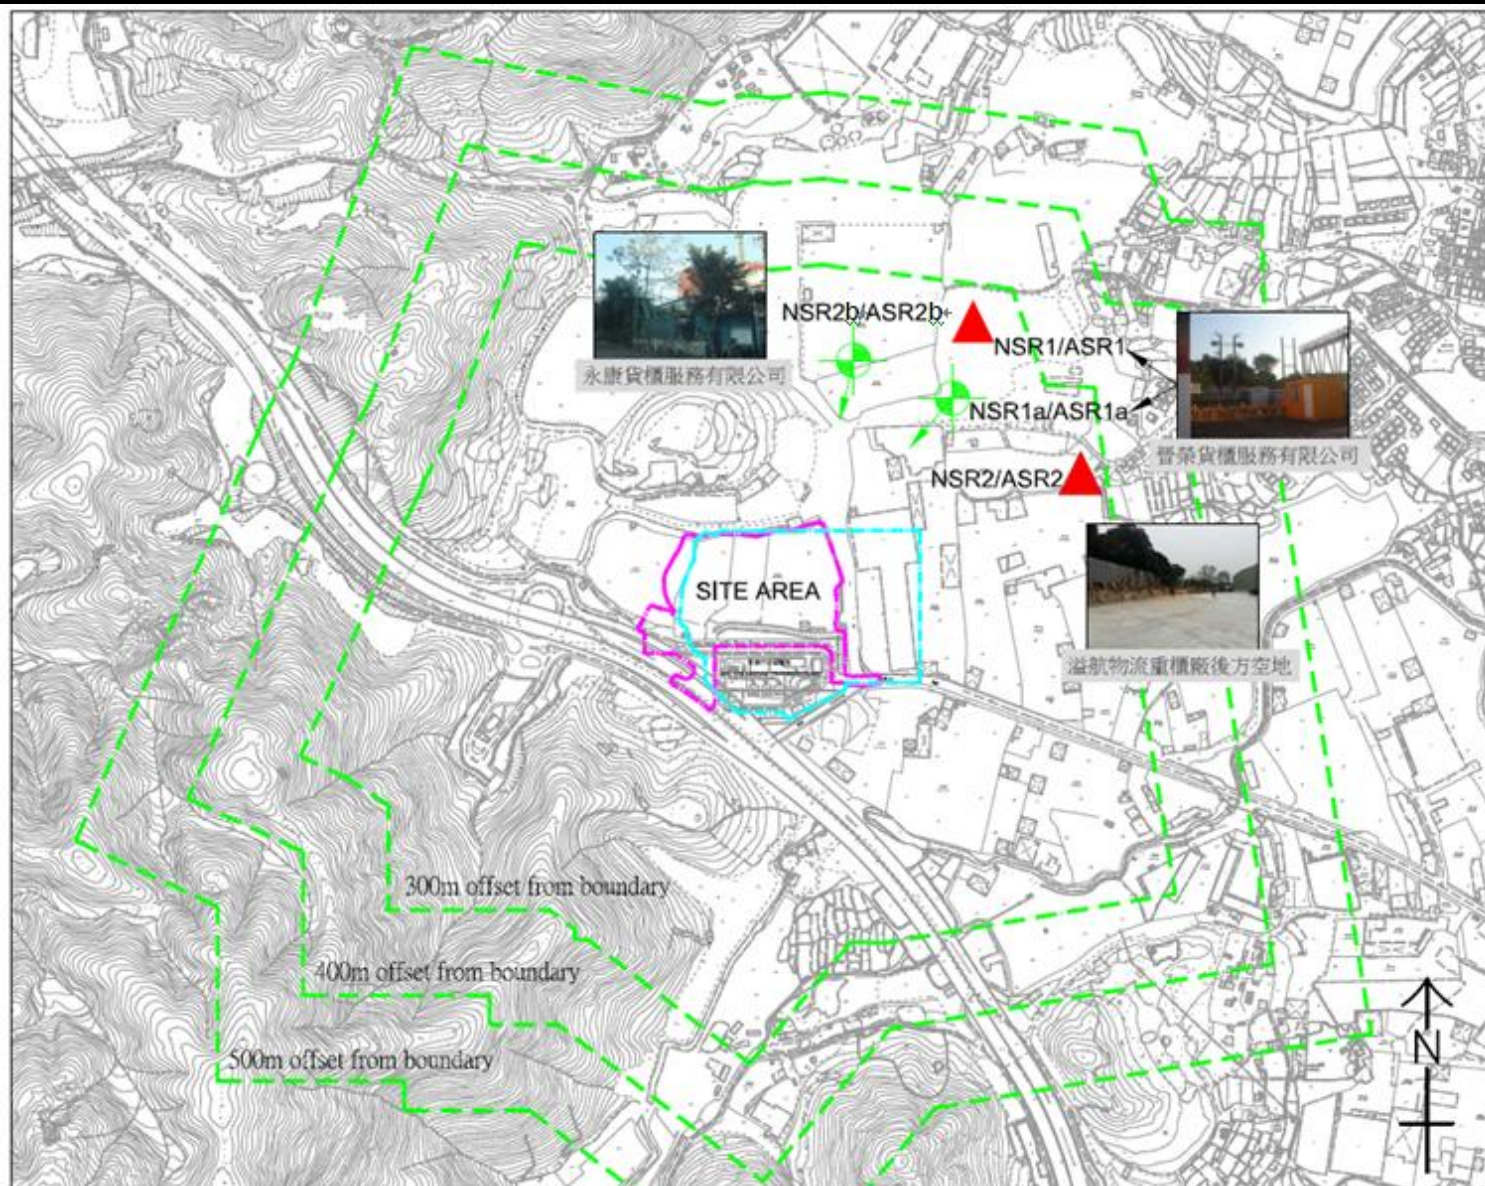
Locations of Air Quality and Noise Monitoring Stations

In accordance with the EM&A Manual, 1-hr and 24-hr TSP air quality monitoring were conducted three times and once per six days correspondingly. Air quality monitoring were conducted at ASR1a (晉榮貨櫃服務有限公司) and ASR2b (永康貨櫃服務有限公司), which was shown in **Figure 1** and **Figure 2**.

Noise levels (L_{eq} , L_{10} and L_{90}) were monitored in the reporting period in accordance with the EM&A Manual. Noise monitoring were performed at NSR1a (晉榮貨櫃服務有限公司) and NSR2b (永康貨櫃服務有限公司), which was shown in **Figure 1** and **Figure 2**.

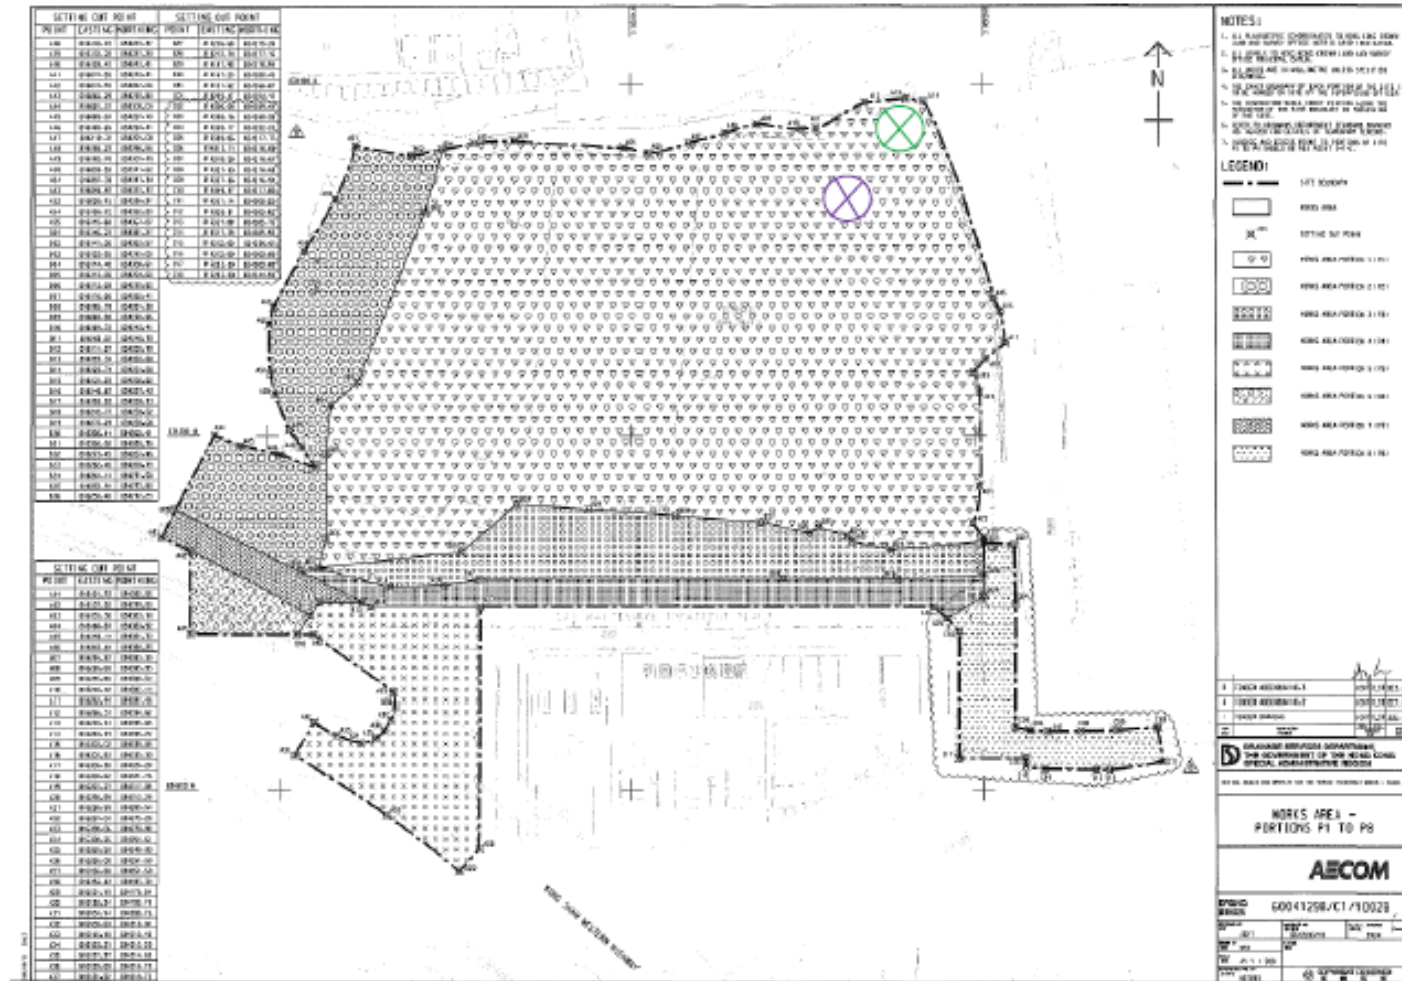
Figure 3

Location Plan for the Wetsep Treatment Tank

3.7.1. Effluent quality was monitored in the reporting quarter in accordance with the EM&A Manual at the discharge point. The location of Wetsep treatment tank was shown in **Figure 3**. A discharge license under Water Pollution Control Ordinance was obtained by the Contractor upon commencement of the Project. Self-monitoring would be performed as per the requirement under the discharge license. According to the EM&A Manual, pH, chemical oxygen demand and total suspended solid are required to be analysed at least once every two week.
