# ATAL-DEGREMONT-CHINA HARBOUR JOINT VENTURE

CONTRACT NO. DC/2013/10 - DESIGN, BUILD AND OPERATE SAN WAI SEWAGE TREATMENT WORKS – PHASE 1

> MONTHLY EM&A REPORT NO. 41

(01 SEPTEMBER - 30 SEPTEMBER 2020)

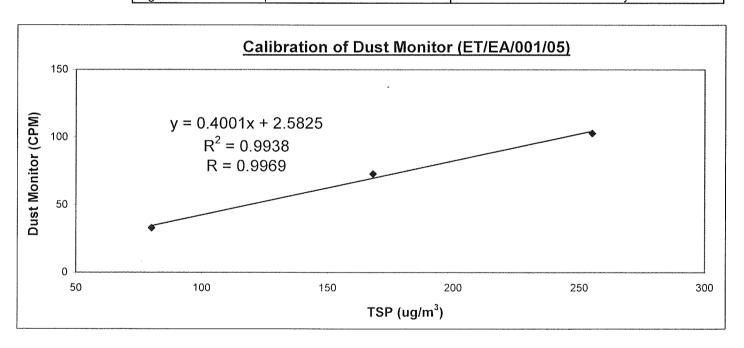
:	Dust Monitor (CPM)	33	73	103
	TSP (ug/m³)	80	168	255
	High Volume Air Sampler Serail No.: 1177	Calibration Due Date: 29 May 2020

Correlation coefficient (r) of the calibration curve greater than 0.990

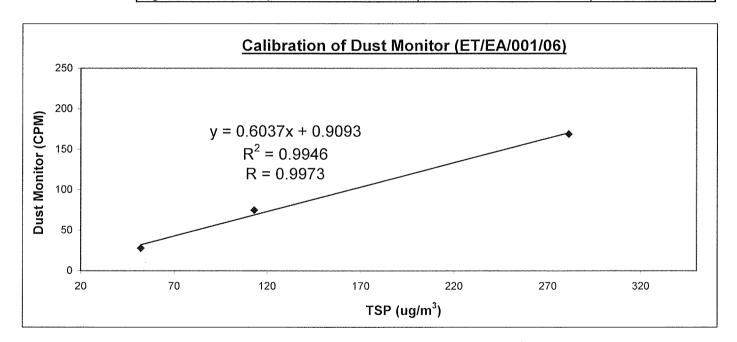
Dust Monitor (CPM)		28	75	169
TSP (ug/m³)		52	113	281
High Volume Air Sampler Serail No : 1177		Calibration	n Due Date: 29 May	2020

Correlation coefficient (r) of the calibration curve greater than 0.990 after

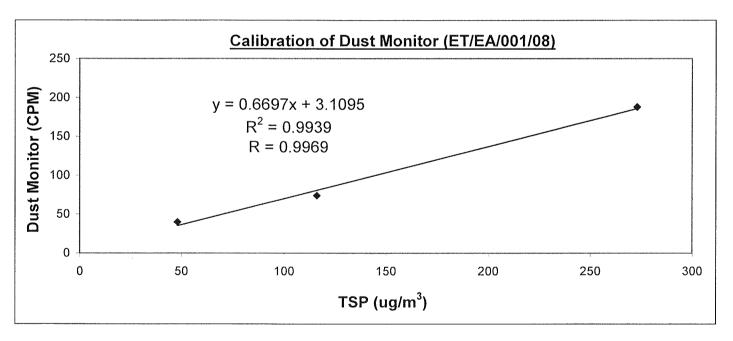
Dust Monitor (CPM)	40	74	188
TSP (ug/m³)	48	116	273
High Volume Air Campler Caroll No :15	177 Colibratio	n Dua Data: 20 Mar	-ah 2020

Correlation coefficient (r) of the calibration curve greater than 0.990

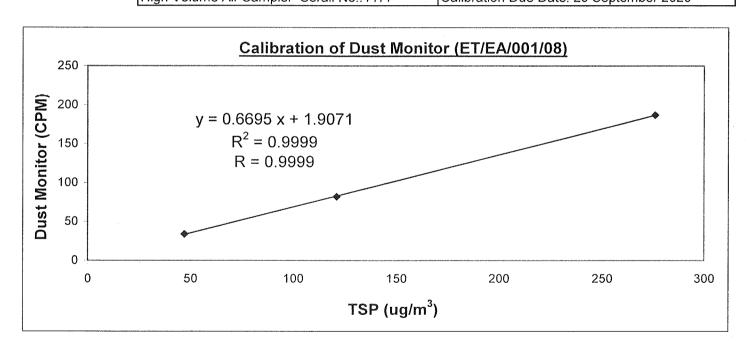
Dust Monitor (CPM)	34	82	187
TSP (ug/m³)	47	121	276
High Volume Air Sampler, Serail No.:11	77 Calibratio	on Due Date: 29 Ser	otember 2020

Correlation coefficient (r) of the calibration curve greater than 0.990

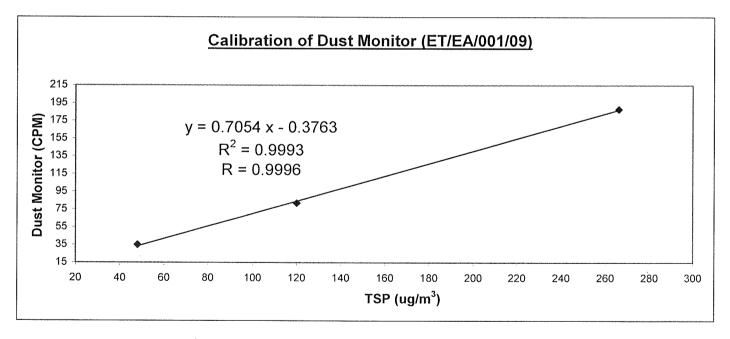
Dust Monitor (CPM)	35	82	188
TSP (ug/m <sup>3</sup> )	48	120	266
High Volume Air Sampler Serail No.: 1177	Calibration Due Date: 29 May 2020

Correlation coefficient (r) of the calibration curve greater than 0.990 after a three-point calibration

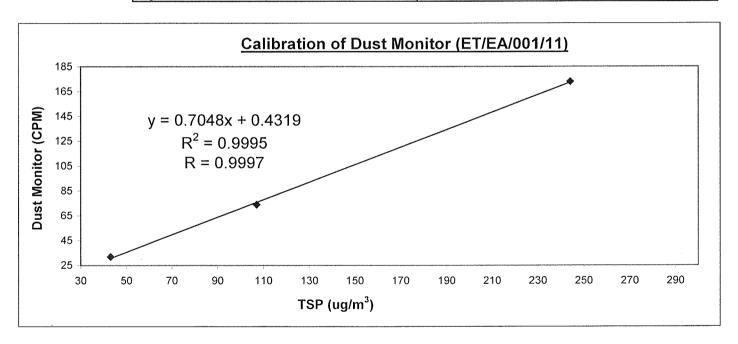
Dust Monitor (CPM)	32	74	173
TSP (ug/m³)	43	107	244
High Volume Air Sampler Serail No :117	77 Calibratio	on Due Date: 29 May	, 2020

Correlation coefficient (r) of the calibration curve greater than 0.990 after a three-point calibration

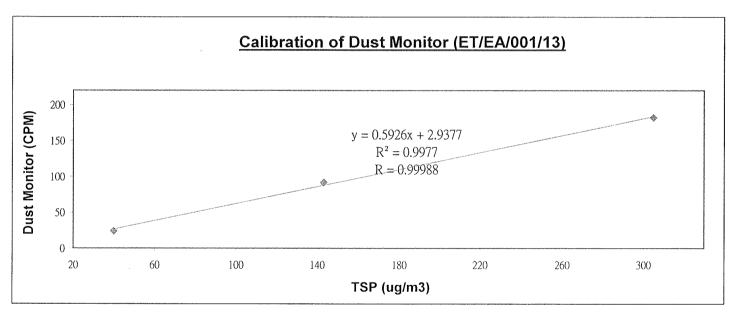
: Dust M	onitor (CPM)		24	92		182
TSP (u	g/m <sup>3</sup> )		40	143		305
High Volume Air Sampler, Sorail No.: 1177, Calibration Due Date: 20 July 2020

Correlation coefficient (r) of the calibration curve greater than 0.990 after a three-point calibration

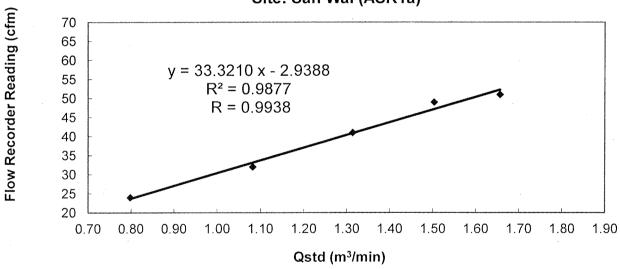
### Sampler 1934 Calibration Curve Site: San Wai (ASR1a)

Flow recorder readir	ng (cfm)		51	49	41	32	24
Qstd (Actual flow rat	re, m³/min)		1.66	1.50	1.31	1.08	0.80
Pressure :	755.31	mm	Hg	Temp.:		303	K

Acceptance Criteria: Correlation coefficient (r) of the calibration curve greater than 0.990 after a 5-point calibration.

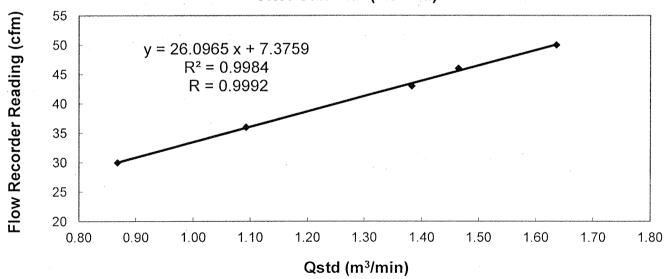
### Sampler 9998 Calibration Curve Site: San Wai (ASR2a)

Flow recorder reading (cfm)		50	46	43	36	30
Qstd (Actual flow rate, m³/min)		1.64	1.46	1.38	1.09	0.87
Pressure:	755.31 mm Hg		Temp.:	303	K

Acceptance Criteria: Correlation coefficient (r) of the calibration curve greater than 0.990 after a 5-point calibration.

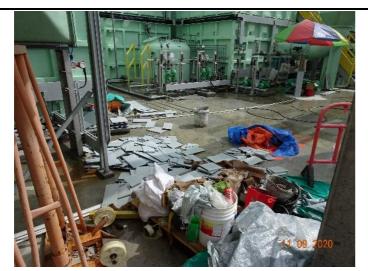
C&D materials were found discarded near EB1, EB2 and DO2.

Follow up action to item 2 on 04/09/2020, stagnant water was cleared near CEPT and outside AB.				
1		To collect the C&D materials properly	200911_002	Yes	17/09/2020

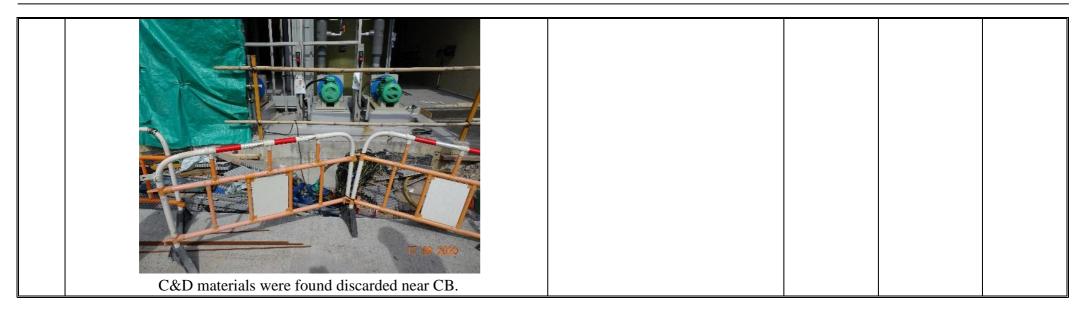
Follow up action to item 1 on 11/09/2020, C&D materials were collected near EB1, EB2 and DO2.				
1		To collect the C&D materials properly	200917_002	Yes	24/09/2020

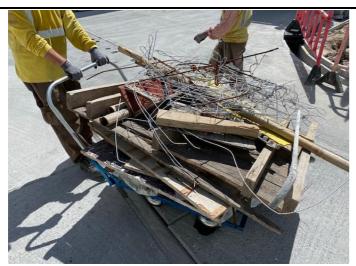
Item	Details of observations	Follow Up Action	Photo Ref.	Further Action Required (Yes/No)	Proposed Follow up Date
			200924_001

Follow up action to item 1 on 17/09/2020, C&D materials were collected near CB.

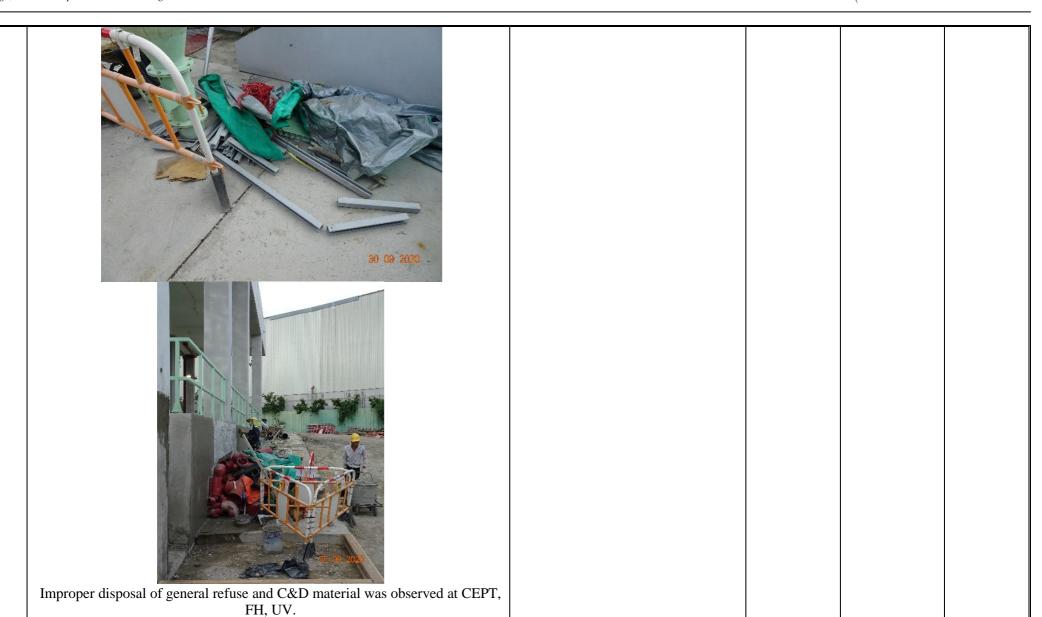
Item	Details of observations	Follow Up Action	Photo Ref.	Further Action Required (Yes/No)	Proposed Follow up Date
1	Stagnant water was observed in the keyhole.	To clear the stagnant water properly	200930_001	Yes	09/10/2020
2	30 09 2020	To collect the C&D materials properly	200930_002	Yes	09/10/2020

3	Improper storage of chemical was observed at UV.	To store the chemical properly	200930_003	Yes	09/10/2020
4	Oil spillage was observed at SDB.	To handle the oil spillage properly	200930_004	Yes	09/10/2020

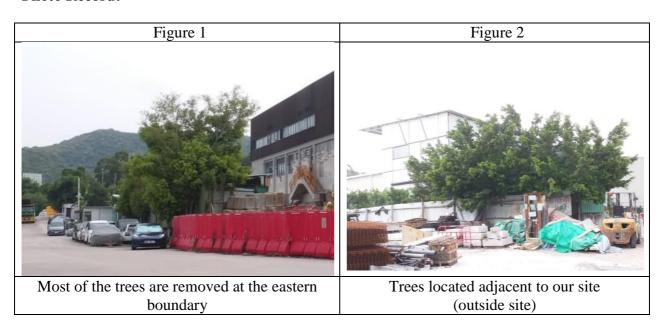
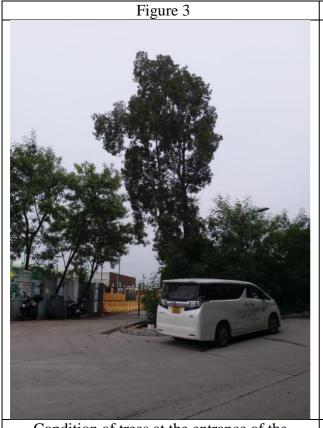
#### **Photo Record:**

- 1. Contractor was reminded to provide TPZ with robust fence, whenever possible, at the drip line of all retained trees unless the trees are well beyond the extend of construction activities.
- 2. Contractor was reminded not to disturb trees outside site along the boundary.

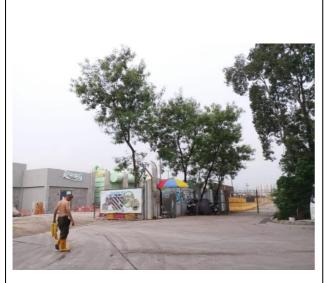
Figure 6

Existing trees at the site entrance

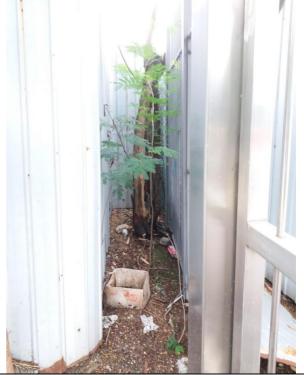
The tree in the tree protection area is drying and has peeling bark. It is in poor health condition. There is high risk of tree felling. Stored debris underneath the tree shall be removed.

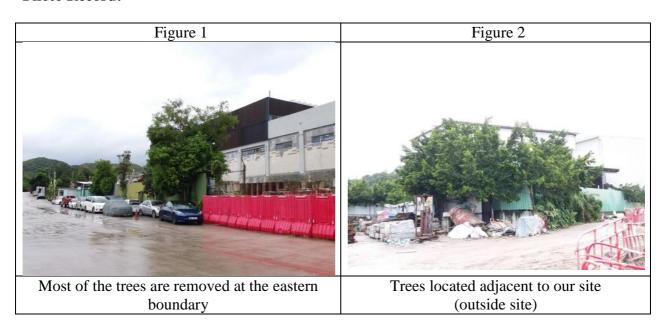
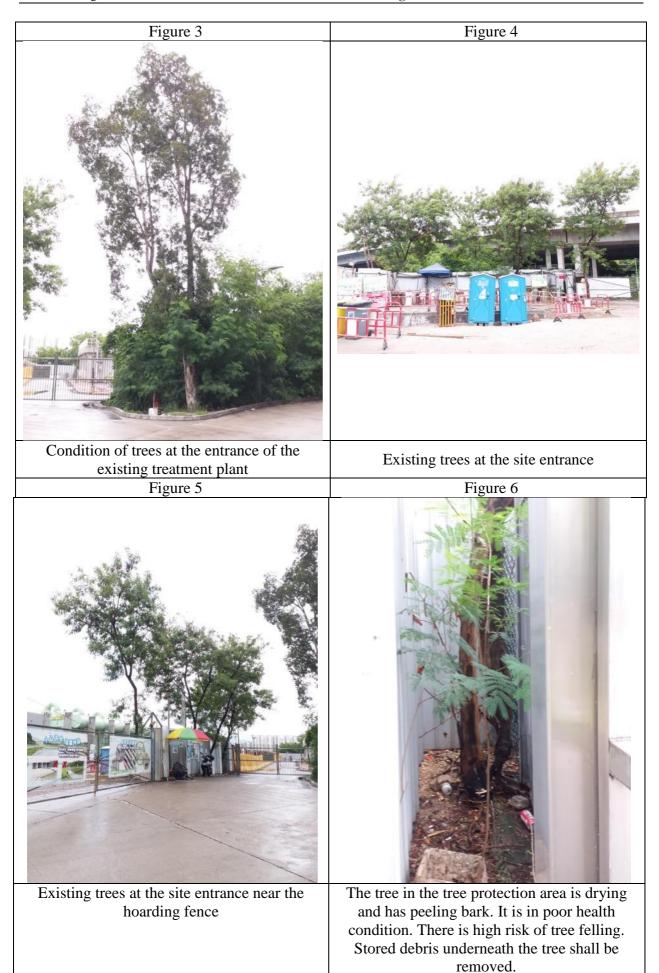
#### **Photo Record:**

- 1. Contractor was reminded to provide TPZ with robust fence, whenever possible, at the drip line of all retained trees unless the trees are well beyond the extend of construction activities.
- 2. Contractor was reminded not to disturb trees outside site along the boundary.

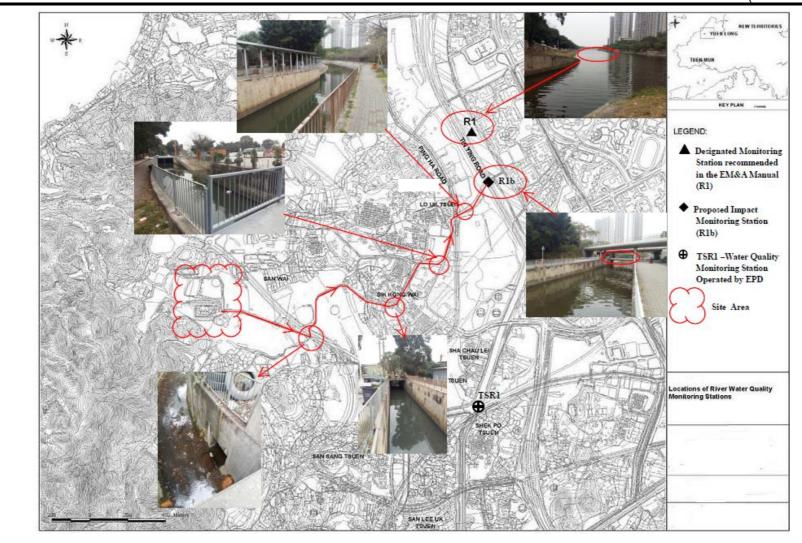
# Figure 2 Locations of Water Quality Monitoring Station

**4.1.1.** Water quality was monitored in the reporting month in accordance with the EM&A Manual at one alternative water quality monitoring station, R1b (at Tin Shui Wai Nullah) which shown in **Figure 2**.
