**CONTRACT NO. DC/2013/10 - DESIGN,
BUILD AND OPERATE SAN WAI
SEWAGE TREATMENT WORKS –
PHASE 1**

**QUARTERLY EM&A REPORT
NO. 14**

(01 AUG 2020 – 31 OCT 2020)

Report No.: ENA07319

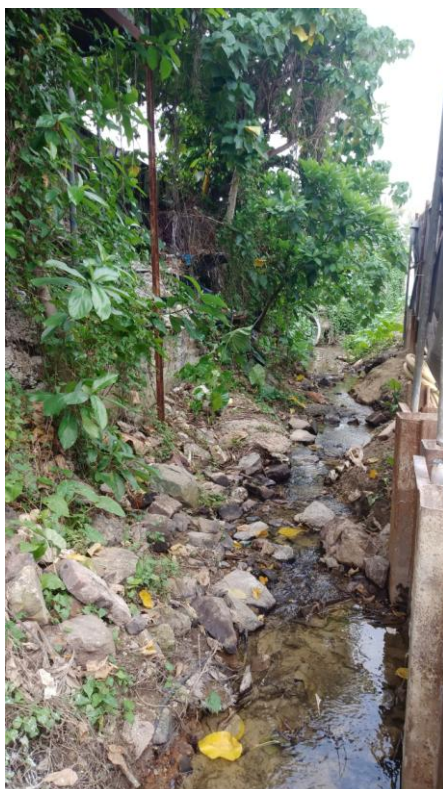
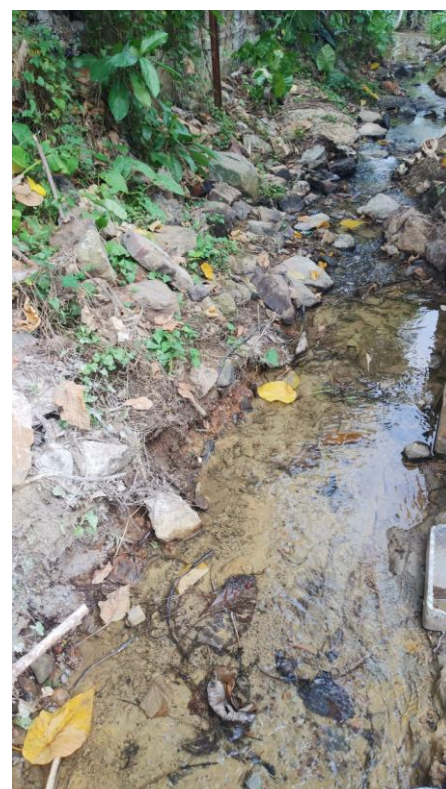
3.4.3. An additional site inspection was carried out on 28 August 2020 by ET, IEC and the contractor regarding to two public enquiries. The first public enquiry was related to an occurrence happened on 5 August 2020 which was about the overflowing of fresh water from a manhole in front of the electrical Building 4 and the second public enquiry was related to an occurrence happened on 24 August 2020 which was about the leakage of very little amount of treated sewage through a sand bag barrier at the end of a pipe near Electrical Building 4. Immediate actions had been taken and no adverse impacts were found due to these two occurrences according to our routine water quality monitoring data as shown in Monthly EM&A Report No.40. During the site inspection on 28 August 2020, no adverse observations in regard to the improper discharge mentioned in the enquiries were recorded. The following photo taken on 28 August 2020 showing the nearby concerning creek:

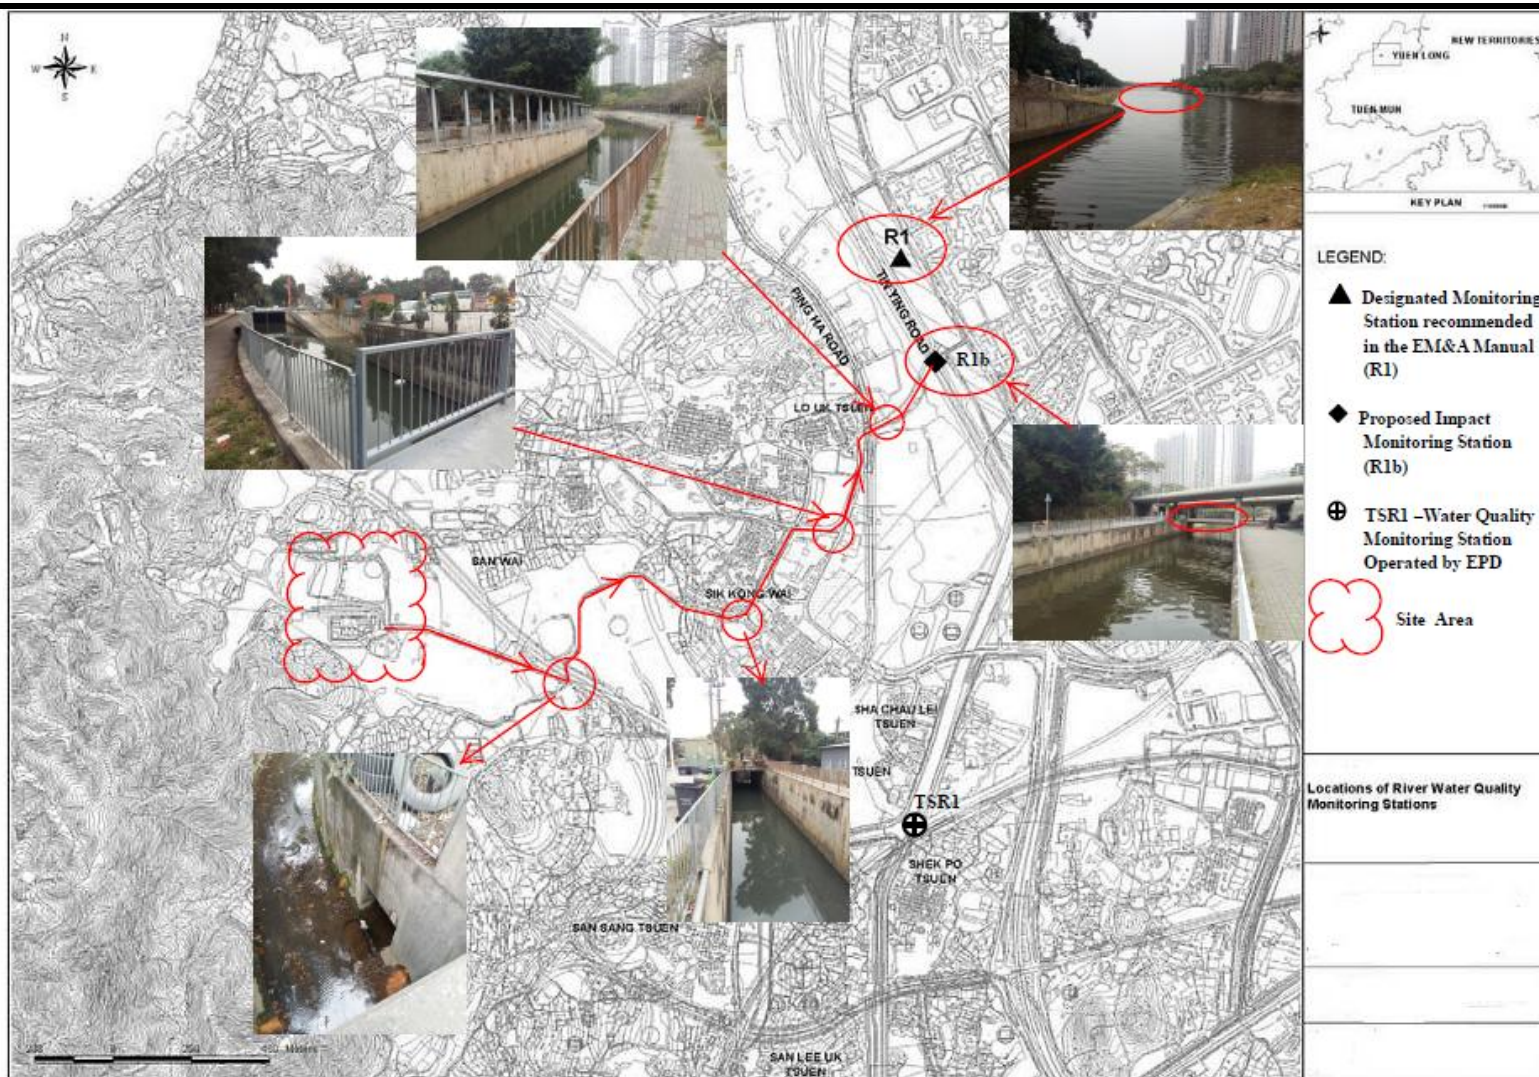
Figure 2

Water quality was monitored 3 times per week in the reporting period in accordance with the EM&A Manual at the one alternative water quality monitoring station, R1b (at Tin Shui Wai Nullah) which shown in **Figure 2**.

Locations of Water Quality Monitoring Station

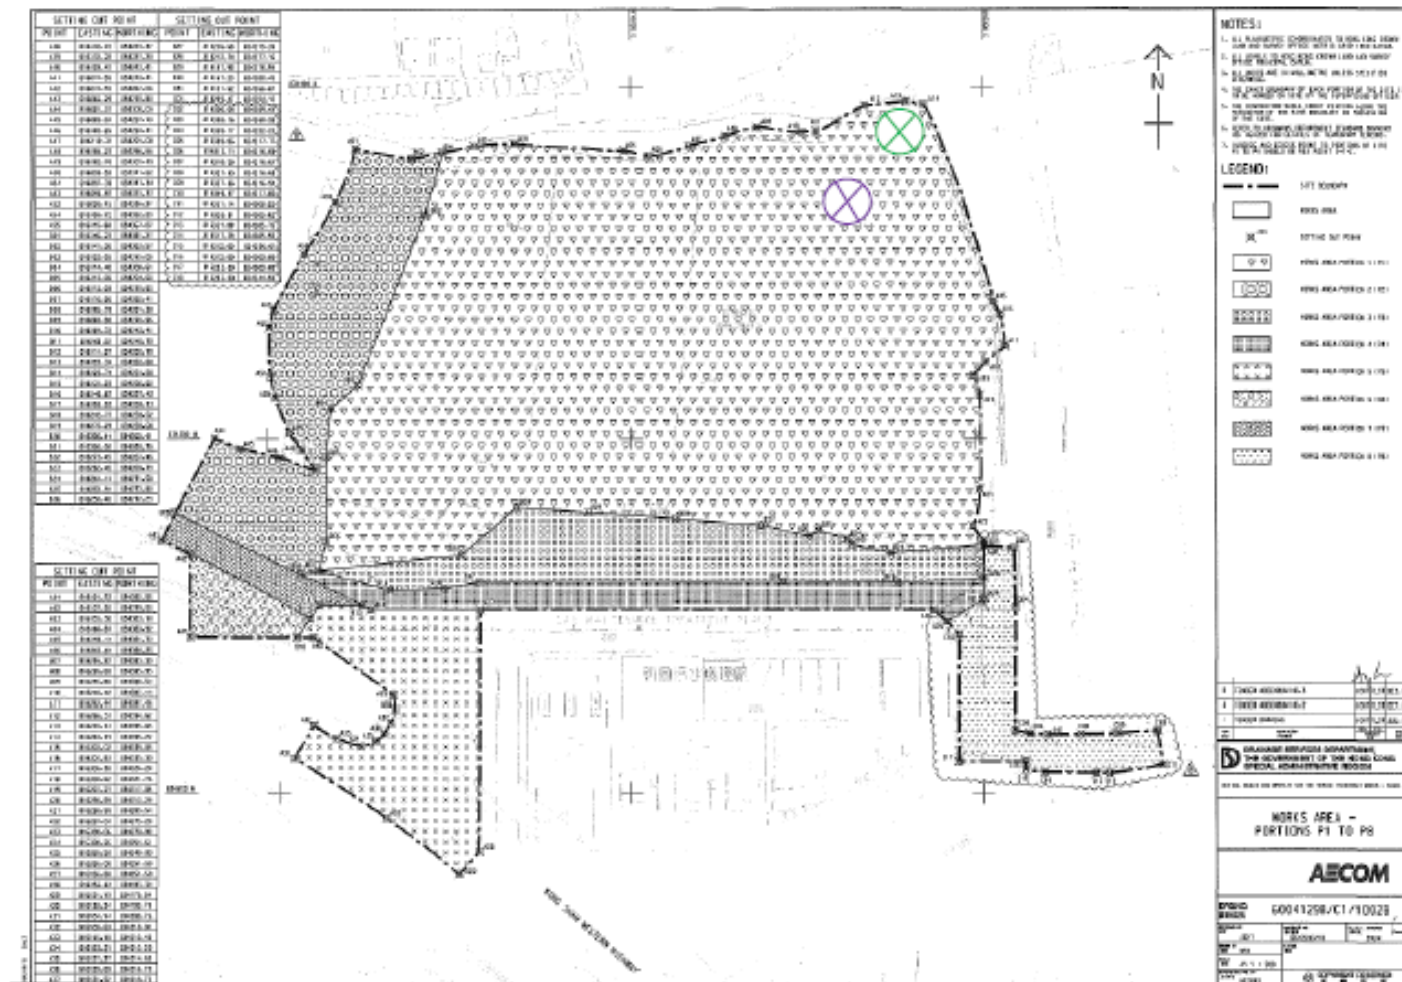
Figure 3

Location Plan for the Wetsep Treatment Tank
