**CONTRACT NO. DC/2013/10 - DESIGN,
BUILD AND OPERATE SAN WAI
SEWAGE TREATMENT WORKS –
PHASE 1**

**MONTHLY EM&A REPORT
NO. 50
(For Construction Phase)
(01 JUNE – 30 JUNE 2021)**

Report No.: ENA13150

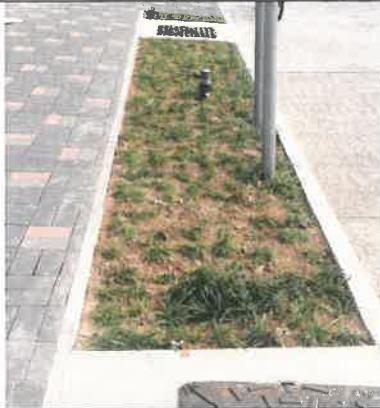
Figure 9

Maintenance of planting is required at the planter along WS and AB building

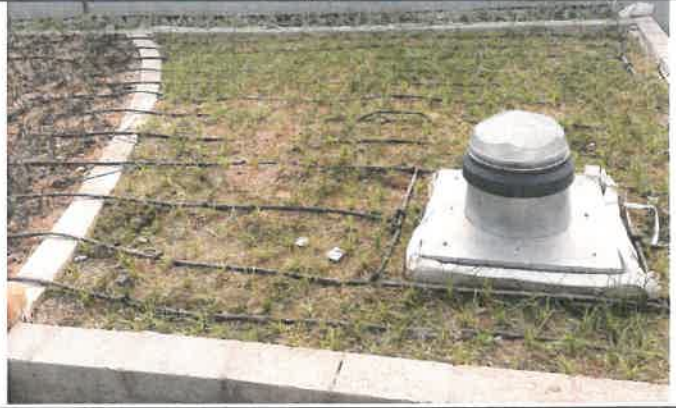
Figure 10

Plant installed and drip irrigation installed

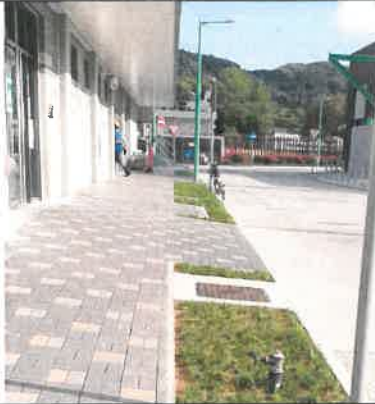
Figure 9

Maintenance of planting is required at the planter along WS and AB building

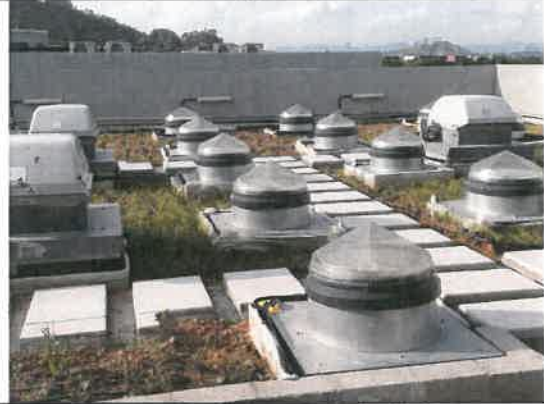
Figure 10

Plants and the roof skylights
