**CONTRACT NO. DC/2013/10 - DESIGN,  
BUILD AND OPERATE SAN WAI  
SEWAGE TREATMENT WORKS –  
PHASE 1**

**MONTHLY EM&A REPORT  
NO. 51  
(For Construction Phase)**

**(01 JULY – 31 JULY 2021)**

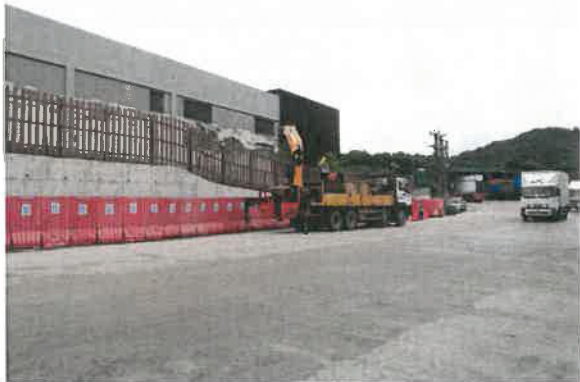
| Figure 1 | Figure 2 |

| Figure 1 | Figure 2 |
|---|---|
| Works are carried out at the eastern boundary | Trees planting are carried out at the western end of the site |

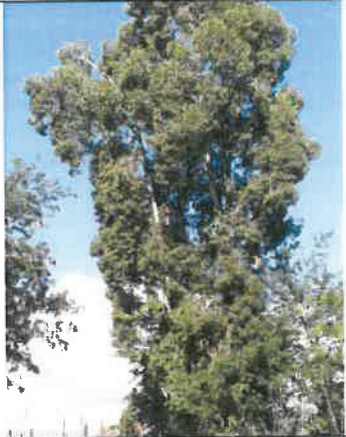
| <p>Figure 3</p> | <p>Figure 4</p> |

| <p>Condition of trees at the entrance of the existing treatment plant</p> | <p>Existing trees at the site entrance</p> |

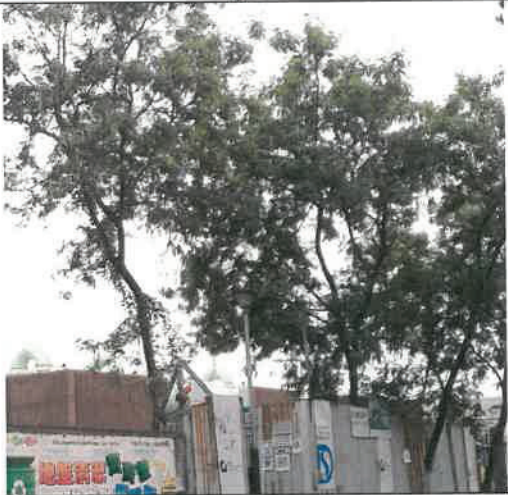
| <p>Figure 5</p> | <p>Figure 6</p> |

| <p>Existing trees at the site entrance near the hoarding fence</p> | <p>Planting works near administration building</p> |

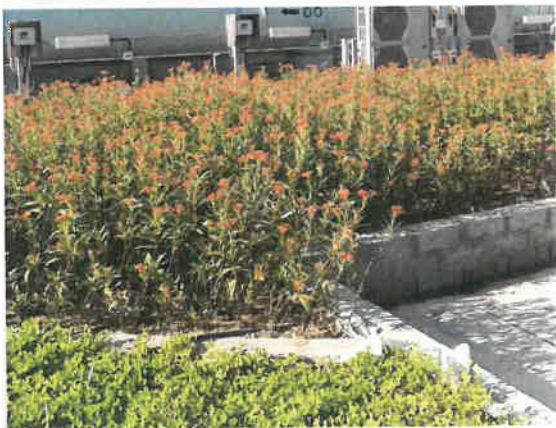
| <p>Figure 7</p> | <p>Figure 8</p> |

| <p>Planting works at SDB</p> | <p>Planting works at CB</p> |

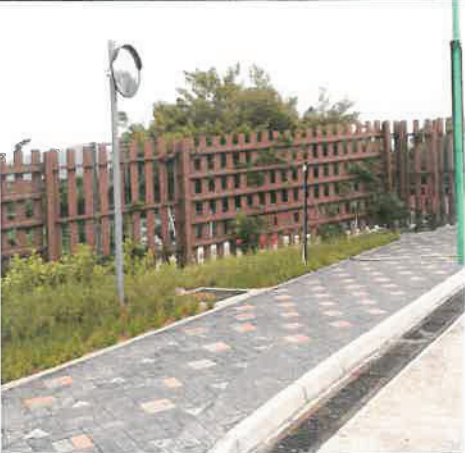
| Figure 9 | Figure 10 |

| Figure 9 | Figure 10 |
|---|---|
| Planting condition near the site entrance | Plants and the roof skylights |

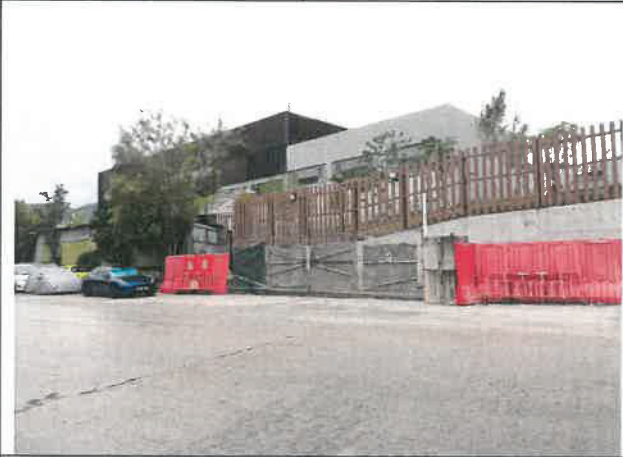
| Figure 1 | Figure 2 |

| Figure 1 | Figure 2 |
|---|---|
| Works are carried out at the eastern boundary | Trees planting are carried out at the western end of the site |

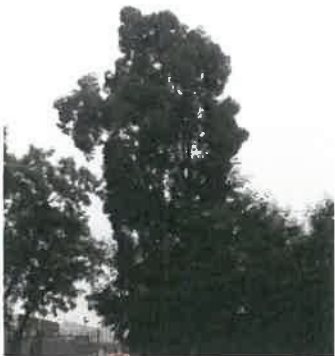
| <p>Figure 3</p> | <p>Figure 4</p> |

| <p>Condition of trees at the entrance of the existing treatment plant</p> | <p>Existing trees at the site entrance</p> |

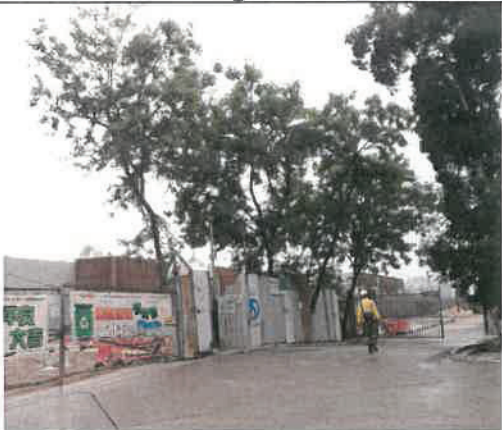
| <p>Figure 5</p> | <p>Figure 6</p> |

| <p>Existing trees at the site entrance near the hoarding fence</p> | <p>Tree planting works near site boundary</p> |

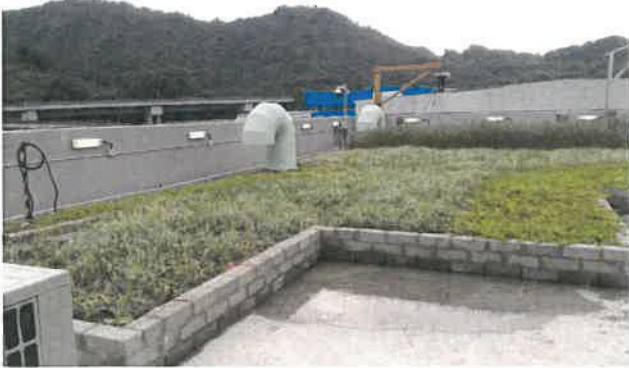
| <p>Figure 7</p> | <p>Figure 8</p> |

| <p>Planting works at SDB</p> | <p>Planting works at CB</p> |

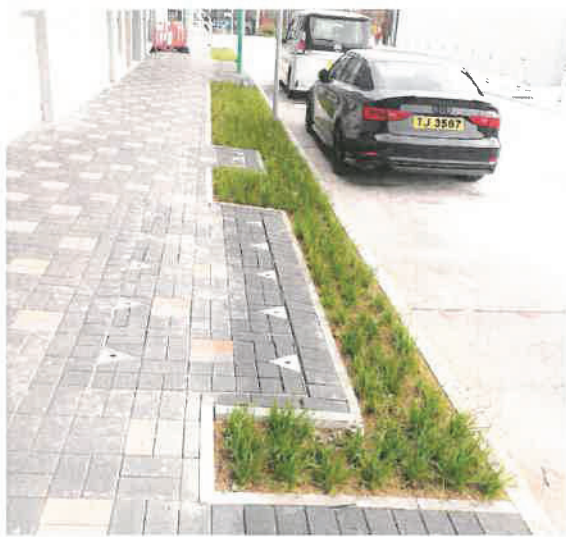
Figure 9

Planting condition near administration building

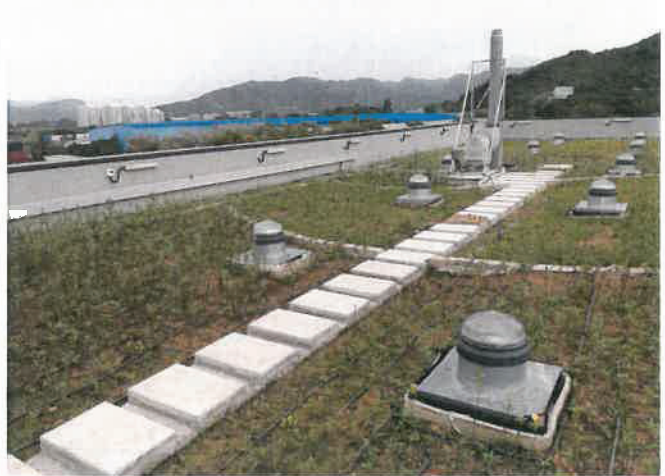
Figure 10

Green roof at administration building
