Figure 7
Emergency Discharge Scenarios
for the Future San Wai STW
and Ha Tsuen PS

Agreement No. CE62/2000 EIA Study for the Upgrading and Expansion of San Wai Sewage Treatment Works and the Expansion of Ha Tsuen Pumping Station

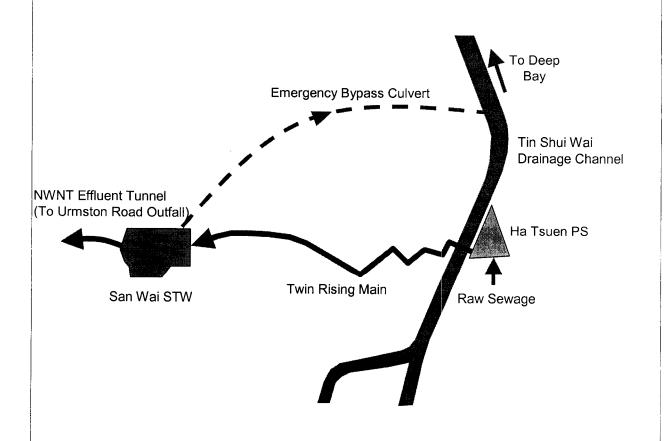
Future Condition (With Emergency Bypass Culvert)

Status of Facilities (✓ = Normal Operation, × = Totally Out of Operation)			Effluent	Discharge
San Wai STW	Ha Tsuen PS	NWNT Tunnel		Location
✓	✓	✓	Treated Effluent	Urmston Road Outfall
	F at A Company		Treated Effluent	TSW Drainage Channel/Deep Bay
*	✓	✓	Raw Sewage	Urmston Road Outfall
√	×	✓	Raw Sewage	TSW Drainage Channel/Deep Bay
