DSD CONTRACT No.: DC/2009/08

CONSTRUCTION OF YUEN LONG SOUTH BRANCH SEWERS AND EXPANSION OF HA TSUEN SEWAGE PUMPING STATION

5<sup>TH</sup> ENVIRONMENTAL MONITORING & AUDIT MONTHLY REPORT – JUNE 2010

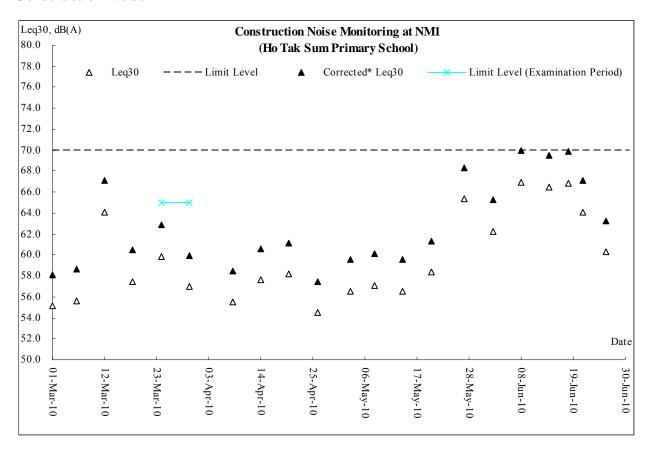
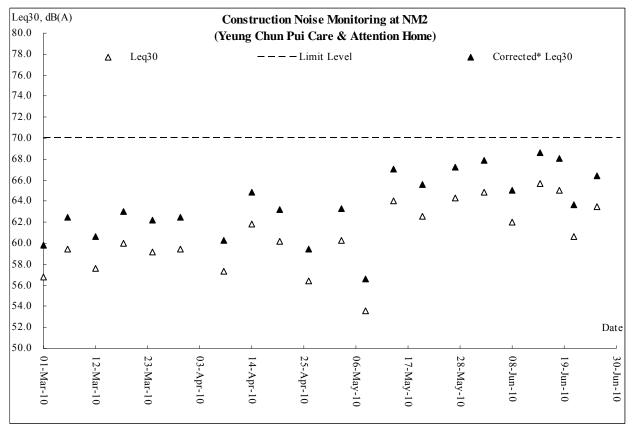
#### **Construction Noise**

4.06 It was noted that no noise complaint (which is an Action Level exceedance) was received. In view of the results shown in *Tables 4-3* and *4-4*, all the values are below 75dB(A), therefore, no Action or Limit Level exceedance was triggered during this month. The graphical plot is shown in *Appendix J*.

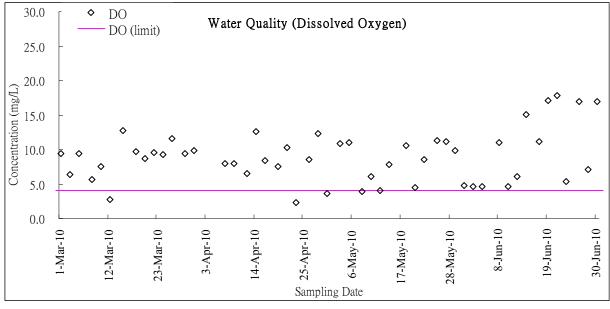
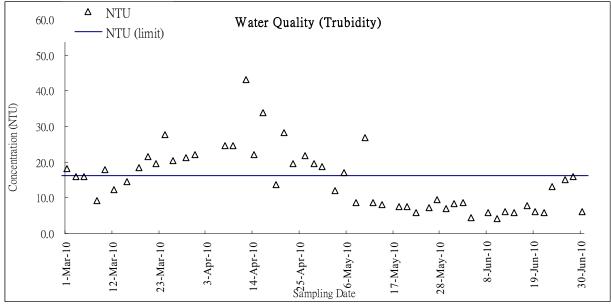
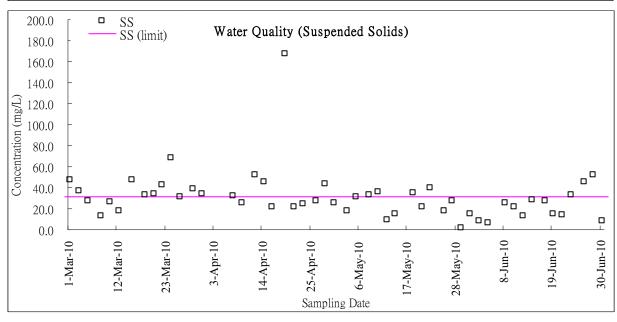
#### Water Quality – Local Stream Course (R1b)

- 4.09 In this Reporting Period, a total of 4 Action/ Limit Level exceedances were recorded at Location R1b, namely 1 Action Level exceedances in Turbidity and 3 Limit Level exceedances in SS. NOE were issued to notify the relevant parties and the investigations for the cause of exceedances are ongoing. Based on site information obtained, installation of pre-bored H-pile was undertaken in this reporting period. Those construction activities would not generate any wastewater or runoff from to be discharged from the site to natural streams and Tin Shui Wai Nullah. Therefore, the preliminary investigation would consider that the exceedances are not due to the Project and the corresponding investigation report is ongoing.

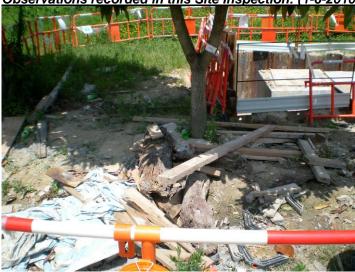
Observations recorded in this Site Inspection: (1-6-2010)

Remark 1: Tree preservation requires further improvement. The Contractor was reminded to proper fence the preserved tree and avoid C&D material accumulated nearby.

- 1. The C&D materials accumulated nearby the preserved tree were removed.
- 2. The broken sand bags were replaced.

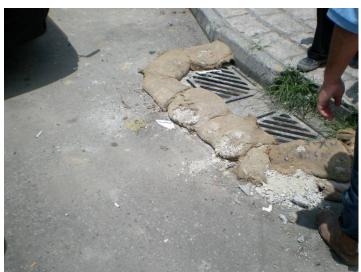
Remark 2: Broken sand bags were observed, the contractor was reminded to change to prevent surface runoff discharged to the public road.

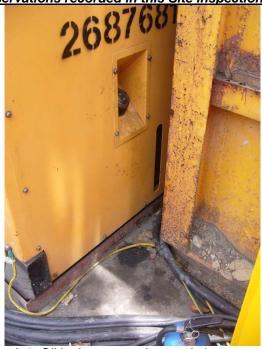
Observations recorded in this Site Inspection: (18-6-2010)

Remark 1: Oil leakage was observed, the contractor was reminded to clean the contamination surface and prevent further leakage from the plant

- 1. No further leakage was observed from the plant of last inspection.
- 2. Free standing chemical container was removed.

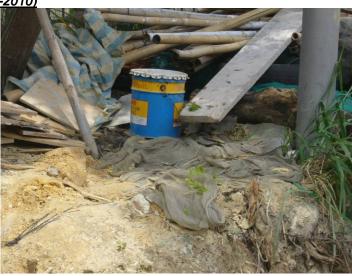
Remark 2: Free standing chemical containers without drip tray and label was observed at the site area, the contractor was reminded to provide drip tray and proper label for all chemical containers.

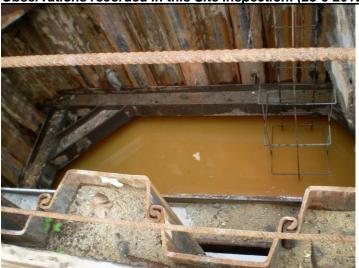
Observations recorded in this Site Inspection: (23-6-2010)

Remark 1: The stagnant water accumulated should be drained away or applied larvidical oil to prevent mosquitoes breeding.

1. The stagnant water accumulation was still observed after rainfall. The Contractor has applied larvidical oil to the stagnant water to prevent mosquitoes breeding.

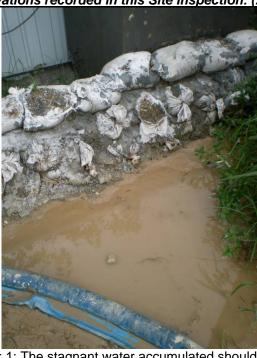
Observations recorded in this Site Inspection: (29-6-2010)

Remark 1: The stagnant water accumulated should be drained away and the sand bag should be re-checked or replaced regularly to prevent any muddy water discharge outside the site.
