JOB No.: TCS00491/09

DSD CONTRACT NO.: DC/2009/08

CONSTRUCTION OF YUEN LONG SOUTH BRANCH  
SEWERS AND EXPANSION OF HA TSUEN SEWAGE  
PUMPING STATION

8<sup>TH</sup> ENVIRONMENTAL MONITORING & AUDIT  
MONTHLY REPORT – SEPTEMBER 2010

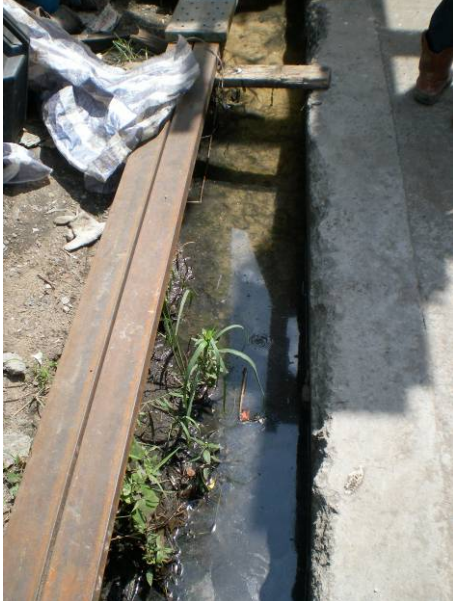
**Observations recorded in this Site Inspection: (7-9-2010)**

| Remark 1: The stagnant water accumulated in the channel should be drained away or applied larvidical oil to prevent mosquitoes breeding. (Ha Tsuen Road) | | |

Larvidical oil was applied on the stagnant water regularly to prevent mosquitoes breeding.

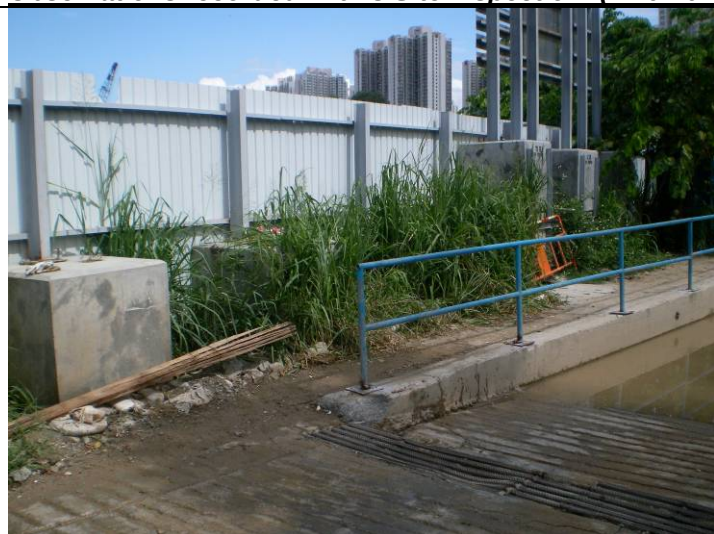
Remark 1: The overgrow weeds along the site access should be removed to minimize mosquito breeding. (Ha Tsuen PS)

The weeds along site access was removed (Ha Tsuen PS)

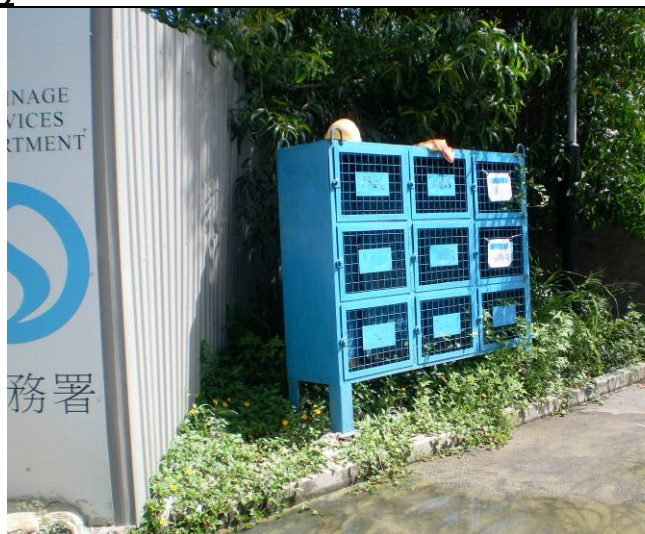
Remark 2: The contractor was reminded to tidy the un-used storage area and remove the surrounding weeds near site exit to improve the house-keeping for the site. (Ha Tsuen PS)

The storage area was tidied up and surrounding weeds was removed. (Ha Tsuen PS)

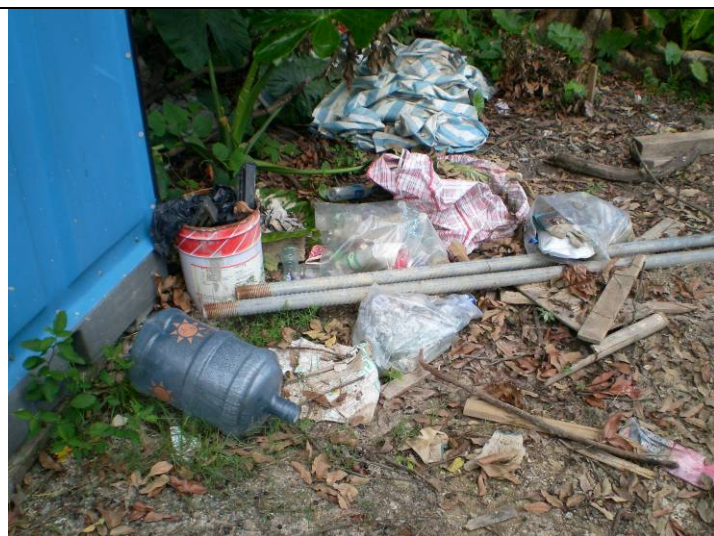
Remark 3: The general refuse and container with stagnant were observed, the contractor was reminded to tidy up to keep the site clean. (Shui Tsiu San Tsuen PS)

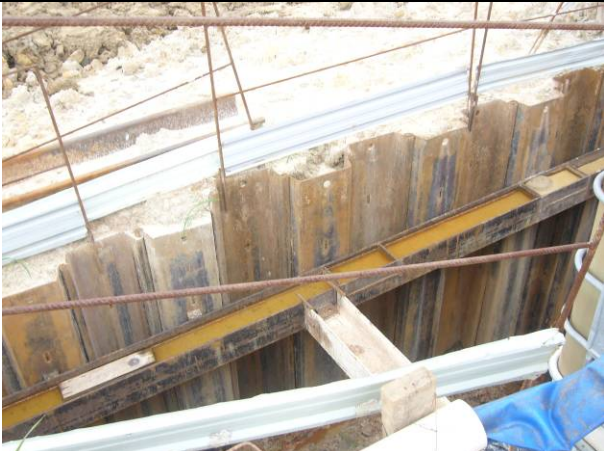
**Observations recorded in this Site Inspection: (30-9-2010)**

| | Stagnant water cumulated inside the I beam was observed, the contractor was reminded to clean to prevent mosquito breeding. |
