DSD CONTRACT No.: DC/2009/08

CONSTRUCTION OF YUEN LONG SOUTH BRANCH SEWERS AND EXPANSION OF HA TSUEN SEWAGE PUMPING STATION

9<sup>TH</sup> ENVIRONMENTAL MONITORING & AUDIT MONTHLY REPORT – OCTOBER 2010

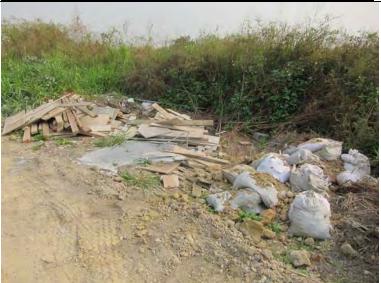
Photo 1: Scattered C&D waste was observed at Pak Sha Tsuen, Kiu Hing Road, the contractor was recommended to place the wastes in a designated location in order to keep the site tidiness.
