DSD CONTRACT NO.: DC/2009/08

CONSTRUCTION OF YUEN LONG SOUTH BRANCH  
SEWERS AND EXPANSION OF HA TSUEN SEWAGE  
PUMPING STATION

**10<sup>TH</sup> ENVIRONMENTAL MONITORING & AUDIT  
MONTHLY REPORT – NOVEMBER 2010**

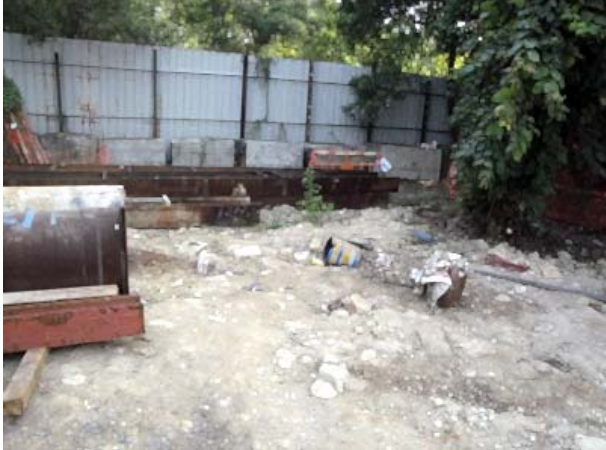
| <p>Photo 1: The contractor was reminded to properly dispose and store the waste chemical container found at Ha Tsuen PS.</p> | <p>Photo 2: At Shui Tsui San Tsuen PS, although drip trays for generator and oil drums are observed, the contractor was reminded to upgrade the mitigation measures to prevent oil spillage during fueling procedures.</p> |

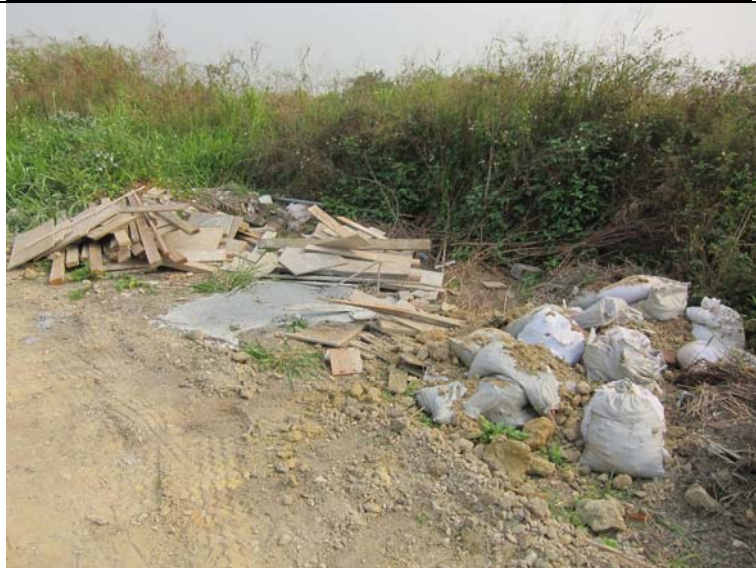
Photo 1: Scattered C&D waste was observed at Pak Sha Tsuen, Kiu Hing Road, the contractor was recommended to place the wastes in a designated location in order to keep the site tidiness.

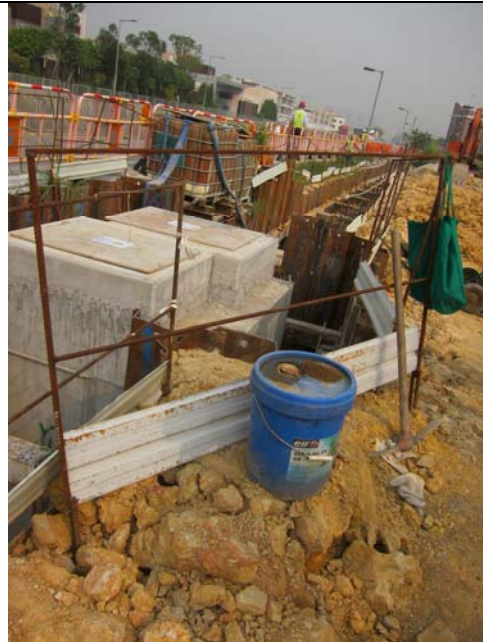
Photo 2: Free standing chemical container without drip tray was observed at Pak Sha Tsuen, Kiu Hing Road, the contractor was reminded to provide drip tray for all chemical containers.

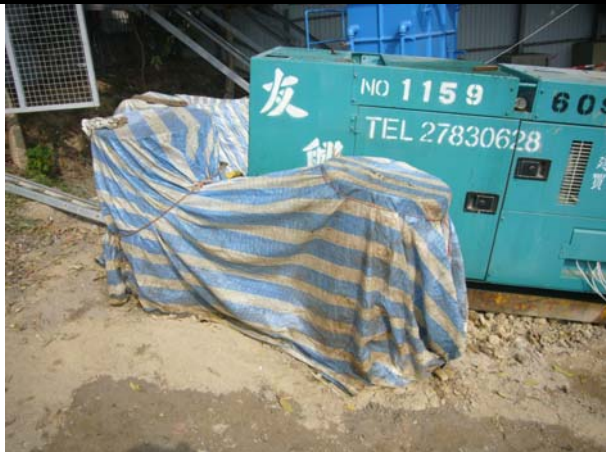
Photo 1: Free standing chemical containers without drip tray was observed at Shui Tsui San Tsuen PS, the contractor was reminded to provide drip tray for all chemical containers.

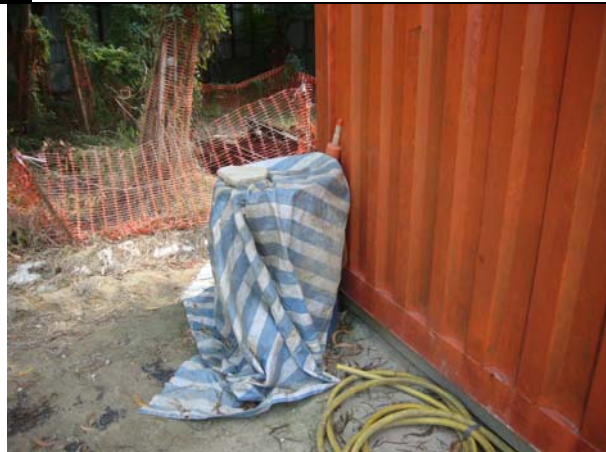
Photo 2: Free standing chemical containers without drip tray was observed at Har Tsuen PS, the contractor was reminded to provide drip tray for all chemical containers.

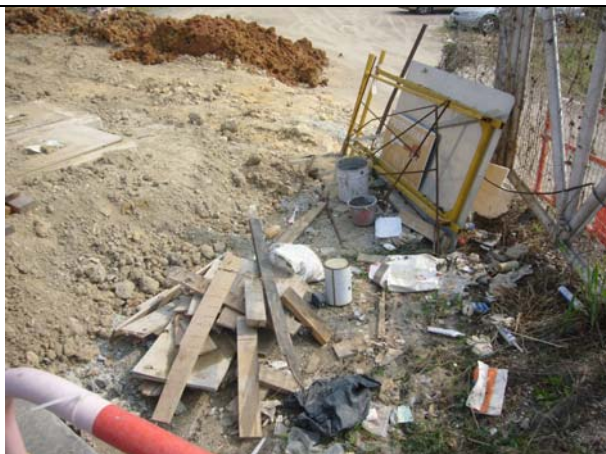
Photo 3: C&D waste cumulated at the site area was observed, the contractor was reminded to clean to maintain the site clean and tidy.

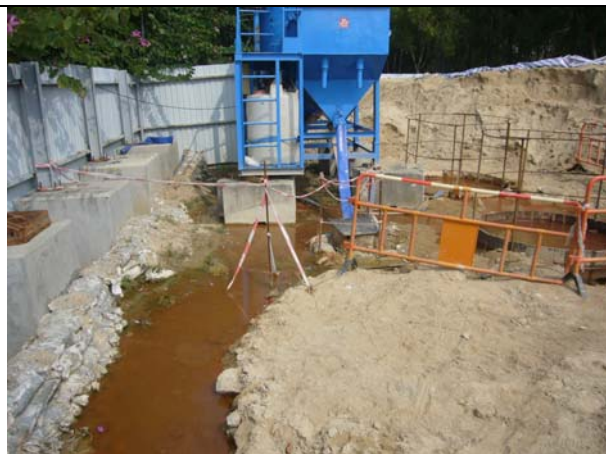
Photo 4: Stagnant water cumulated at Har Tsuen PS, the contractor was reminded to clean.

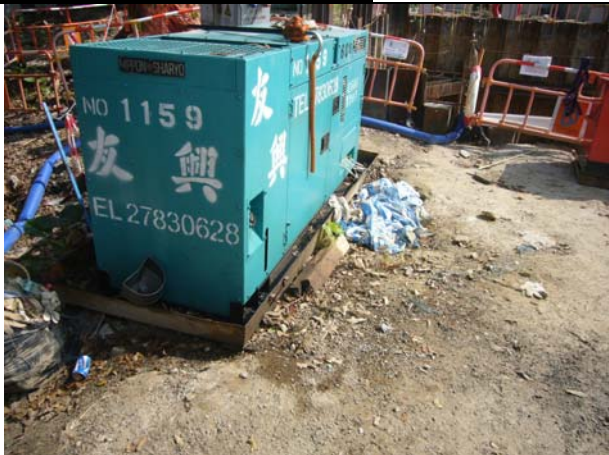
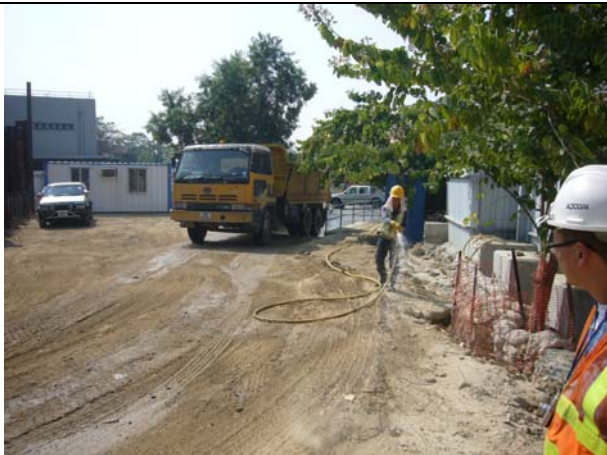
| <p>1. Free standing chemical container at Shui Tsui San Tsuen PS was removed.</p> | <p>2. Water spraying at Har Tsuen PS was observed to minimize dust generation.</p> |

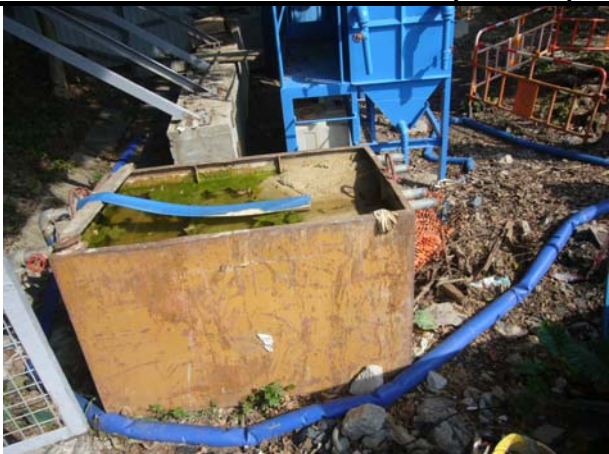
| <p>Photo 1: Sedimentation tank at Shui Tsui San Tsuen PS was full of sediment, the contractor was reminded to clean to maintain the tank efficient.</p> | |

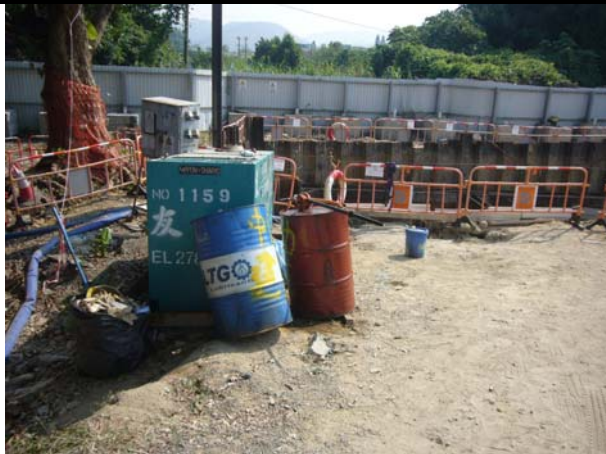
Photo 1: Free standing chemical containers without drip tray was observed at Shui Tsui San Tsuen PS, the contractor was reminded to provide drip tray for all chemical containers.

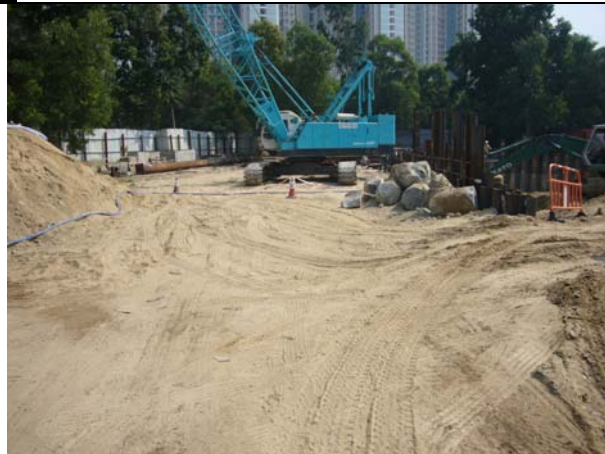
Photo 2: Dusty access road was observed at Har Tsuen PS, the contractor was reminded to provide proper dust mitigation measure to minimize dust generation.
