DSD CONTRACT NO.: DC/2009/08

CONSTRUCTION OF YUEN LONG SOUTH BRANCH  
SEWERS AND EXPANSION OF HA TSUEN SEWAGE  
PUMPING STATION

**13<sup>TH</sup> ENVIRONMENTAL MONITORING & AUDIT  
MONTHLY REPORT – FEBRUARY 2011**

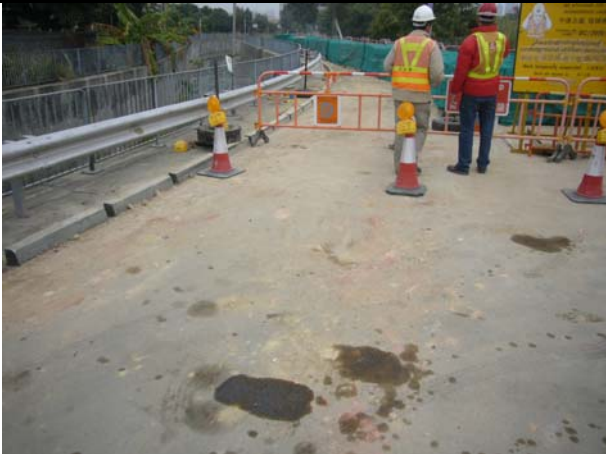
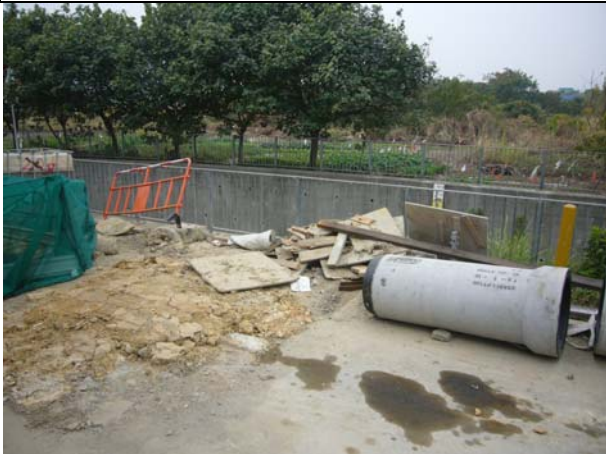
| <p>Photo 1: Loose soil and mud was observed at the site exit, the contractor was reminded to clean and maintain the public area near the site clean and tidy.</p> | <p>Photo 2: C&amp;D waste scattered on site was observed, housekeeping should be improve at the works area.</p> |

| Loose soil and mud observed at the site exit was cleared. | C&D waste observed at last inspection was cleared. |

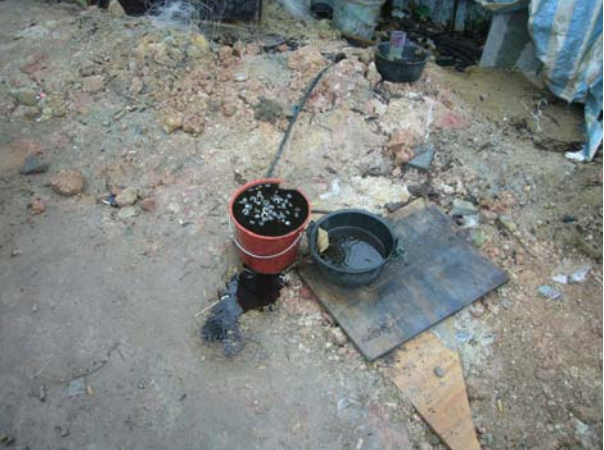
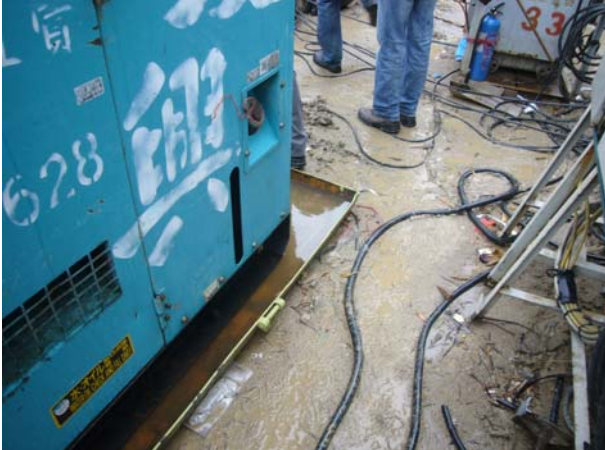
| <p>Photo 1: Oil leakage from the chemical container was observed at Shui Tsui San Tsuen PS, the contractor was requested to clean immediately and provide drip tray for all chemical containers.</p> | <p>Photo 2: Stagnant water cumulated inside the drip tray was observed, the contractor was reminded to clean.</p> |

Chemical container without drip tray was removed and the oil leakage was cleared.

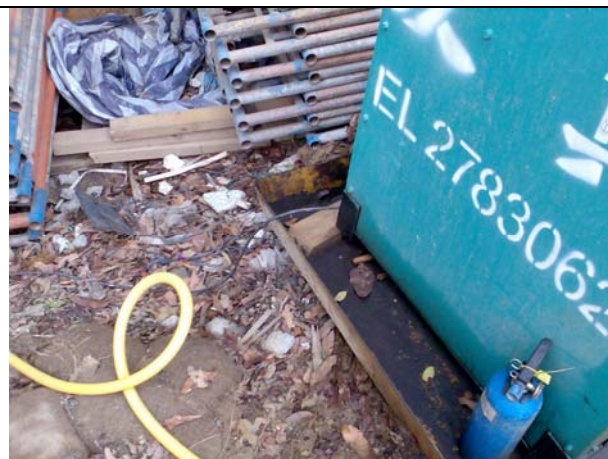
Stagnant water inside the drip tray was cleared.

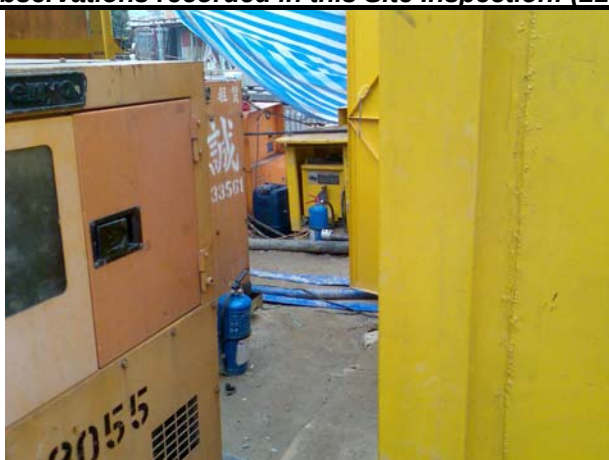
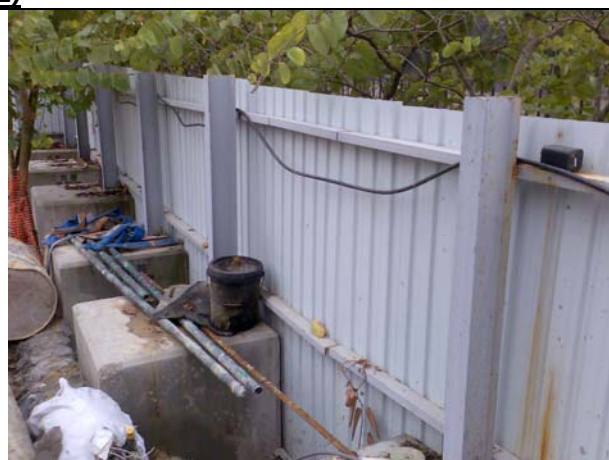
Photo 1 & 2: Free standing chemical containers without drip tray were observed Shui Tsui San Tsuen works area and Ha Tsuen PS, the contractor was requested to provide drip tray for all chemical containers.

| Date | Findings / Deficiencies | Follow-Up |
|---|---|---|
| 21 February 2011 | <ul style="list-style-type: none"> <li>Free standing chemical container without drip tray was observed Ha Tsuen PS, the contractor was requested to provide drip tray for all chemical containers</li> <li>Turbidity water discharged to the u-channel was observed at Ha Tsuen PS, the contractor was reminded to provide sand bags to divert the surface runoff to de-silting facility.</li> </ul> | <p>Rectified before the next inspection</p> <p>Rectified before the next inspection</p> |
