JOB No.: TCS00491/09

DSD CONTRACT NO.: DC/2009/08

CONSTRUCTION OF YUEN LONG SOUTH BRANCH  
SEWERS AND EXPANSION OF HA TSUEN SEWAGE  
PUMPING STATION

**14<sup>TH</sup> ENVIRONMENTAL MONITORING & AUDIT  
MONTHLY REPORT – MARCH 2011**

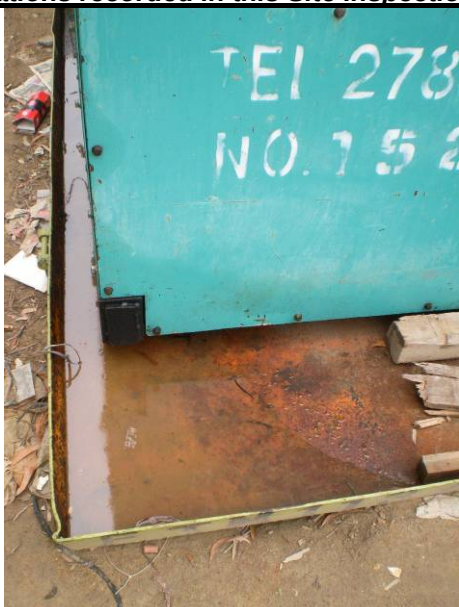
Photo 1: Stagnant water was observed within the drip tray. The Contractor was reminded to clear water to prevent mosquito breeding. (Ha Tsuen PS)

Stagnant water cumulated inside the drip tray at Ha Tsuen PS was cleared.

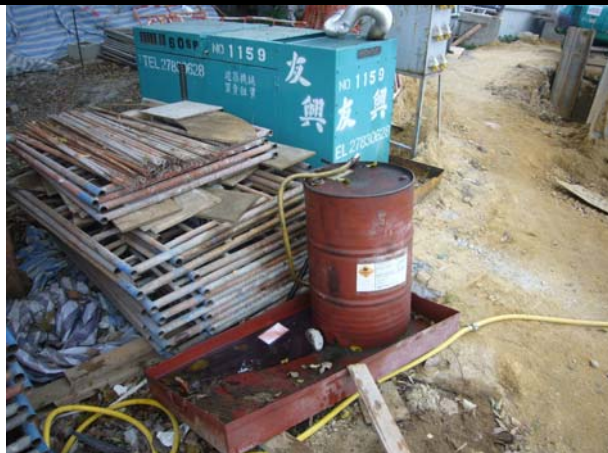
Photo 1: Stagnant water was observed within the drip tray. The Contractor was reminded to clear water to prevent mosquito breeding. (STSTPS)

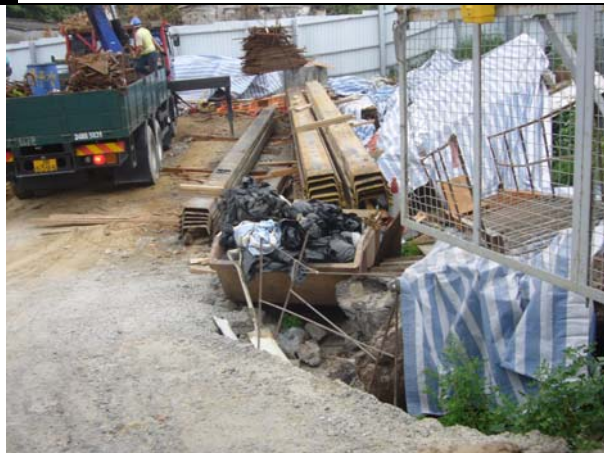
Photo 2: General and C&D waste cumulated was observed, the contractor was reminded to clean in regular basis. (STSTPS)

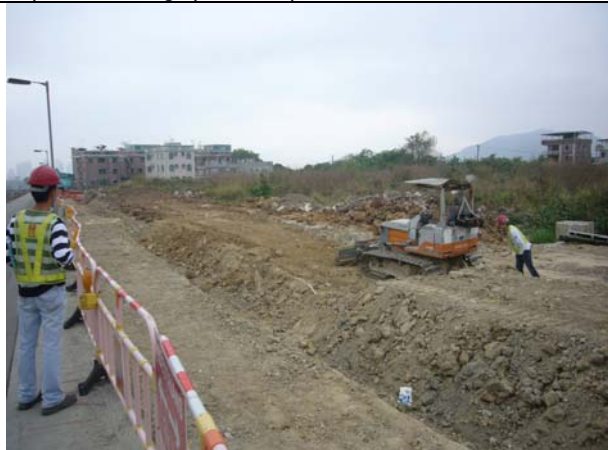
Photo 3: Stockpile at Kiu Hing Road without cover was observed, the contractor was reminded to provide proper mitigation measures to prevent dust generation.

| Stockpile at Kiu Hing Road was removed. | Drip trays were observed for chemical containers. |

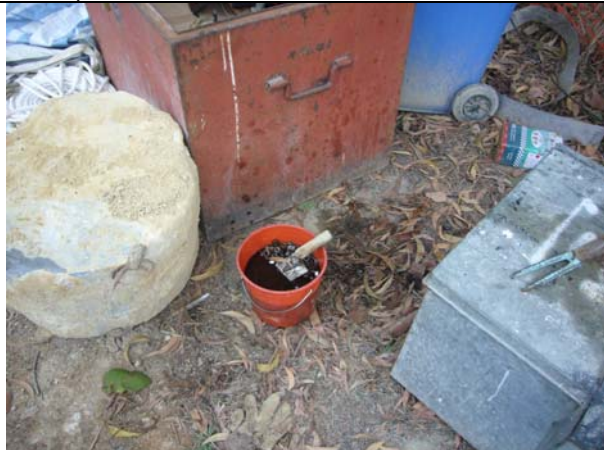
Photo 4: Free standing chemical container without drip tray was observed, the contractor was reminded to provide drip tray for all chemical container in the site area.

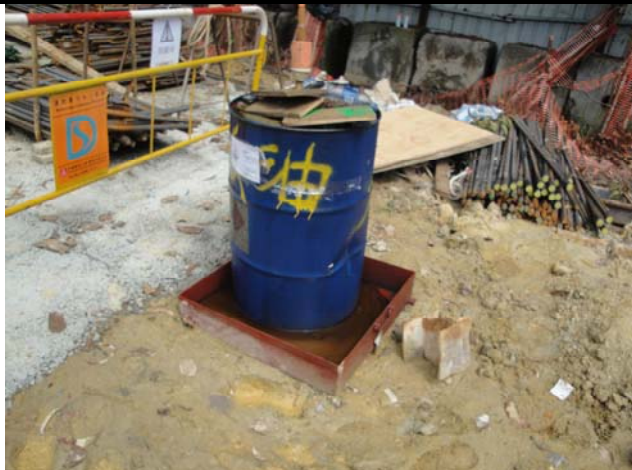
Photo1: The Contractor was reminded to remove the C&D waste on the chemical container and to regularly clear the water accumulated within the drip tray. (HSPS)

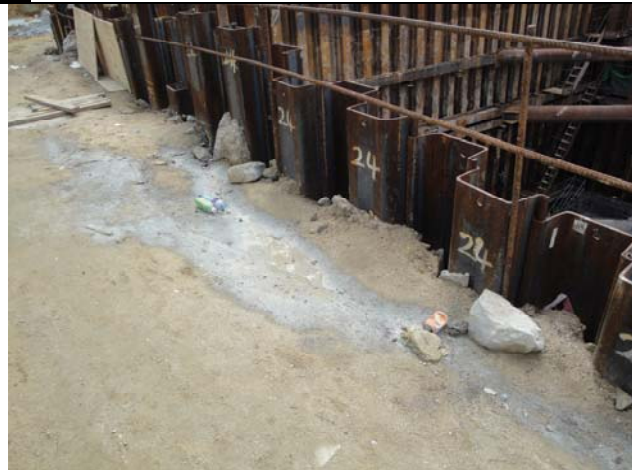
Photo 2: General refuse was found scattered around the site. The Contractor was reminded to clear the refuse in a regular basis. (HSPS)

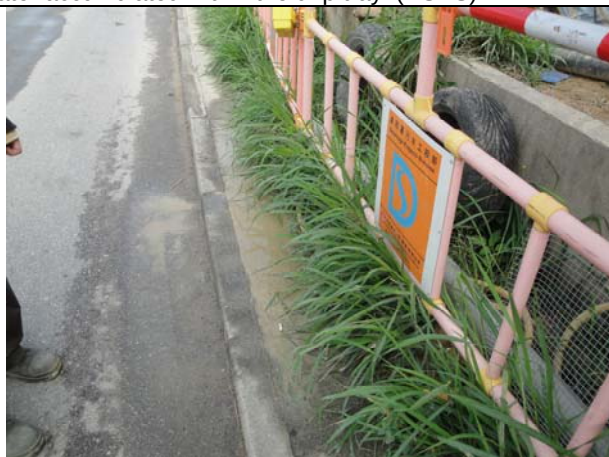
Photo 3: Some slurry was observed along the site boundary. The contractor was reminded to maintain good practice to confine and treat the waste water in order to prevent direct discharge of waste water.

| The slurry observed along the site boundary was found to be removed. | Housekeeping at HSPS should be further improved. |

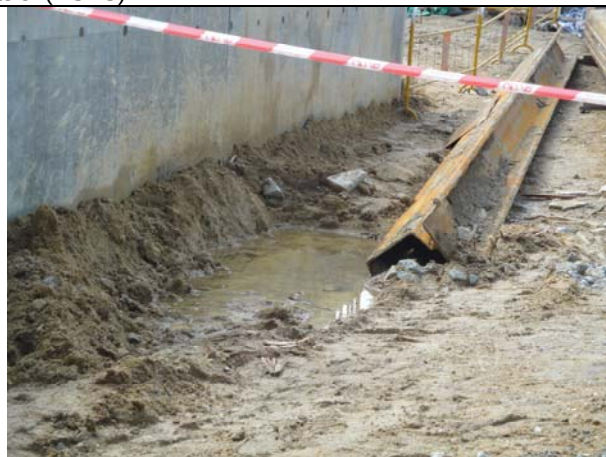
Photo 4: Some stagnant water was observed. The contractor was reminded to implement proper measures to alleviate the potential impact of mosquitoes breeding. (STSTPS)

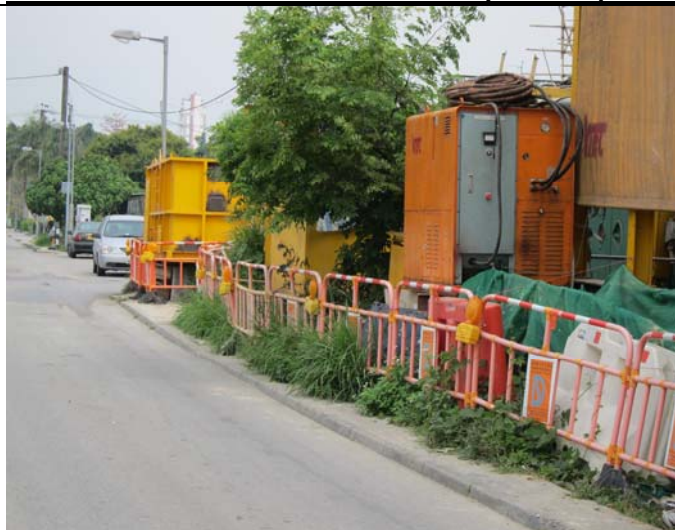
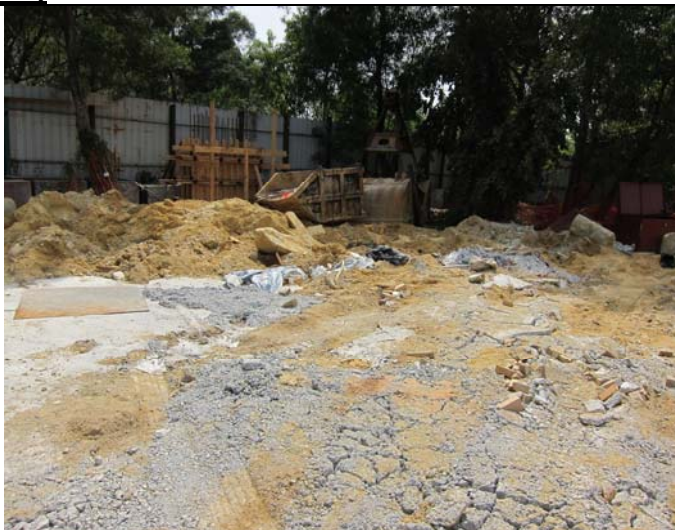
| Photo1: The Contractor was reminded to remove the overgrown weeds to minimize mosquito breeding. (Tai Shu Ha Road East) | Photo 2: General refuse and C&D waste were found scattered around the site. The Contractor was reminded to improve the housekeeping of the site to achieve a higher standard. (HSPS) |
