DSD CONTRACT No.: DC/2009/08

CONSTRUCTION OF YUEN LONG SOUTH BRANCH  
SEWERS AND EXPANSION OF HA TSUEN SEWAGE  
PUMPING STATION

**16<sup>TH</sup> ENVIRONMENTAL MONITORING & AUDIT  
MONTHLY REPORT – MAY 2011**

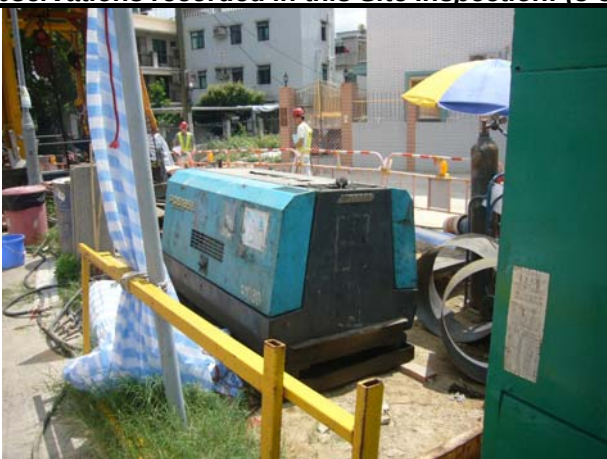
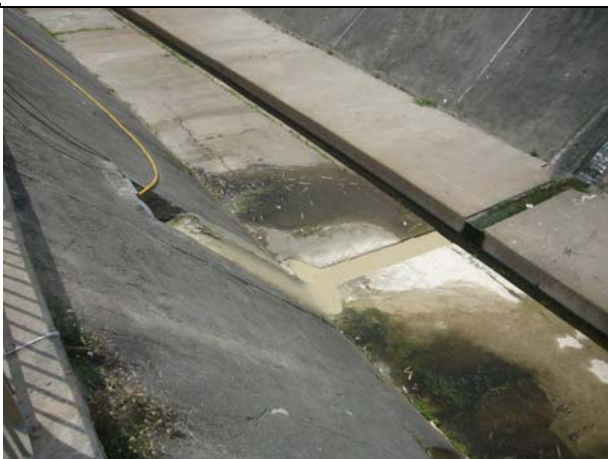
**Observations recorded in this Site Inspection: (3-5-2011)**

| <p>Remark 1: Air compressor without noise label was observed at Shui Tsiu San Tsuen works area, the contractor was reminded to provide proper noise emission label for all air compressor in the site area.</p> | <p>Remark 2: Turbidity water discharge to the nullah was observed at Tai She Har East Road, the contractor was request immediately stop to discharge the turbidity water and improve the de-silting facility.</p> |

| Noise Emission Label was provided for the Air Compressor | Discharge of turbid water was not observed. |

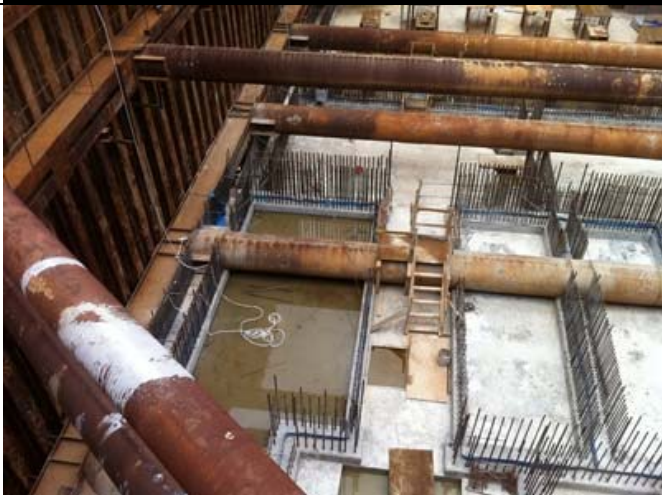
**Observations recorded in this Site Inspection: (11-5-2011)**

| <p>Remark 1: Stagnant water ponding was observed at Ha Tsuen Pumping Station. The Contractor was reminded to provide proper mitigation measures for preventing mosquitoes breeding</p> | | |

| Date | Findings / Deficiencies | Follow-Up |
|---|---|---|
| 11 May 2011 | Stagnant water ponding was observed at Ha Tsuen Pumping Station. The Contractor was reminded to provide proper mitigation measures for preventing mosquitoes breeding | The issue was rectified before next inspection. |

| Application of larvicidal oil record was observed for Ha Tsuen Pumping Station Area. | |

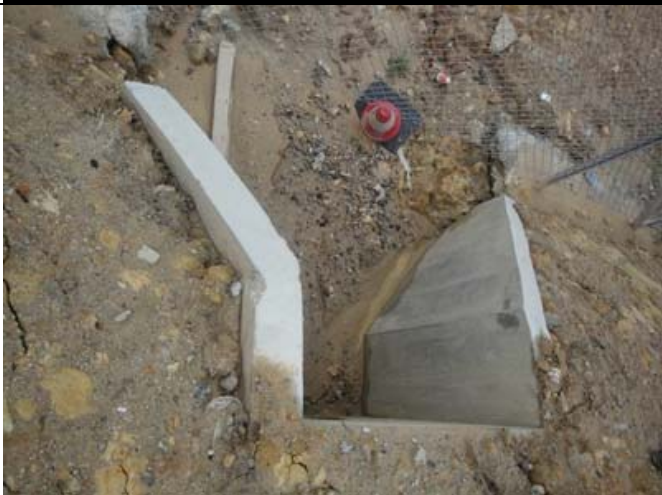
**Observations recorded in this Site Inspection: (24-5-2011)**

| <p>Remark 1: A built drainage inlet near Kung Um Road was found accumulated with soil materials after heavily rainfall. The Contractor was requested to clean and protect any stockpile nearby.</p> | |

The soil accumulated at the inlet was removed.
