JOB No.: TCS00491/09

DSD CONTRACT NO.: DC/2009/08

CONSTRUCTION OF YUEN LONG SOUTH BRANCH  
SEWERS AND EXPANSION OF HA TSUEN SEWAGE  
PUMPING STATION

**20<sup>TH</sup> ENVIRONMENTAL MONITORING & AUDIT  
MONTHLY REPORT – SEPTEMBER 2011**

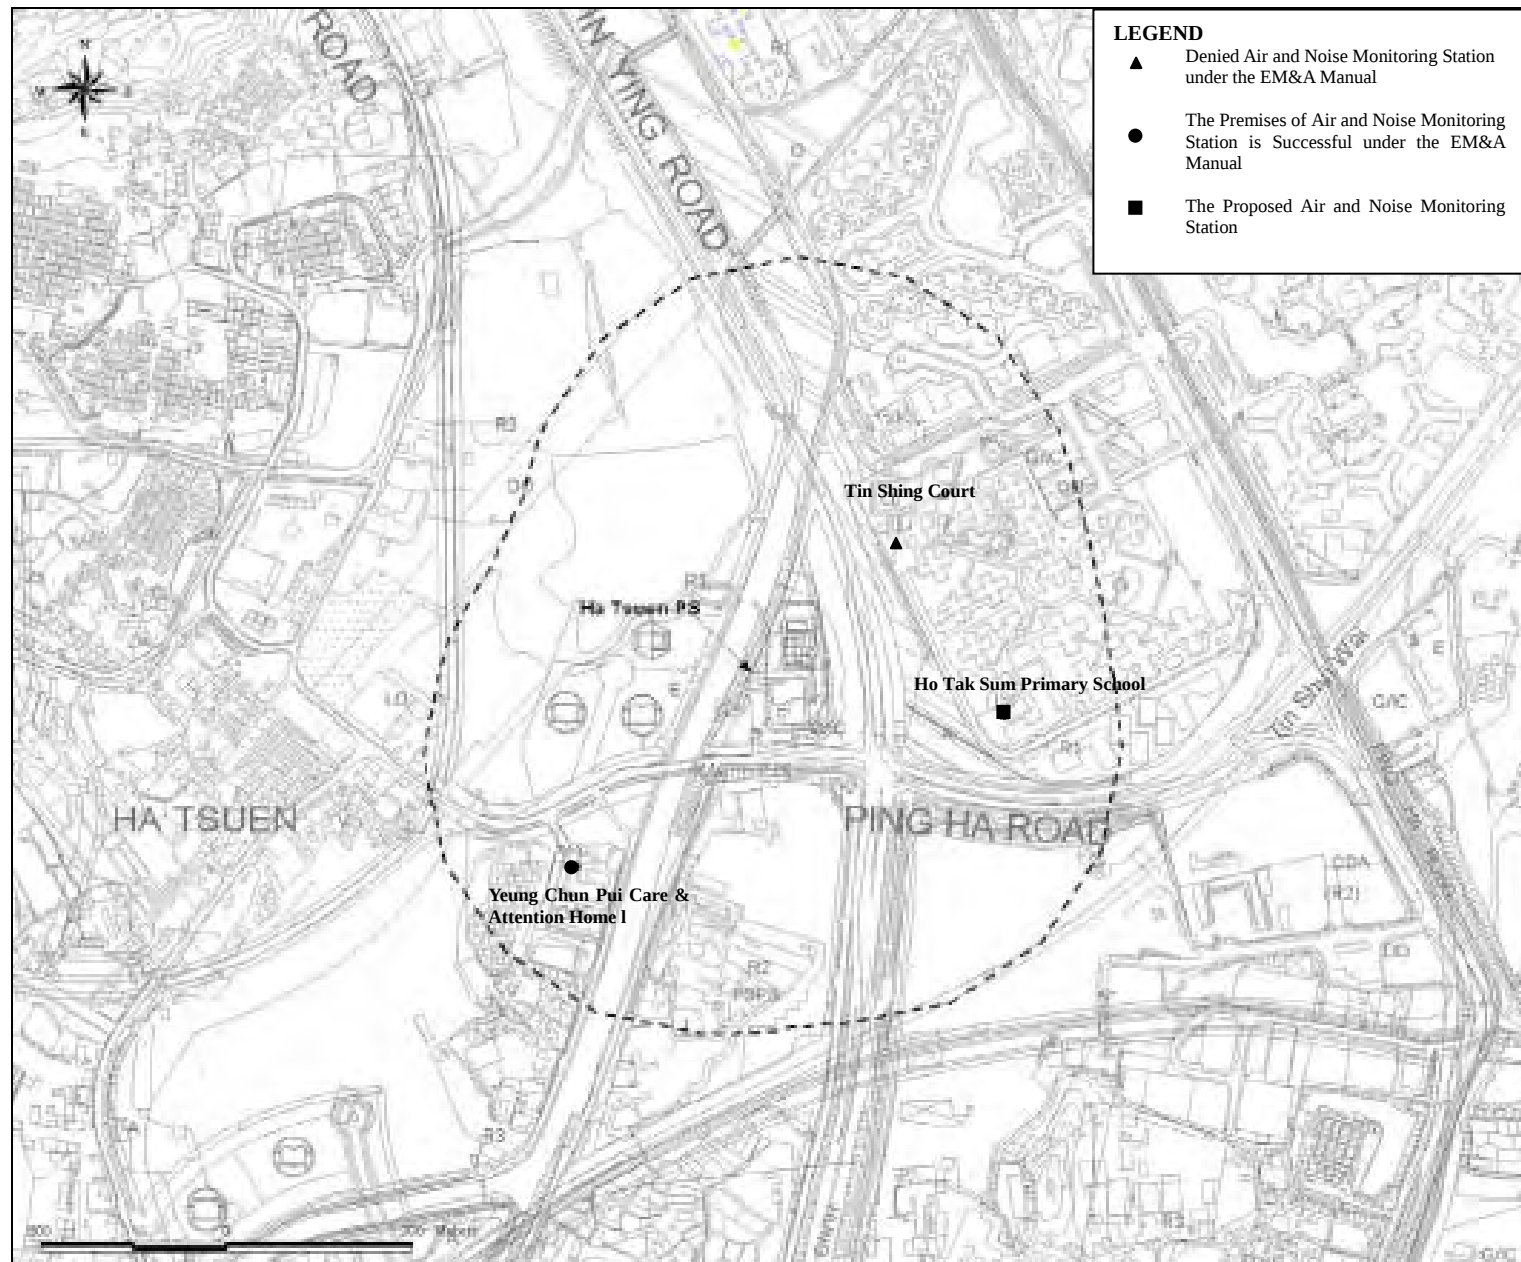
**Proposed Air and Noise Monitoring Station**

| Monitoring Location ID | Identified Address | Remarks |
|---|---|---|
| AM1 | Ho Tak Sum Primary School | Replace the Designated Monitoring Station Tin Shing Court |

| Monitoring Location ID | Identified Address | Remarks |
|---|---|---|
| NM1 | Ho Tak Sum Primary School | Replace the Designated Monitoring Station Tin Shing Court |

- 3.05 In this case, the alternative location Ho Tak Sum Primary School as one sensitive receiver mentioned in the EIA Report (Register No. AEIAR-072/2003) is proposed to be the replacement to undertake air quality monitoring during the expansion works of Ha Tsuen Sewage Pumping Station in accordance with the EM&A Manual Clauses 2.2.1.20. Simultaneously, air monitoring at the designated location Yeung Chun Pui Care & Attention Home is proposed to be performed. The proposal and recommendation is agreed by IEC and as endorsed by EPD. The monitoring stations are detailed to list in **Table 3-2** and illustrated in **Appendix D**.

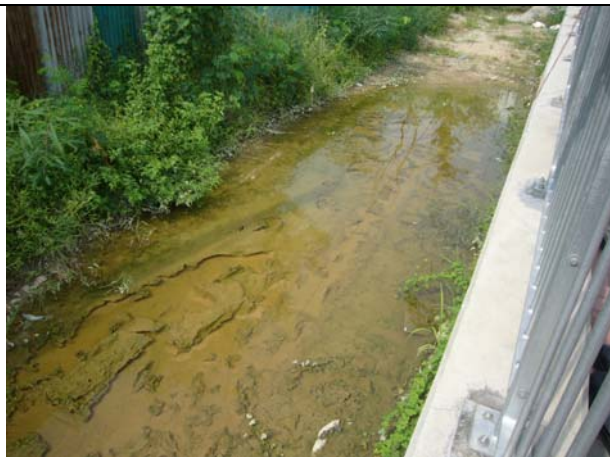
**Observations recorded in this Site Inspection: (6-09-2011)**

3. Stagnant water was observed along the site.  
Mosquito control is reminded.

| <b>Date</b> | <b>Findings / Deficiencies</b> | <b>Follow-Up Status</b> |
|---|---|---|
| 6 September 2011 | <ul style="list-style-type: none"> <li>Stagnant water was observed along the site. Mosquito control is reminded.</li> </ul> | Rectified as observed on 16 Sep 2011. |

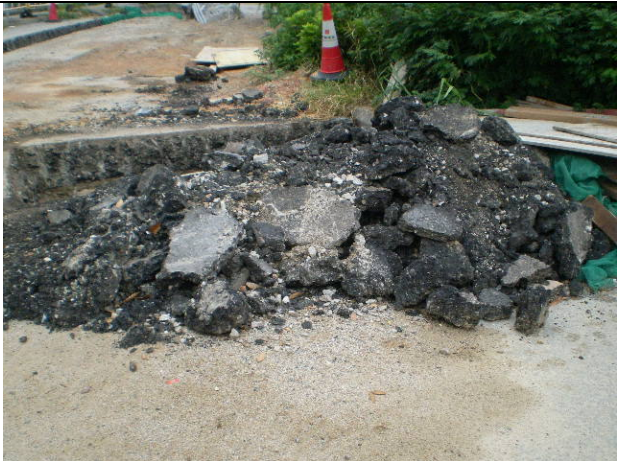
**Observations recorded in this Site Inspection: (20-09-2011)**

| The contractor was reminded to cover the excavation soil to avoid dust nuisance. | |

| <b>Date</b> | <b>Findings / Deficiencies</b> | <b>Follow-Up Status</b> |
|---|---|---|
| 20 September 2011 | <ul style="list-style-type: none"> <li>The contractor was reminded to cover the excavation soil to avoid dust nuisance.</li> </ul> | Rectified as observed on 27 Sep 2011. |

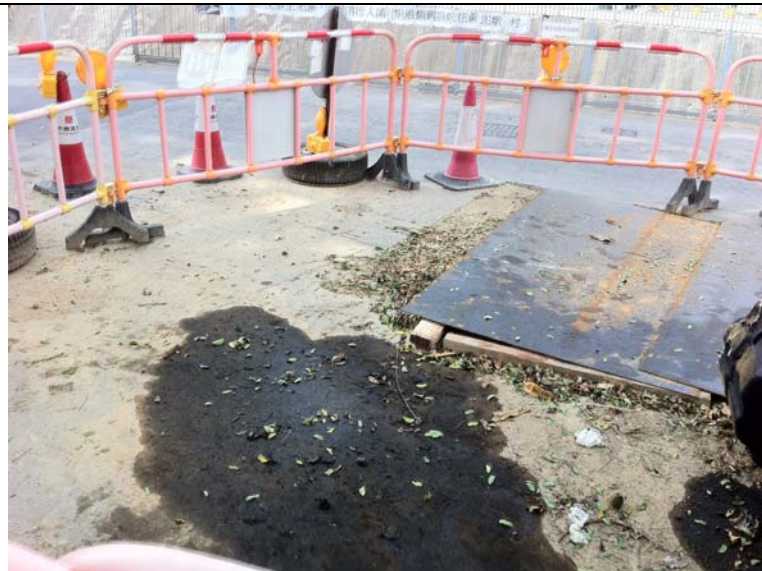
**Observations recorded in this Site Inspection: (27-09-2011)**

1. Oil stain was observed on the hard paved ground at Kiu Hing Road, the Contractor is reminded to clean the oil stain immediately to avoid land contamination.
2. No observation was recorded at Ha Tsuen Pumping Station.
