DSD CONTRACT NO.: DC/2009/08

CONSTRUCTION OF YUEN LONG SOUTH BRANCH  
SEWERS AND EXPANSION OF HA TSUEN SEWAGE  
PUMPING STATION

22<sup>ND</sup> ENVIRONMENTAL MONITORING & AUDIT  
MONTHLY REPORT – NOVEMBER 2011

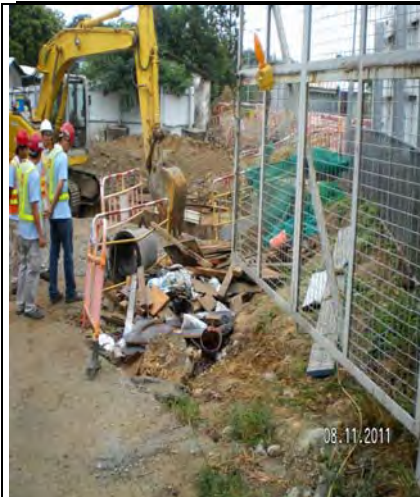
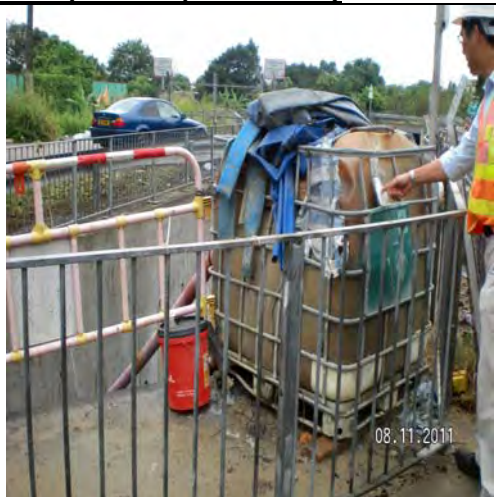
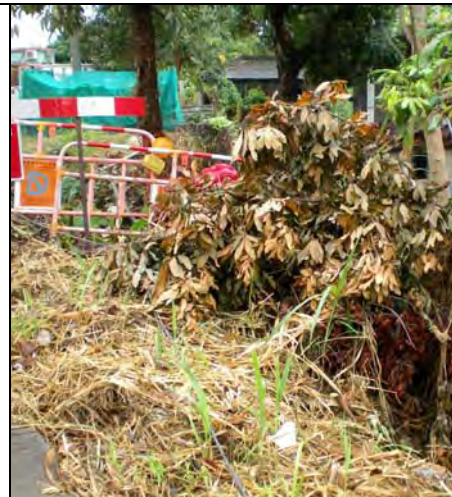
Remark 1: Construction waste was observed within the site of Shui Tsiu San Tsuen. Regular clearing is reminded

1 & 2: Construction waste and ponding water was cleared.

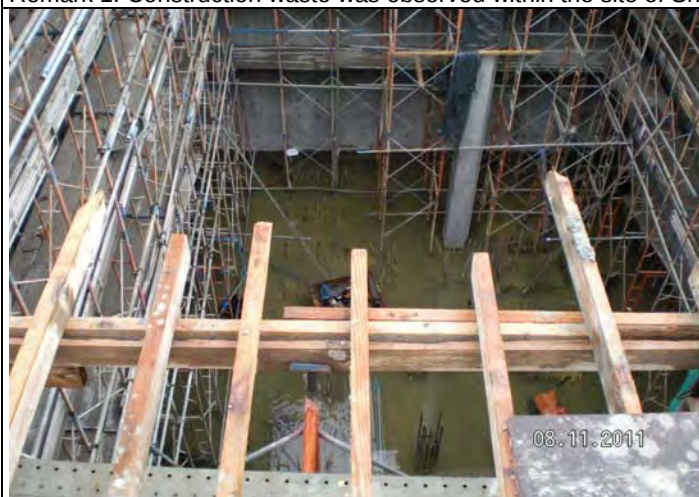
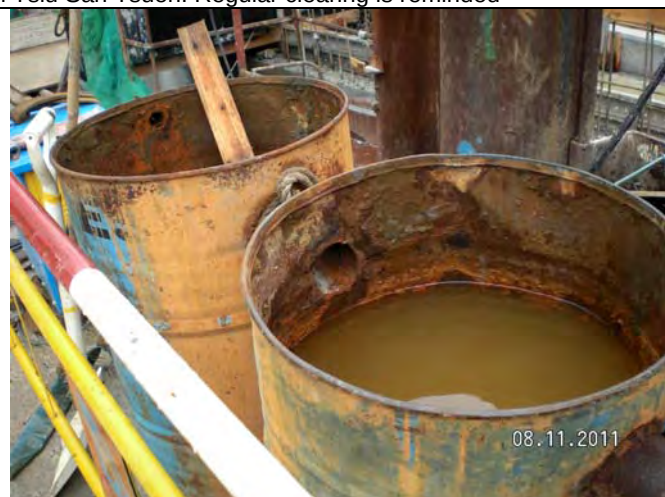
| <b>Date</b> | <b>Findings / Deficiencies</b> | <b>Follow-Up Status</b> |
|---|---|---|
| 8 November 2011 | <ul style="list-style-type: none"> <li>Ponding water was observed within the site of Ha Tsuen Pumping Station. Drying off the ponding water or mosquito control measures is reminded.</li> </ul> | <ul style="list-style-type: none"> <li>Rectified at before site inspection on 16 November 2011.</li> <li></li> </ul> |

Remark 2: Ponding water was observed within the site of Ha Tsuen Pumping Station. Drying off the ponding water or mosquito control measures is reminded.

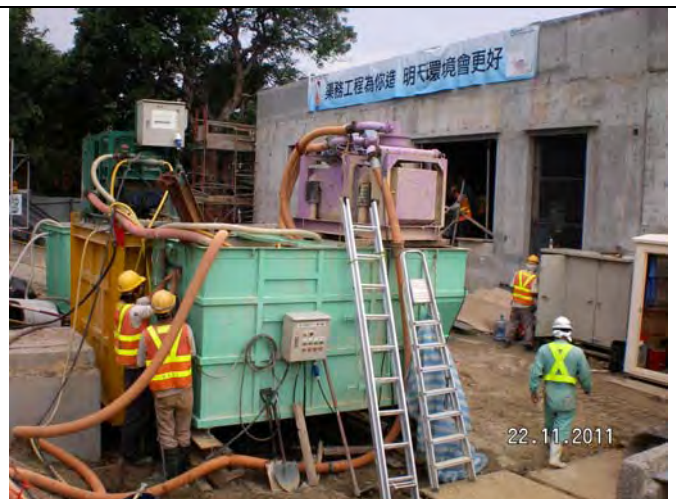
1. Ponding water was cleared.

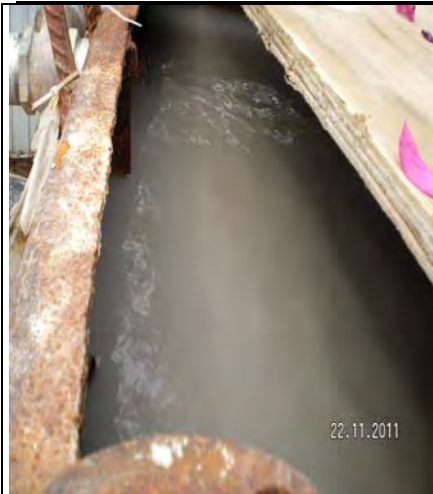
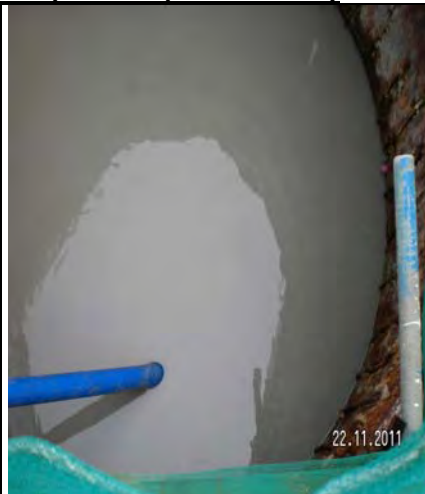
Remark 1: Dry and dusty construction activities were observed within Shui Tsui Tsuen site. Watering is reminded during dry and windy conditions.

- 1) Clearance of the accumulated sediment in the sedimentation tanks is on-going.
- 2) Dry and dusty construction activities were not observed within Shui Tsiu Tsuen site.

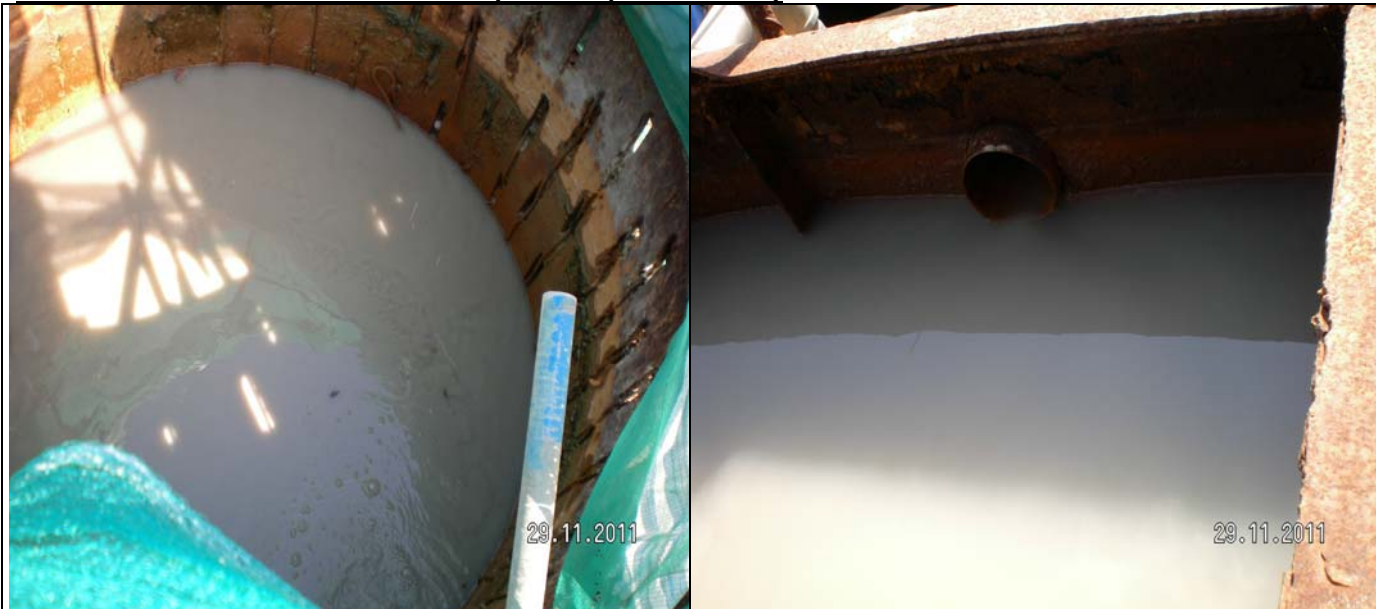
| <b>Date</b> | <b>Findings / Deficiencies</b> | <b>Follow-Up Status</b> |
|---|---|---|
| 29 November 2011 | <ul style="list-style-type: none"> <li>Turbid water was observed in the discharge of sedimentation tanks in Ha Tsuen Pumping Station, improvement of the sedimentation is required.</li> </ul> | <ul style="list-style-type: none"> <li>On-going</li> </ul> |

Remark 1: Turbid water was observed in the discharge of sedimentation tanks in Ha Tsuen Pumping Station, improvement of the sedimentation is required.
