DSD CONTRACT NO.: DC/2009/08

CONSTRUCTION OF YUEN LONG SOUTH BRANCH  
SEWERS AND EXPANSION OF HA TSUEN SEWAGE  
PUMPING STATION

**23<sup>RD</sup> ENVIRONMENTAL MONITORING & AUDIT  
MONTHLY REPORT – DECEMBER 2011**

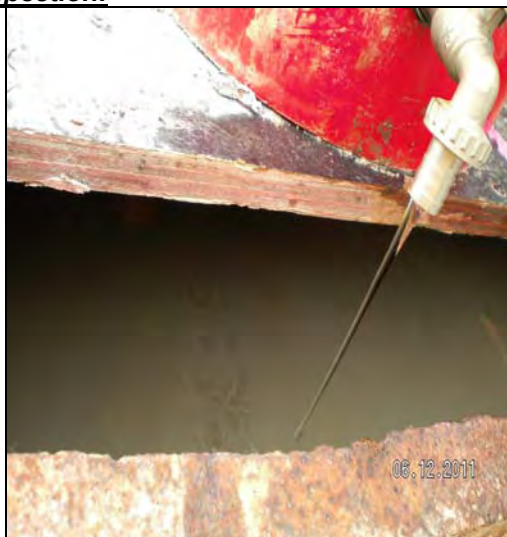
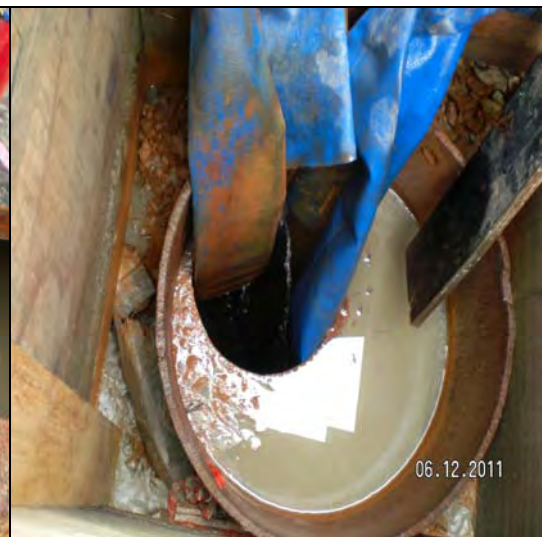
**Follow up of last Site Inspection:**

- 1) Pretreatment of the turbid water prior to discharge and improvement of water quality was observed.

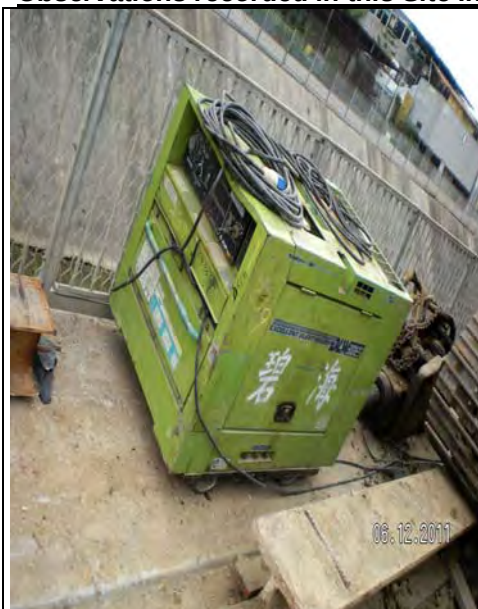
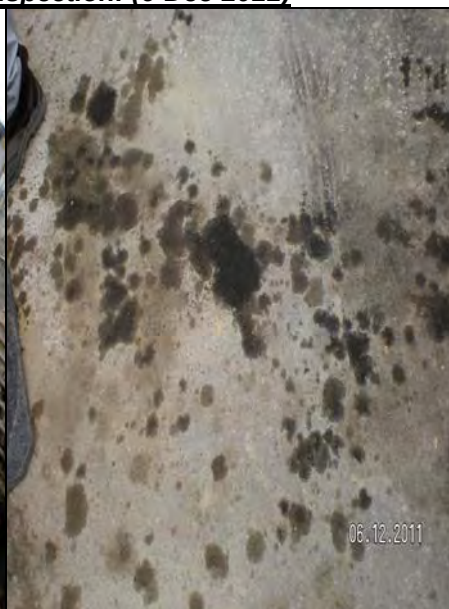
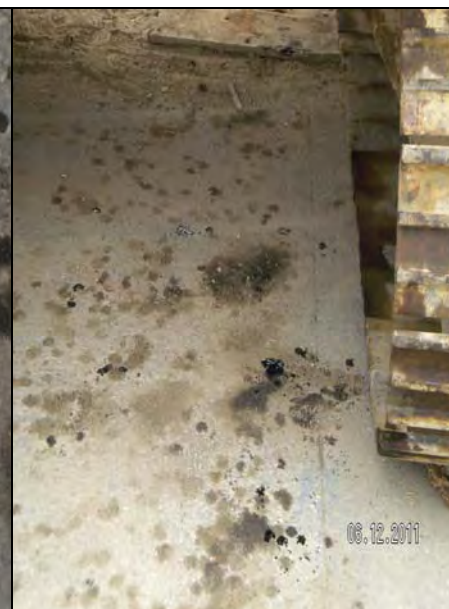
**Observations recorded in this Site Inspection: (6-Dec-2011)**

Remark 1: Generator without drip tray was observed within Yuen Long South (Tai Shu Ha Rd) construction site. Drip tray is required to prevent spilled or leaked oil from entering the nearby receiving water stream .

Remark 2: Trace of leaked oil was observed on the road nearby the Yuen Long South (Tai Shu Ha Rd) construction site. The source of the oil was found to be the oil leaked from a construction plant . Regular maintenance and repair of the plant is required. In addition, clearance of the trace of leaked oil is required.

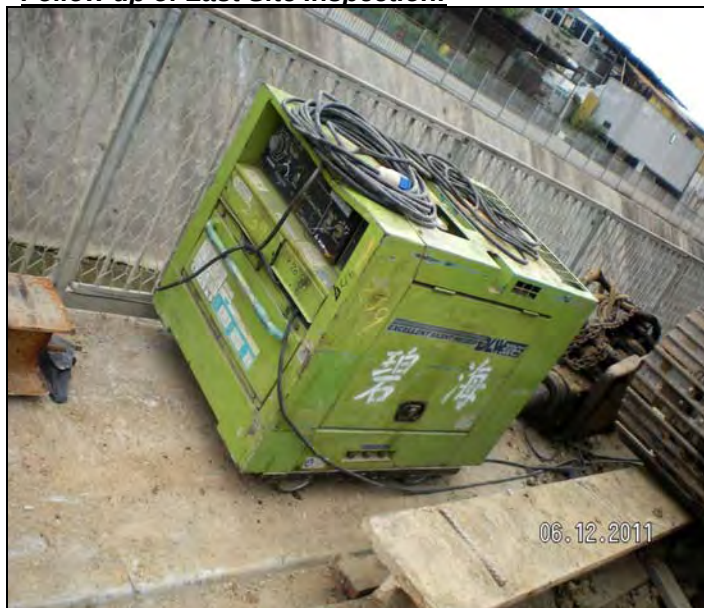
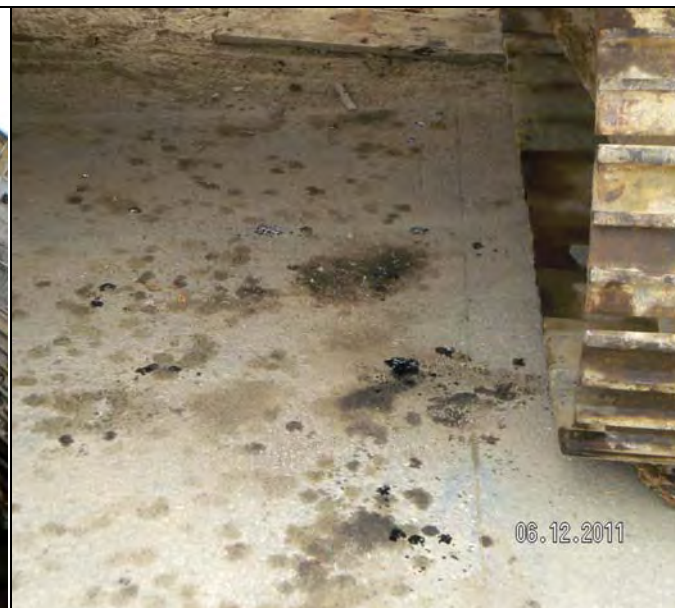
**Follow up of Last Site Inspection:**

1) Provision of drip tray was on going.

2) Clearance of trace of leaked oil was on going.

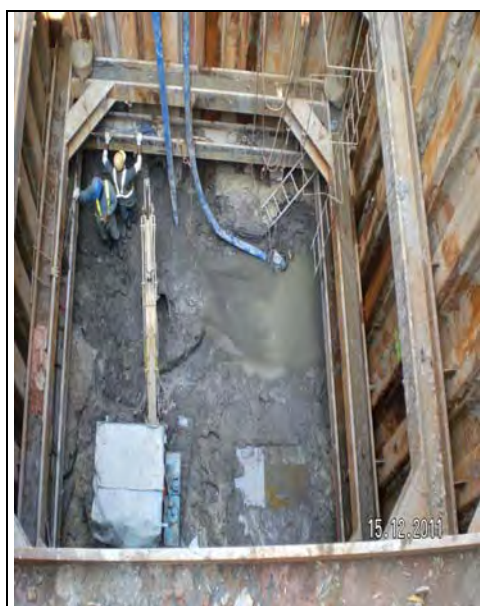
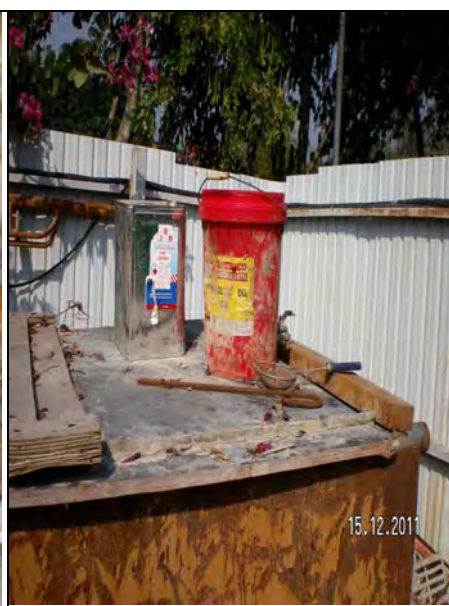
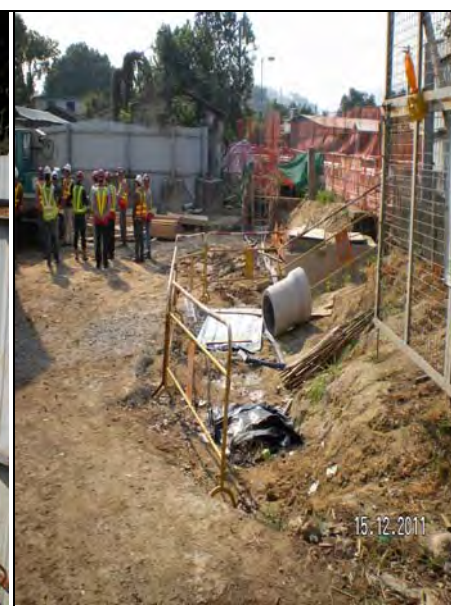
**Observations recorded in this Site Inspection: (15-Dec-2011)**

1) Pumping of turbid water was observed in Ha Tsuen Pumping Station. Desilting of the water prior to discharge is required.

| <b>Date</b> | <b>Findings / Deficiencies</b> | <b>Follow-Up Status</b> |
|---|---|---|
| 15 December 2011 | Pumping of turbid water was observed in Ha Tsuen Pumping Station. Desilting of the water prior to discharge is required. | Treatment of the turbid water was observed during site inspection on 20 December 2011 |

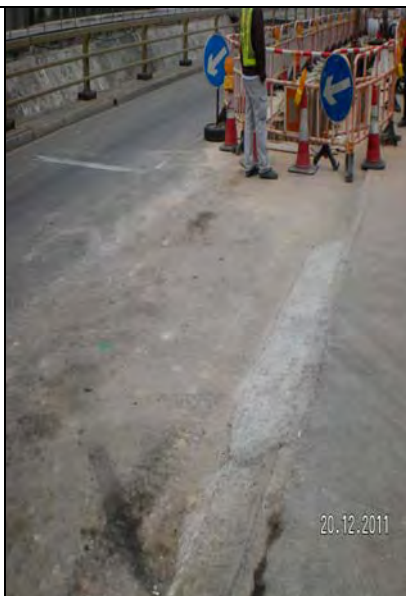
Photo 1

- 1) Generator without drip tray was not observed.
- 2) The leaked oil was not observed. (Photo 1)
- 3) Treatment of the turbid water was observed. (Photo 2)

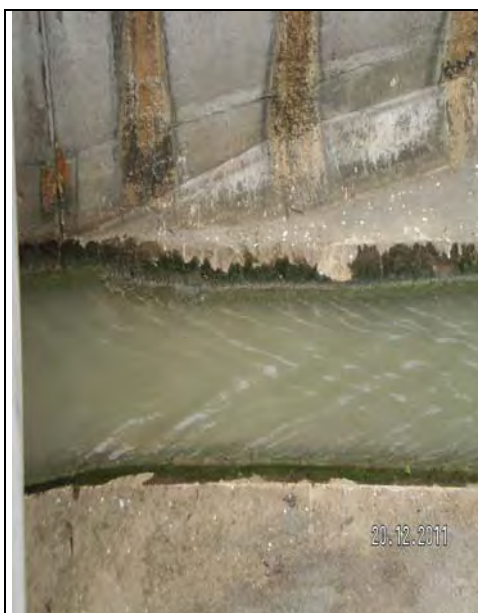
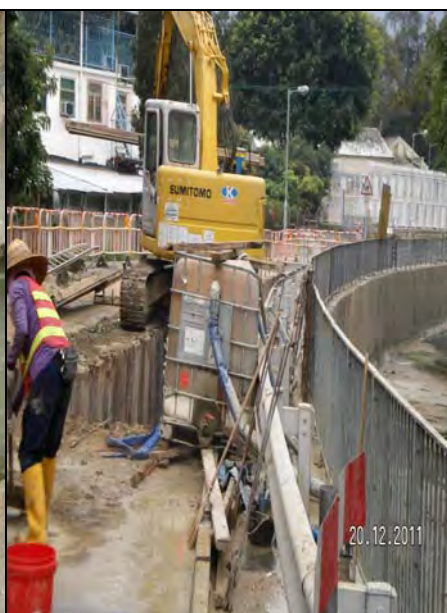
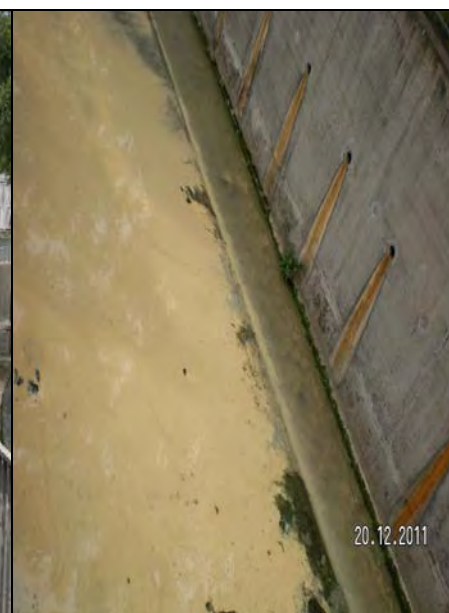
**Observations recorded in this Site Inspection: (20-Dec-2011)**

- 1) Turbid water discharge was observed along Shui Tsiu San Tsuen site. The source of turbidity was found to be the washing of soil spillages on the ground of the upstream site during loading of the excavated soil. Proper treatment of the washing is required prior to discharge.
