JOB No.: TCS00491/09

DSD CONTRACT NO.: DC/2009/08

CONSTRUCTION OF YUEN LONG SOUTH BRANCH  
SEWERS AND EXPANSION OF HA TSUEN SEWAGE  
PUMPING STATION

24<sup>TH</sup> ENVIRONMENTAL MONITORING & AUDIT  
MONTHLY REPORT – JANUARY 2012

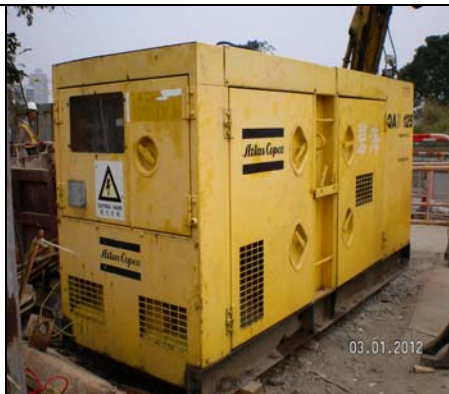
- 1) Generators without drip trays were observed within the site along Tai Shu Ha Road. Drip trays are required to be provided during use of the equipment to avoid spillages of oils. (Photos 1 to 3)
- 2) Construction waste was observed within the site at Ha Tsuen Pumping Station and Shui Tsiu Tsuen Pumping Station. Regular clearance is reminded to avoid excessive accumulation. (Photos 4 & 5)

Photo 1 Generators without drip trays

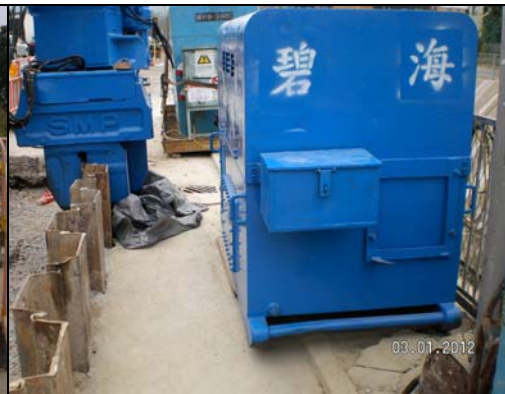
Photo 2 Generators without drip trays

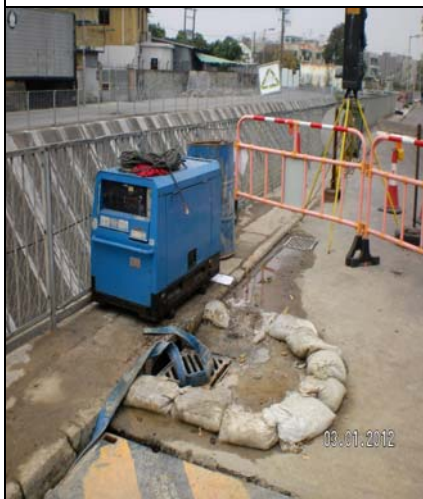
Photo 3 Generators without drip trays

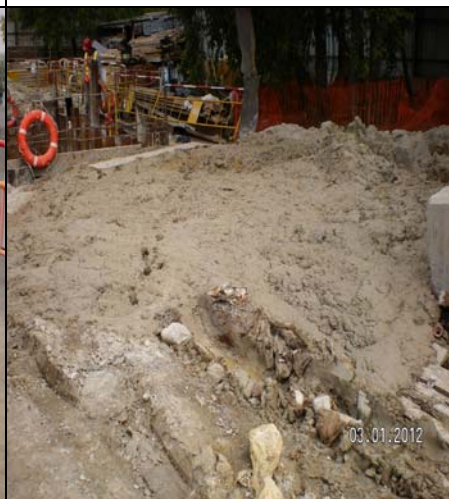
Photo 4 Mud stock piled within the site at Ha Tsuen Pumping Station

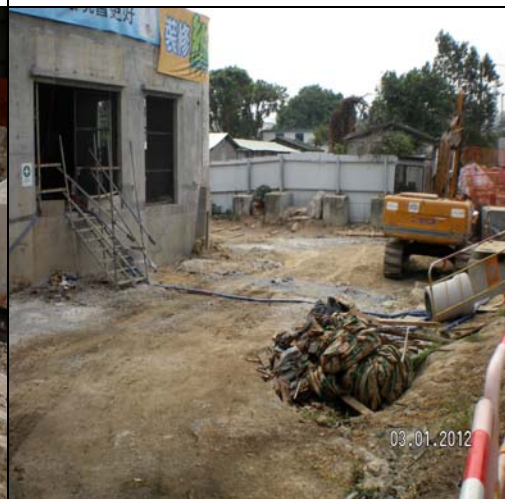
Photo 5 Construction waste stock piled within the site at Shui Tsiu Tsuen Pumping Station.

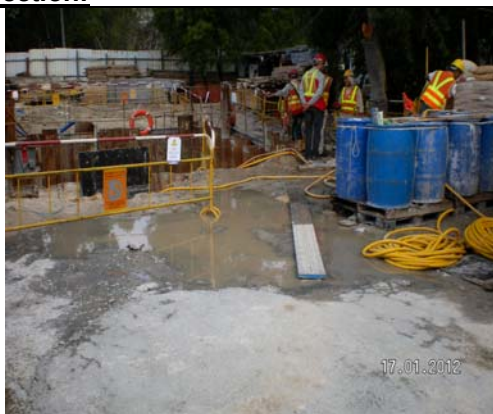
Photo 1

- 1) Provision of drip trays is on-going.
- 2) Construction waste was cleared. (Photo 1)
- 3) Construction waste within Shui Tsiu San Tsuen was cleared. (Photo 2)

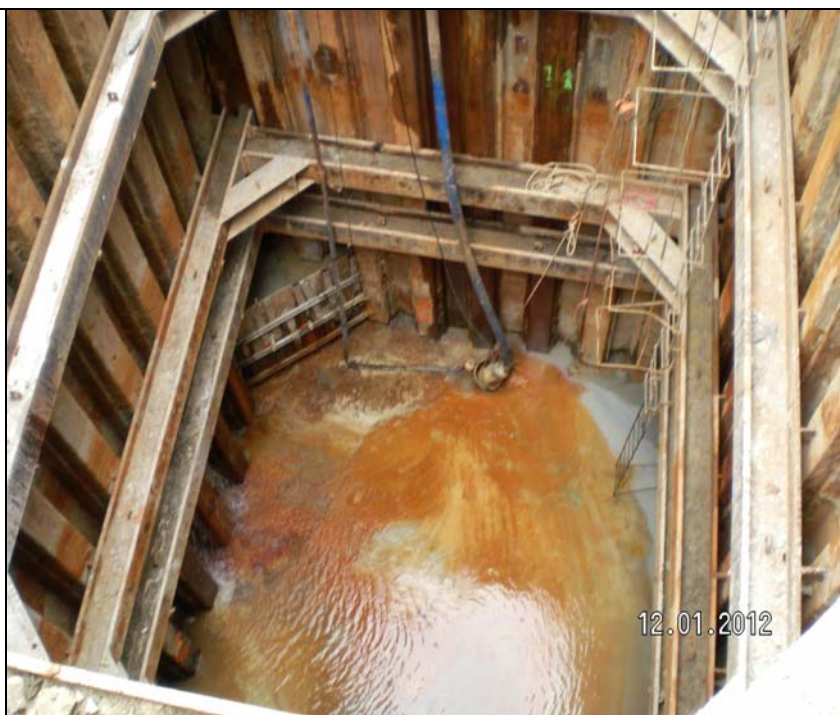
- 1) Groundwater pumping was observed within construction site at Ha Tsuen Pumping Station. Pre-treatment of the groundwater prior to discharge is reminded. (Photo 3)

Photo 3 Groundwater pumping

| <b>Date</b> | <b>Findings / Deficiencies</b> | <b>Follow-Up Status</b> |
|---|---|---|
| 12 January 2012 | Groundwater pumping was observed within construction site at Ha Tsuen Pumping Station. Pre-treatment of the groundwater prior to discharge is reminded. | Not required for reminder. |

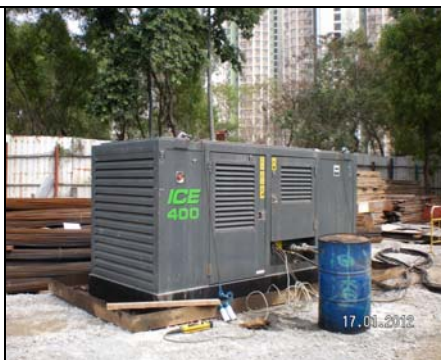
- 1) Oil Drum without drip tray was observed at Ha Tsuen Pumping Station (photo 1) and Tai Shu Ha Rd. Provision of drip tray or removal of the oil drum from the site is required.

Photo 1: Oil drum without drip tray at Ha Tsuen Pumping Station.

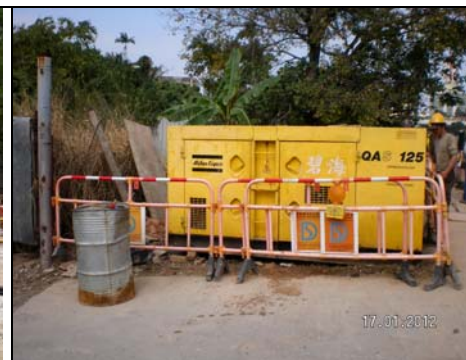
Photo 2: Oil drum without drip tray at Tai Shu Ha Tsuen.

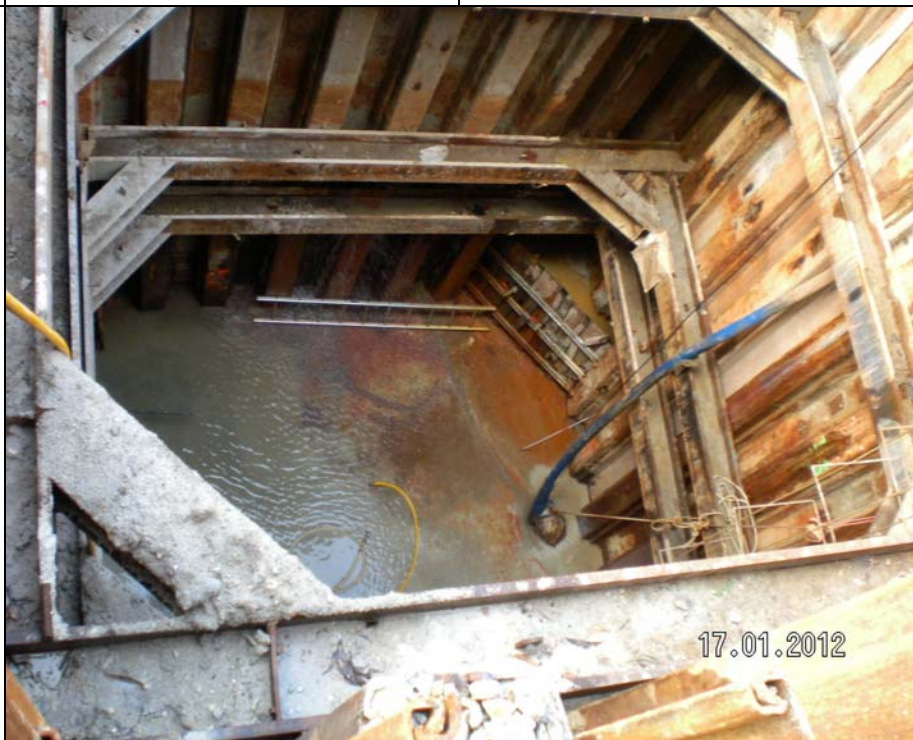
- 2) Groundwater pumping was observed within Ha Tsuen Pumping Station. Pretreatment of the groundwater prior to discharge is reminded.

Photo 3 Groundwater pumping at Ha Tsuen Pumping Station.

| <b>Date</b> | <b>Findings / Deficiencies</b> | <b>Follow-Up Status</b> |
|---|---|---|
| 17 January 2012 | Groundwater pumping was observed within construction site at Ha Tsuen Pumping Station. Pre-treatment of the groundwater prior to discharge is reminded. | Not required for reminder. |

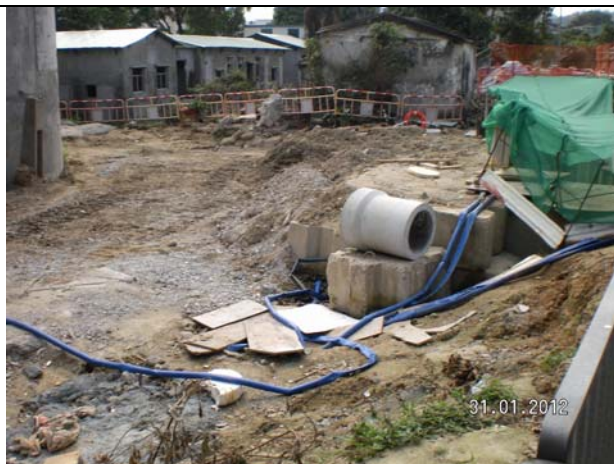
Photo 1

- 1) Discharge of groundwater was observed at Shui Tsiu San Tsuen Pumping Station. Pre-treatment of the groundwater prior to discharge is reminded. (Photo 1)
- 2) Water ponding was observed at Ha Tsuen Pumping Station. Mosquito control measures is reminded. (Photo 2)
