DSD CONTRACT No.: DC/2009/08

CONSTRUCTION OF YUEN LONG SOUTH BRANCH SEWERS AND EXPANSION OF HA TSUEN SEWAGE PUMPING STATION

25TH ENVIRONMENTAL MONITORING & AUDIT MONTHLY REPORT – FEBRUARY 2012

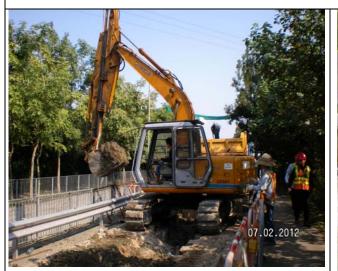
Photo 1 Photo 2

- Loading of excavated soil to a dump truck was observed on the site beside the up-stream of water course at Shui Tsui Tsuen Prevention of soil spillage from dropping to the nearby water stream and public road is reminded. (Photo 1)
- Oil stains were observed below the backhoe under repair. The oil stains was promptly cleared on site upon notification by inspection team (Photo 2);
- Refilled wheel washing bay at Ha Tsuen Pumping Station site exit was observed. Manual wheel washing is reminded to prevent carrying excavated soil to the surrounding public roads. (Photo 3)
- Generator without drip tray was observed idling within the site. Drip tray is required to avoid oil contamination if the generator is put into service. (Photo 42)

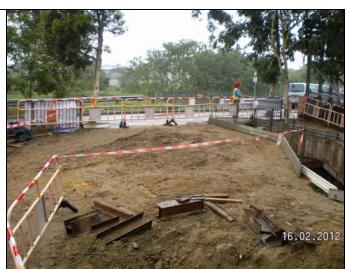
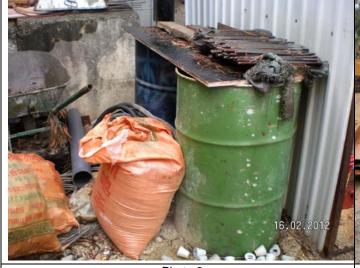
Photo 1 Photo 2

- Dusty haul road was observed at the entrance/exit of Shui Tsiu San Tsuen Pumping Station. Watering of the haul road during dusty construction activities under dry and windy conditions and wheel washing of any vehicle prior to exit is reminded. (Photo 1)
- Two oil drums were observed at Ha Tsuen Pumping Station full of water. Regular drying off the water in the drums is reminded.(Photo 2).
- 3) One rubbish bins at Ha Tsuen Pumping Station were found Mismanaged. Improvement is reminded. (Photo 3)

- 1) Dusty haul road was observed at the entrance/exit of Shui Tsiu San Tsuen Pumping Station. Watering of the haul road during dusty construction activities under dry and windy conditions and wheel washing of any dusty vehicle prior to exit is reminded. (Photo 3)
- 2) Dusty construction site was observed at Ha Tsuen Pumping Station. Construction dust suppression measures is reminded under dry and windy conditions and wheel washing of any dusty vehicle prior to exit is eminded. (Photo 4 & 5)
