DSD CONTRACT No.: DC/2009/08

CONSTRUCTION OF YUEN LONG SOUTH BRANCH SEWERS AND EXPANSION OF HA TSUEN SEWAGE PUMPING STATION

28TH ENVIRONMENTAL MONITORING & AUDIT MONTHLY REPORT – MAY 2012

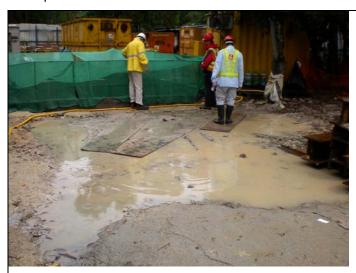
Photo 1

1. Rain water was observed ponding within the site along Yuen Long South and Ha Tsuen Pumping Station. Mosquito control measures is reminded.

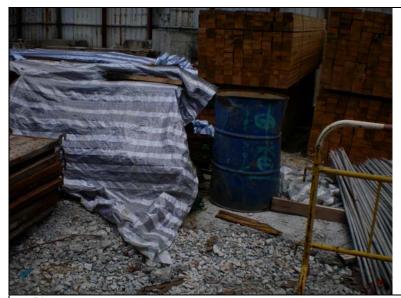
Photo 1

1. Oil drum without drip tray was observed within the site at Ha Tsuen Pumping Station. Drip tray is required or removal of the oil drum from the site is required.

1) Oil drum without drip tray was not observed within the site at Ha Tsuen Pumping Station.

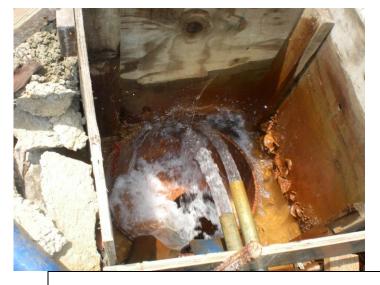
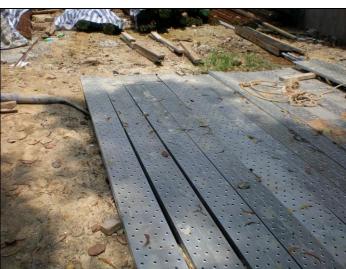
1. Discharge of groundwater was observed at water Ha Tsuen Pumping Station after pre-treatment via sedimentation pond. Compliance with all requirements stipulated in the Discharge License is reminded.

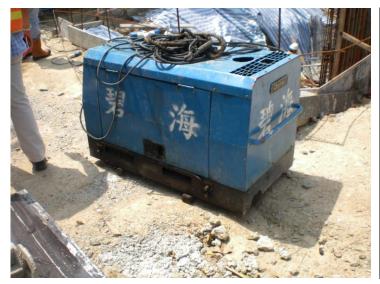
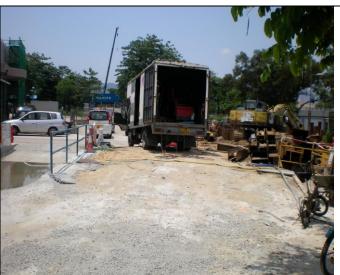
- 1. Generator without oil drum was observed within the site at Tai Shu Ha Road. Drip tray is required to avoid water quality and land contamination by leakage of fuel oil from the generator. (Photo 1)
- 2. Dusty and dry surface was observed within the site at Ha Tsuen Pumping Station. Construction dust suppression measures are reminded during dusty construction activities under dry and windy conditions.

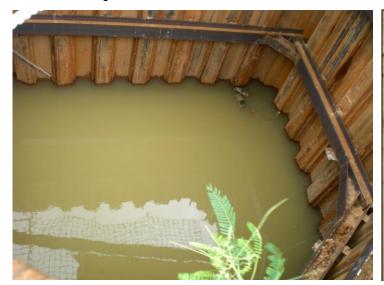
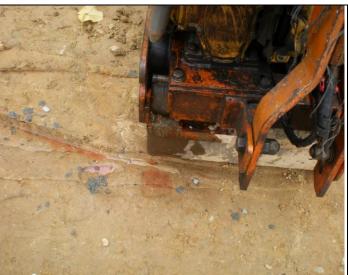
- 1. Ponding water was observed within the site at Tai Shu Ha Rd. Mosquito control is reminded.
- 2. Leakage of oil was observed within the site at Tai Shu Ha Rd, the Sub-Contractor was instructed to rectified the oil leakage on site.
