JOB NO.: TCS00491/09

DSD CONTRACT No.: DC/2009/08

CONSTRUCTION OF YUEN LONG SOUTH BRANCH SEWERS AND EXPANSION OF HA TSUEN SEWAGE PUMPING STATION

29TH ENVIRONMENTAL MONITORING & AUDIT MONTHLY REPORT – JUNE 2012

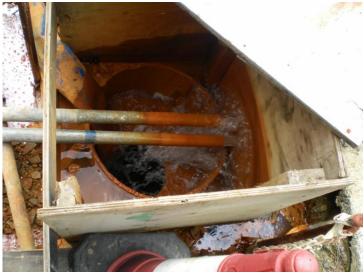
Photo 1 Discharge of groundwater at Ha Tsuen Pumping Station

1. Discharge of groundwater generated from Ha Tsuen Pumping Station after sedimentation was observed. Compliance with discharge license i.e. regular water quality testing, is reminded.

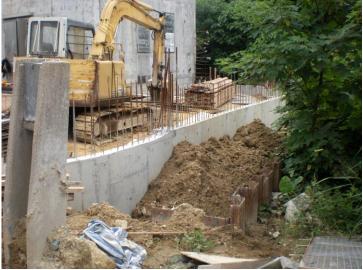
Photo 1 Duty construction activities at Shui Tsui Tsuen Pumping Station

1. Dusty construction is observed within construction site at Shui Tsuin Tsuen Pumping Station (Photo 1) and Ha Tsuan Pumping Station (Photo 2). Full implementation of the required environmental mitigation, particularly watering during dusty activities under dry and windy conditions is reminded.

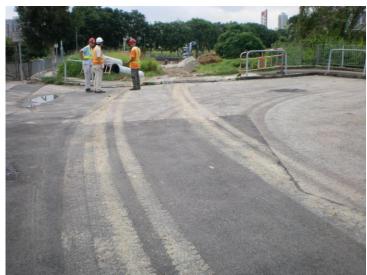
Photo 1 Soil trails on the public road at the exit of construction site at Shan Chung Rd.

- 1. Soil trails were observed on the public road at the site exit, wheel washing of the construction plants or vehicles is required prior to exit. (Photo 1)
- 2. Dusty haul road surfaces were observed within construction site at Shan Chung Rd. Full implementation of the required environmental mitigation measures is reminded. (Photo 2)

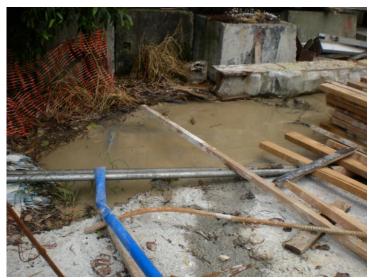
Photo 1 Photo 2

- 1. Ground water was observed overflowing from underground balancing pond causing flooded area within the site at Ha Tsuen Pumping Station. Remediation measures are required. (Photo 1)
- 2. Excessive construction waste was observed on within the site at at Ha Tsuen Pumping Station. Regular clearance is recommended. (Photo 2)
