JOB No.: TCS00491/09

DSD CONTRACT NO.: DC/2009/08

CONSTRUCTION OF YUEN LONG SOUTH BRANCH  
SEWERS AND EXPANSION OF HA TSUEN SEWAGE  
PUMPING STATION

**30<sup>TH</sup> ENVIRONMENTAL MONITORING & AUDIT  
MONTHLY REPORT – JULY 2012**

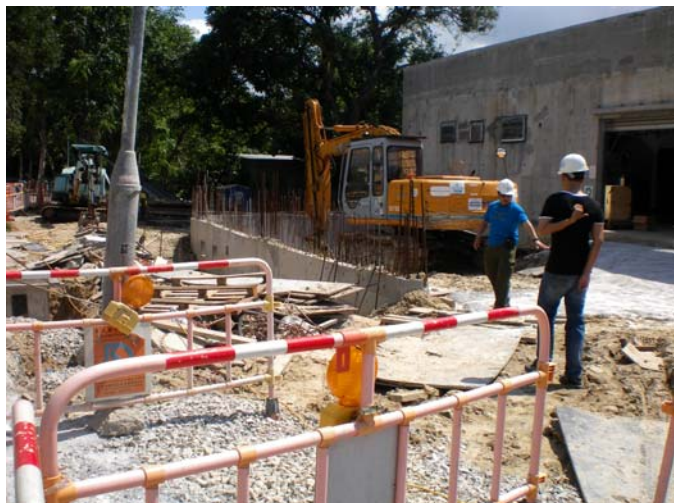
Photo 1

1. Construction waste was observed scattering within Shui Tsui Tsun Pumping Station site. Regular clearance and proper disposal of the waste is reminded. (Photo 1)
2. Dry and dusty surfaces were observed within the site at Ha Tsuen Pumping Station. Construction dust suppression measures are reminded. (Photo 2)

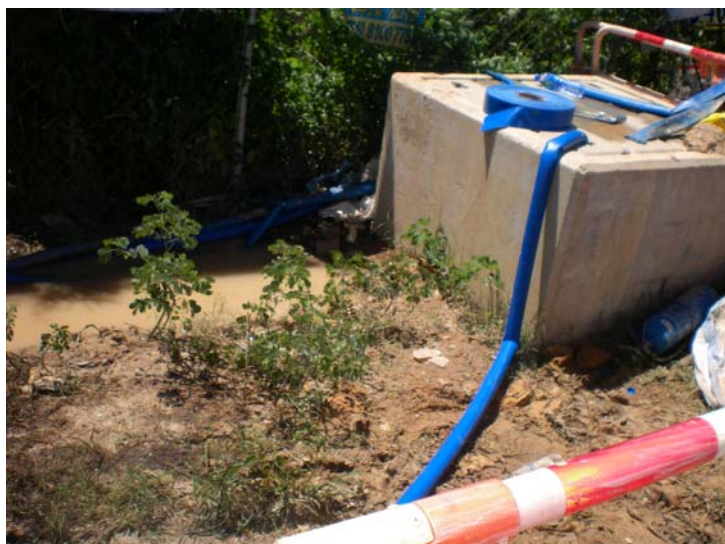
Photo 1

1. Ponding water due to rain was observed within the site along Yuen Long South. Clearance of the ponding water after rain is required or mosquito control measures are reminded. (Photo 1)
2. Dry and dusty surfaces were observed within the site along Yuen Long South. Construction dust suppression measures are reminded. (Photo 2)

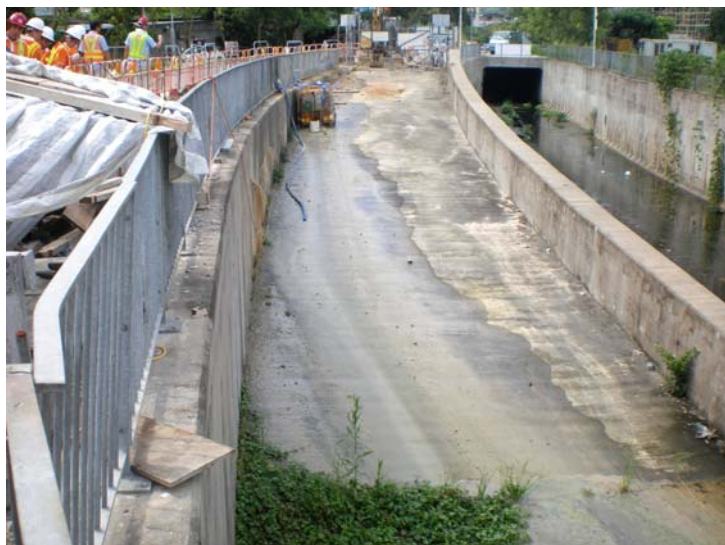
Photo 1

1. Turbid water and trails of sediments from water treatment tank were observed along the ramp beside the water stream. Improvement of the water treatment and clearance of the trails is required to minimize the water quality impacts on the receiving water body. (Photo 1)
2. Discharge of groundwater from the site at Ha Tsuen Pumping Station was observed with considerably higher flow rate than Discharge Licence Limit of 15 M<sup>3</sup>/day. Reduction of flow rate to below 15 M<sup>3</sup>/day or application of variation of flow rate limit is required. (Photo 2)

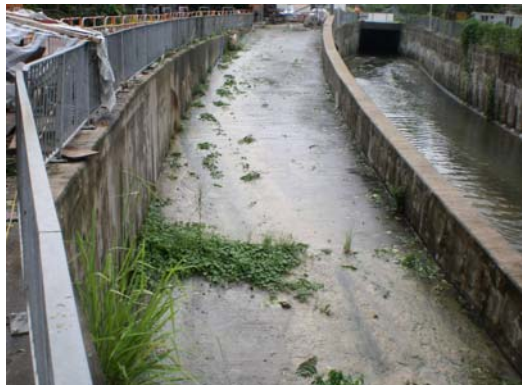
Photo 1

- 1) Trails of sediments were not observed along the ramp beside the water stream at Shui Tsiu San Tsuen construction site; (Photo 1)
- 2) Discharge of groundwater from the site was not observed at Ha Tsuen Pumping Station. (Photo 2)

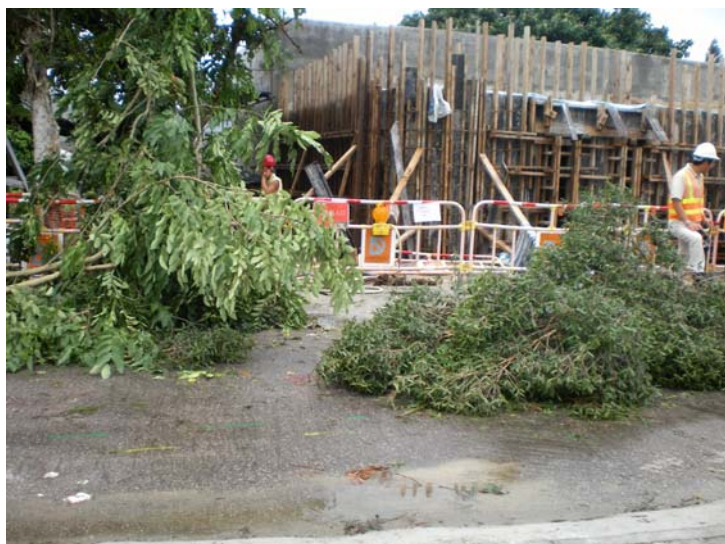
Photo 3

1. Fallen trees and tree branches due to typhoon were observed beside the site at at Shui Tsiu San Tsuen. Clearance and proper disposal of the fallen trees or branches is reminded. (Photo 3)

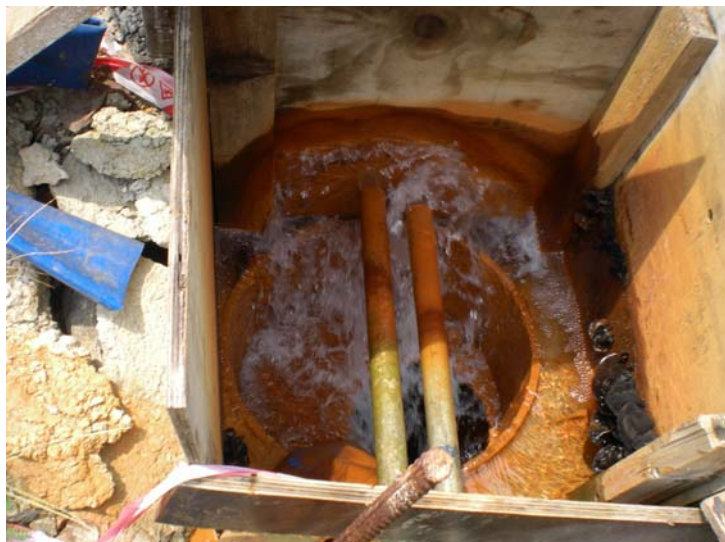
1. Excessive discharge (Photo 1) and flooded area (Photo 2 & 3) was observed within the site at Ha Tsuen Pumping Station. The sources of flood were overflow from underground balancing water pond. Remedial actions are required to rectify the situation.
2. Fallen trees/branches due to typhoon were observed at Ha Tsuen Pumping Station. Regular clearance and proper disposal of the fallen trees/ branches is reminded. (Photo 4)

Photo 1: Excessive discharge at Ha Tsuen Pumping Station

| Date | Findings / Deficiencies | Follow-Up Status |
|---|---|---|
| 31 July 2012 | <ul style="list-style-type: none"> <li>Excessive discharge and flooded area was observed within the site at Ha Tsuen Pumping Station. The sources of flood were overflow from underground balancing water pond. Remedial actions are required to rectify the situation.</li> <li>Fallen trees/branches due to typhoon were observed at Ha Tsuen Pumping Station. Regular clearance and proper disposal of the fallen trees/ branches is reminded.</li> </ul> | To be followed in August 2012. |

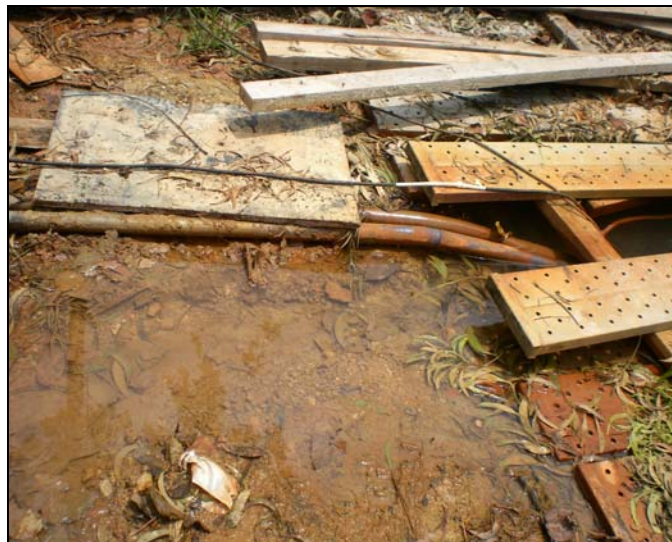
Photo 2: Flooded area at Ha Tsuen Pumping Station

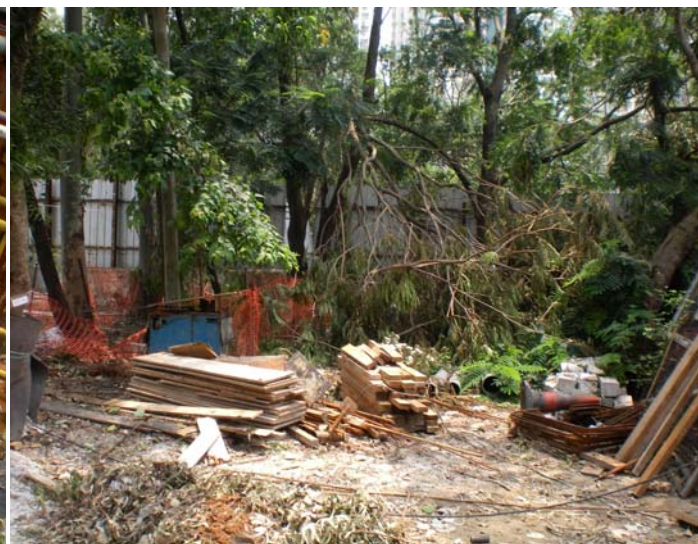
Photo 4: Fallen tree/branches at Ha Tsuen Pumping Station
