DSD CONTRACT No.: DC/2009/08

CONSTRUCTION OF YUEN LONG SOUTH BRANCH SEWERS AND EXPANSION OF HA TSUEN SEWAGE PUMPING STATION

31ST ENVIRONMENTAL MONITORING & AUDIT MONTHLY REPORT – AUGUST 2012

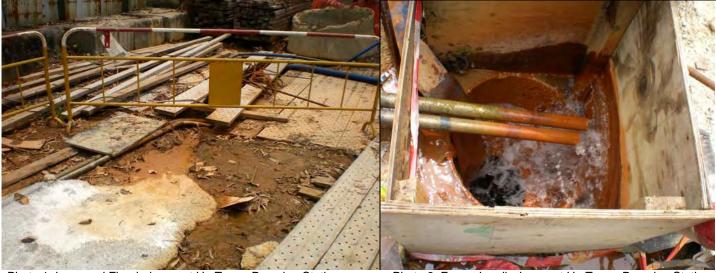
- 1) Condition in flooded area was improved within the site at Ha Tsuen Pumping Station (Photo1);
- 2) Remedial actions for excessive discharge was on-going (Photo 1).

Photo 1: Improved Flooded area at Ha Tsuen Pumping Station.

Photo 2: Excessive discharge at Ha Tsuen Pumping Station

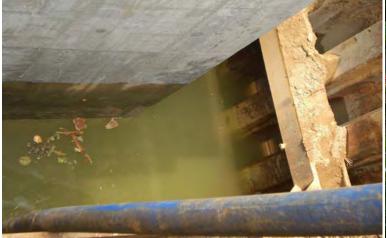
- 1. Excessive groundwater discharge was observed at Ha Tsuen Pumping Station. (Photo 2 & 3) Remedial actions are required to rectify the situation.
- 2. Construction waste scattered within the site at Sham Chung. Regular clearance is reminded.

Photo 3: Source of groundwater at Ha Tsuen Pumping Station.

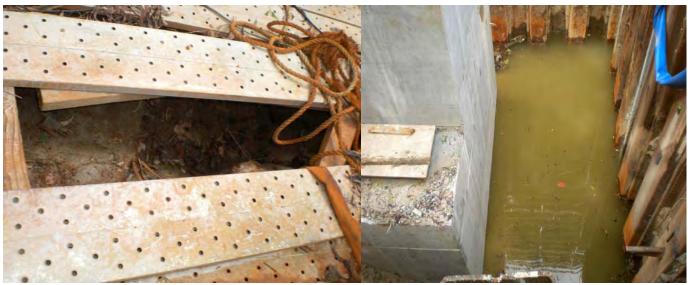
- 1) Groundwater within the site at Ha Tsuen Pumping Station has been stopped from the source. No discharge was observed and the case was closed. (Photo1&2);
- 2) Construction waste scattered within the site was not observed at Sham Chung.

<u>Photo 1</u> No groundwater was pumped out, no overflow was observed and discharged.

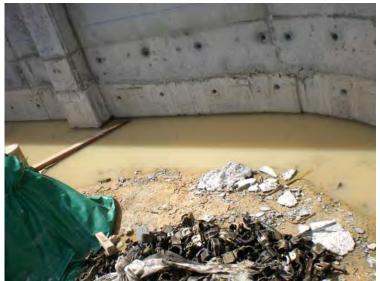
- 1. Rain water was observed at Shui Tsiu San Tsuen Pumping Station. (Photo 3) Clearance of the stagnant water or mosquito control measures are required.
- 2. Construction waste was observed stock piled within the site at Shui Tsiu san Tsuen. Regular clearance is reminded (Photo 4)

Photo 3: Rainwater stagnant within the site at Shui Tsiu San Tsuen Pumping Station.

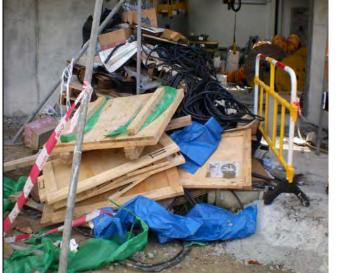
Photo 4: Excessive waste was stock pile at Ha Tsuen Pumping Station. Regular clearing is required.

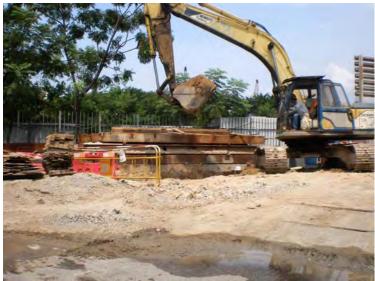
1. Dusty construction activities (Photo 1) were observed within the site at Ha Tsuen Pumping Station. Construction dust suppression measures are reminded during dry and windy conditions.

Photo 1: Dusty construction activities were observed within the site at Ha Tsuen Pumping Station.
