DSD CONTRACT NO.: DC/2009/08

CONSTRUCTION OF YUEN LONG SOUTH BRANCH  
SEWERS AND EXPANSION OF HA TSUEN SEWAGE  
PUMPING STATION

**33<sup>RD</sup> ENVIRONMENTAL MONITORING & AUDIT**  
**MONTHLY REPORT – OCTOBER 2012**

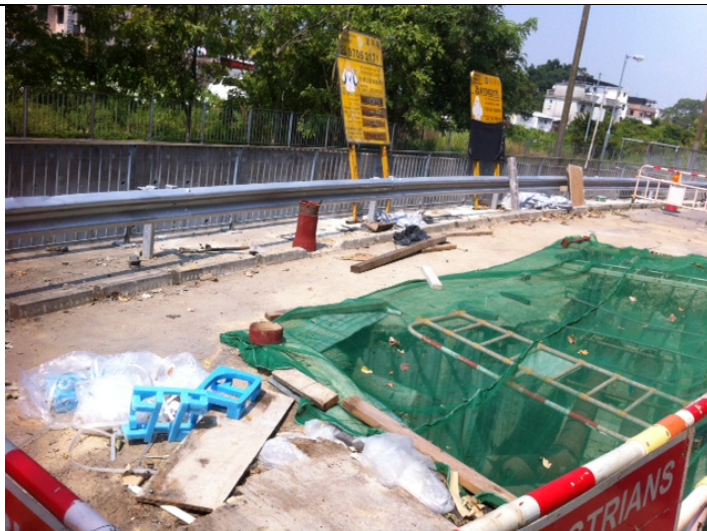
Photo 1:  
Scattered of C&D waste was observed in Shui Tsui San Tsuen road, the Contractor should improve the housekeeping of the construction site.

1. The housekeeping in Shui Tsui San Tsuen Road was found to be improved.
2. The opened cement bag was found to be removed.

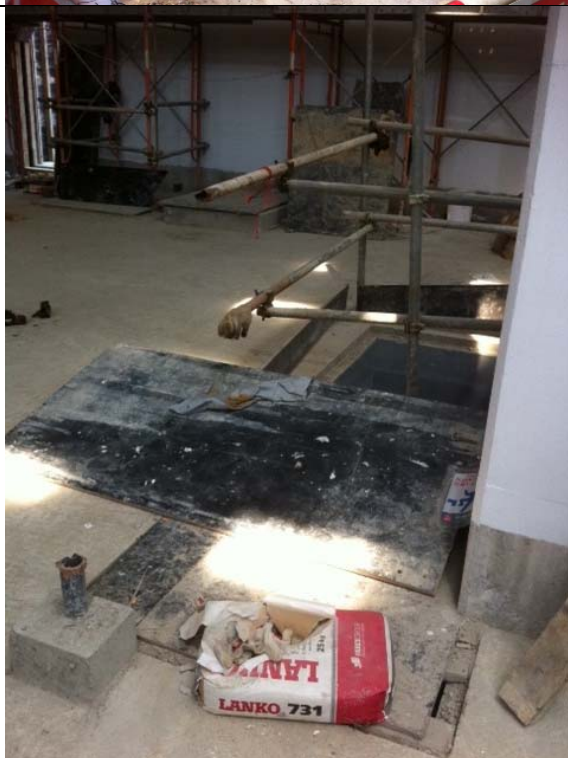
Photo 2:  
An opened cement bag was observed in Ha Tsuen Sewage Pumping Station, the Contractor should cover it with tarpaulin sheet or other means to prevent fugitive dust or remove it immediately.

| Date | Findings / Deficiencies | Follow-Up Status |
|---|---|---|
| 3 October 2012 | <ul style="list-style-type: none"> <li>An opened cement bag was observed in Ha Tsuen Sewage Pumping Station, the Contractor should cover it with tarpaulin sheet or other means to prevent fugitive dust or remove it immediately.</li> </ul> | <ul style="list-style-type: none"> <li>The opened cement bag was removed during site inspection on 9 October 2012.</li> </ul> |

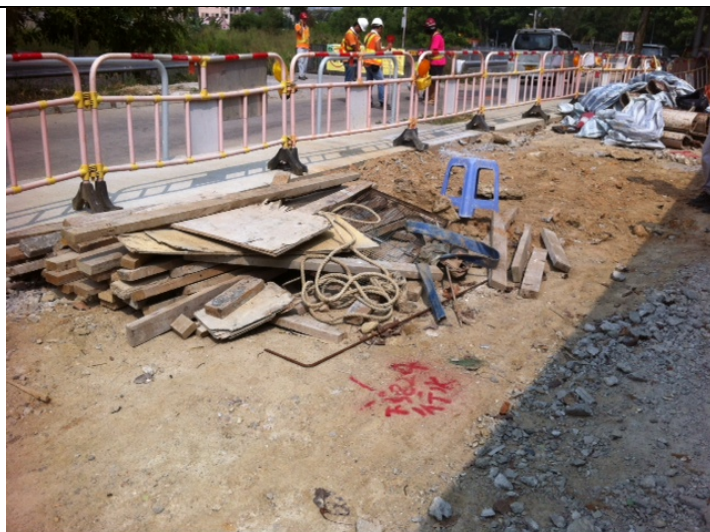
Photo 1:

A heap of C&D waste was observed in Shui Tsui San Tsuen Pumping Station, the Contractor should remove and store the C&D waste in a designated area in order to enhance site tidiness.

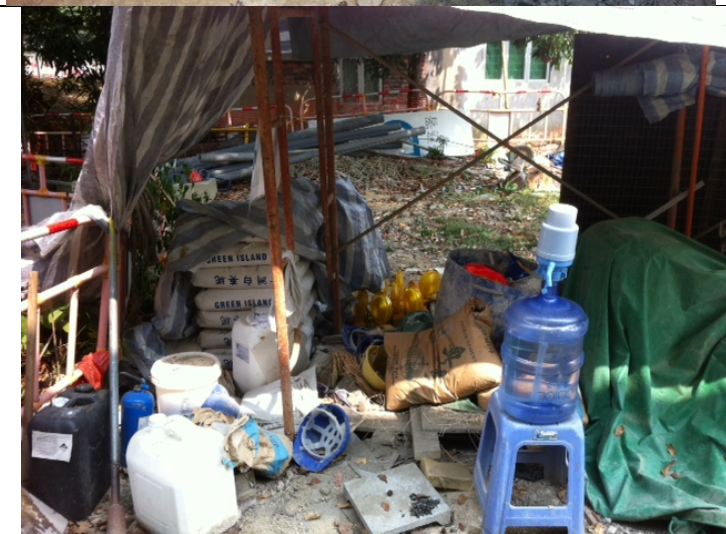
Photo 2:

Mix of construction material and unused chemical drums was observed inside the storage area in Shui Tsui San Tsuen Pumping Station, housekeeping should be improved.

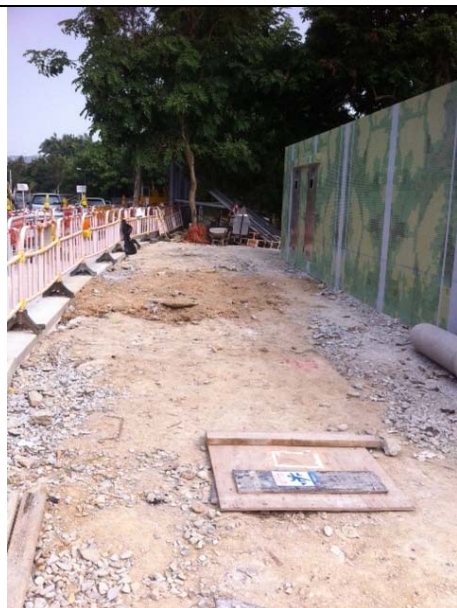
1. The C&D waste in Shui Tsui San Tsuen Pumping Station was found to be removed.

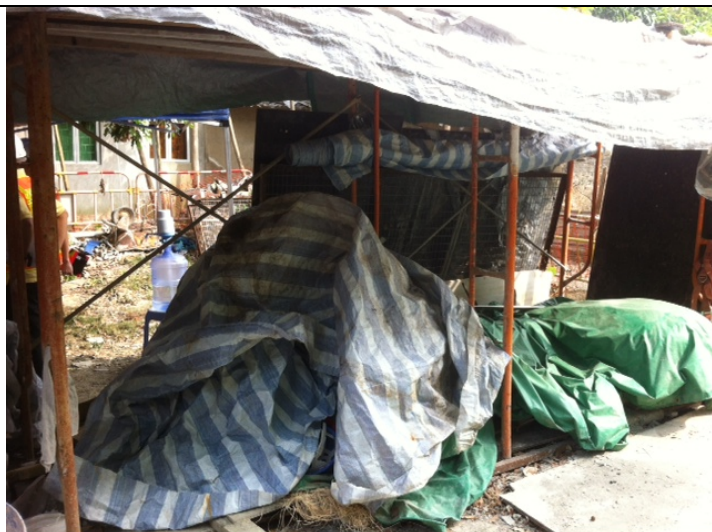
2. Housekeeping in the storage area in Shui Tsui San Tsuen Pumping Station was found to be improved.

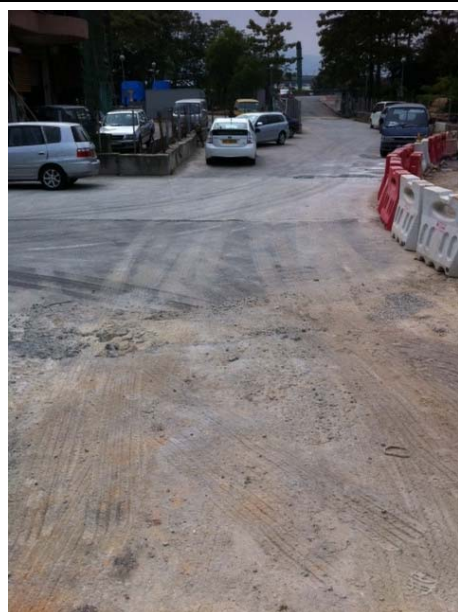
Photo 1:

Mud trail was observed at the exit/ entrance of the site of Ha Tsuen Sewage Pumping Station, watering at the site exit should be applied more frequently.

| Date | Findings / Deficiencies | Follow-Up Status |
|---|---|---|
| 18 October 2012 | <ul style="list-style-type: none"> <li>Mud trail was observed at the exit/entrance of the site of Ha Tsuen Sewage Pumping Station, watering at the site exit should be applied more frequently.</li> </ul> | <ul style="list-style-type: none"> <li>Watering was found to be applied at the site exit of Ha Tsuen Sewage Pumping Station during site inspection on 24 October 2012.</li> </ul> |
