JOB NO.: TCS00491/09

DSD CONTRACT No.: DC/2009/08

CONSTRUCTION OF YUEN LONG SOUTH BRANCH SEWERS AND EXPANSION OF HA TSUEN SEWAGE PUMPING STATION

34TH ENVIRONMENTAL MONITORING & AUDIT MONTHLY REPORT – NOVEMBER 2012

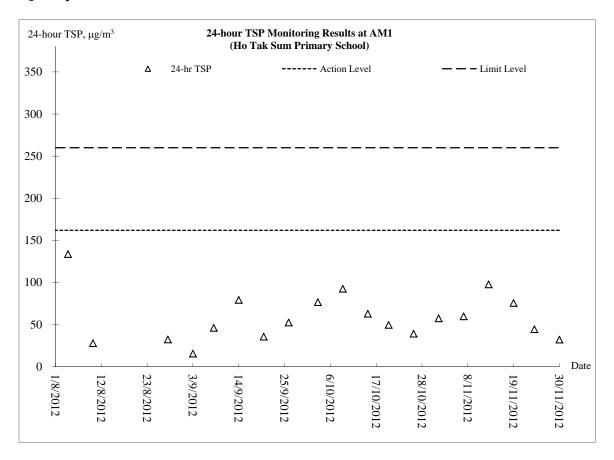
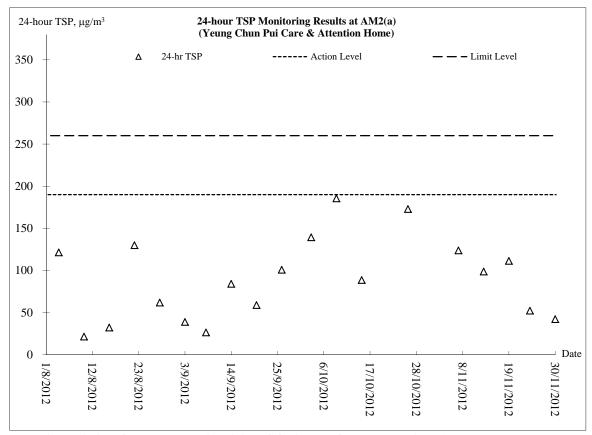
Air Quality - 24-hour TSP

Remark: newly location AM2(a) replaced the original AM2 since 7 November 2012.

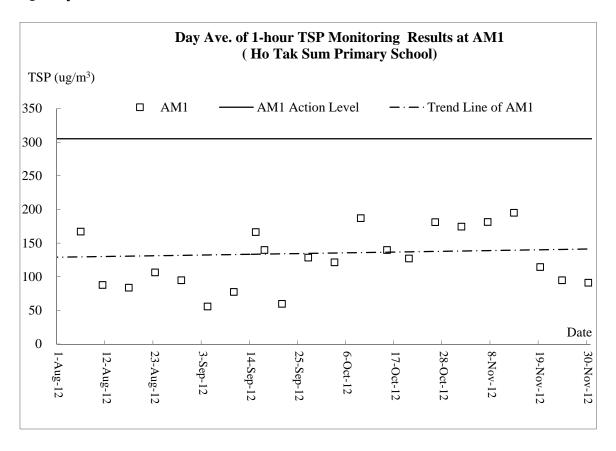
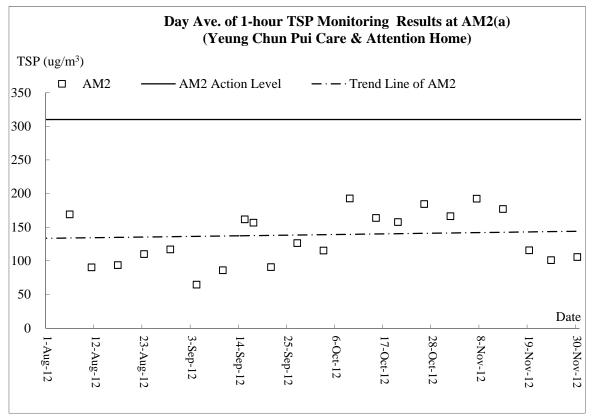
Air Quality – 1 hour TSP

Remark: newly location AM2(a) replaced the original AM2 since 7 November 2012.

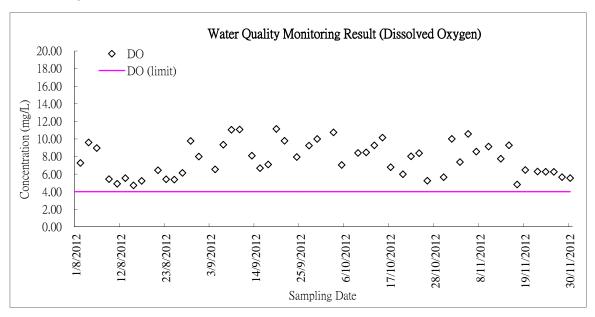
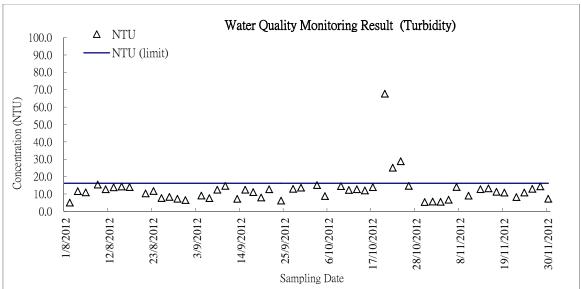
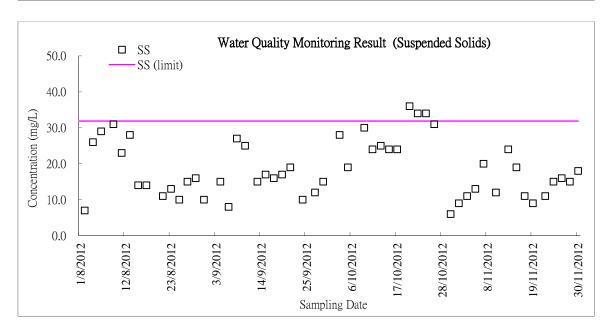
Water Quality - Local Stream Course (R1b)

4.11 In Reporting Period, no exceedance of water quality monitoring recorded at water samples collected from location "R1b". No NOE was therefore issued and no corrective measures recommended.

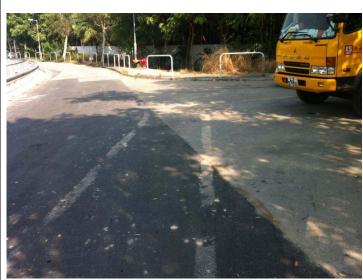
Photo 1: Mud trail was observed at the access road of Shui Tsui San Tsuen, the Contractor should clear the mud or apply water spray on the road regularly.
