DSD CONTRACT No.: DC/2009/08

CONSTRUCTION OF YUEN LONG SOUTH BRANCH SEWERS AND EXPANSION OF HA TSUEN SEWAGE **PUMPING STATION**

46TH ENVIRONMENTAL MONITORING & AUDIT MONTHLY REPORT - NOVEMBER 2013

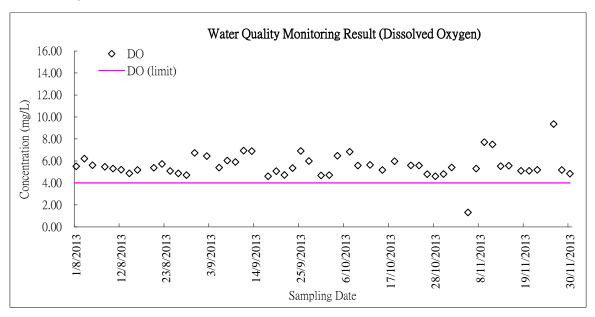
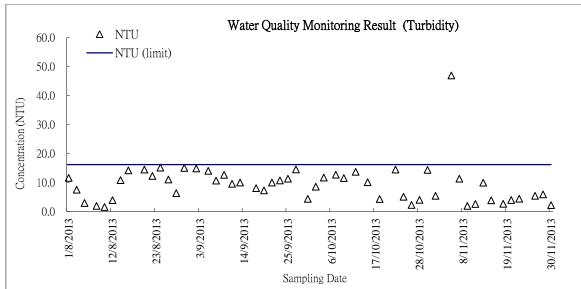
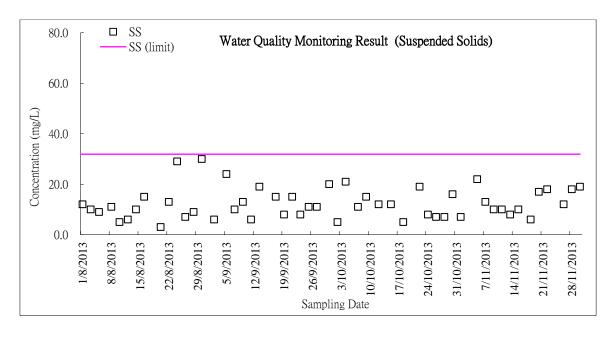
Water Quality - Local Stream Course (R1b)

- 4.09 During the Reporting Period, field measurements showed that water temperature and pH value of the local stream are within 19.2°C to 28.7°C and 7.3 to 8.2 respectively.
- 4.10 In Reporting Period, two (2) Limit Level exceedances were recorded at water samples collected from location "R1b" on 5 November 2013. NOEs were issued to relevant parties upon confirmation of the results. The investigation for the cause of exceedance was completed and the result is presented as follow:
