**SHA TIN NEW TOWN STAGE II
CONTRACT NO. ST 86/2000
CONSTRUCTION OF ROAD T7 IN MA ON SHAN
ENVIRONMENTAL MONITORING AND AUDIT
MONTHLY EM&A REPORT - AUGUST 2003**

Report No.: 23156-33

MONTHLY EM&A REPORT - AUGUST 2003

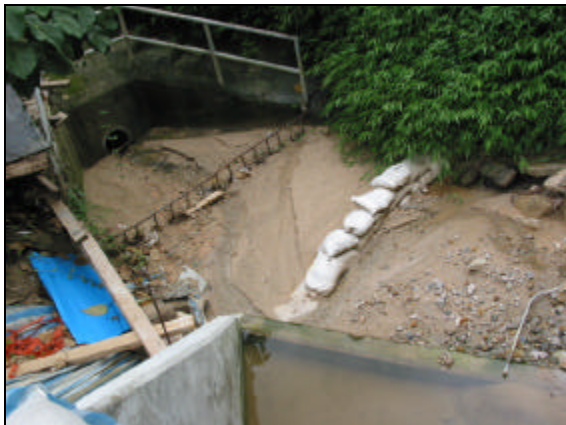
Figure 6-1 – The silty channel at stream S28.

- Five Construction Noise Permits (CNP) for the construction works near Saddle Ridge Garden, Heng On Estate, Cheung Muk Tau Village, Heng On Estate and Lee On Estate were issued from EPD on 18th, 13th, 16th, 20th and 22nd August 2003 respectively. Details of the permit conditions are given in CNP No. GW-TN0272-2003, GW-TN0273-2003, GW-TN0276-2003, GW-TN0280-2003 and GW-TN0285-2003 respectively. (Appendix 7).
- Silt was observed at stream S28 and channel along discharge point no. 7. As instructed by ET, the Contractor had cleaned up the concerned areas immediately. Photos showing the silty channel at stream S28 and channel along discharge point no. 7 are given in Figure 6-1 and Figure 6-2 respectively.

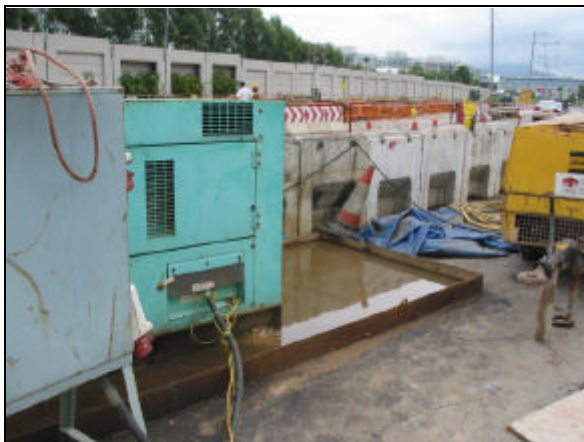
Figure 6-3 – Stagnate water in drip tray.

- Stagnate water was observed in the drip tray. As instructed by ET, the Contractor had cleaned up the concerned area. Photo showing the stagnate water in drip tray is given in Figure 6-3.

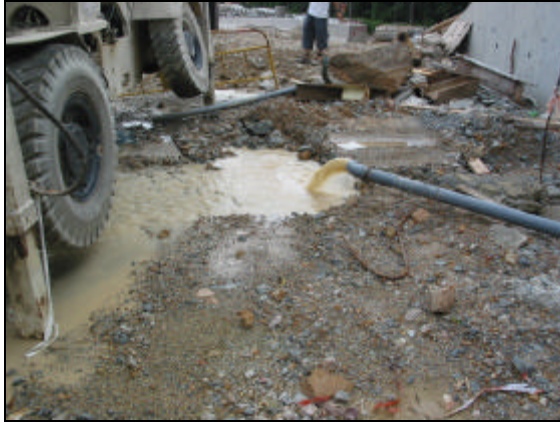
Figure 6-4 – Surface runoff at Portal D area

- Surface runoff was observed at Portal D area. As instructed by ET, the Contractor had agreed to divert surface runoff to channel near Portal D area via sedimentation system. Photos showing the surface runoff at Portal D area are given in Figure 6-4 and Figure 6-5 respectively.

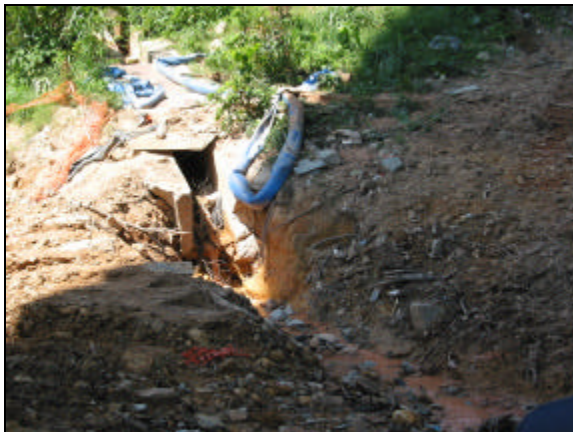
Figure 6-6 - The exposed surround of channels near discharge point no.4

- The exposed surrounding of channels were observed near discharge point no.3 and no.4. As instructed by ET, the Contractor agreed to cover or hydroseed the exposed slopes. Photo showing the exposed surround of channels near discharge point no.3 and no.4 is given in Figure 6-6 and Figure 6-7 respectively.
